THOMAS PARK POOL AUDIT

CITY OF COLLEGE STATION
Home of Texas A&M University®

March 2018

Kimley»»Horn

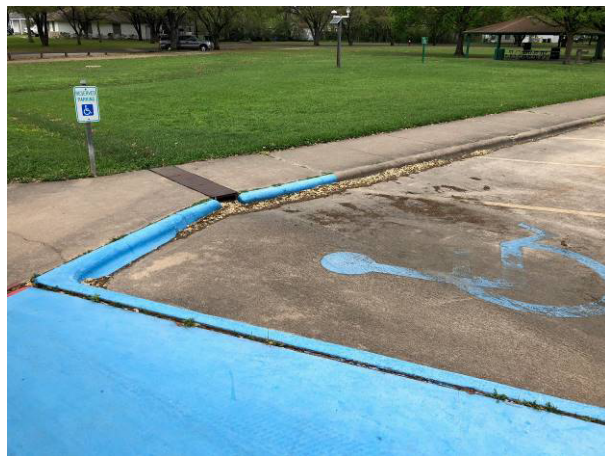
The current space marked as an accessible space does not meet Section 206 of the 2012 Texas Accessibility Standards that require an accessible route from the parking area to the building entrance. The parking space also fails to meet Section 502 of the Texas Accessibility Standards which also requires a 60" minimum marked access aisle that connects to the accessible route.

To meet the 2012 TAS standards, the parking lot would require restriping, a curb cut and accessible ramp needs to be provided and the entire path to the entry should be less than 2% cross slope.

Opinion of probable cost: \$15,000

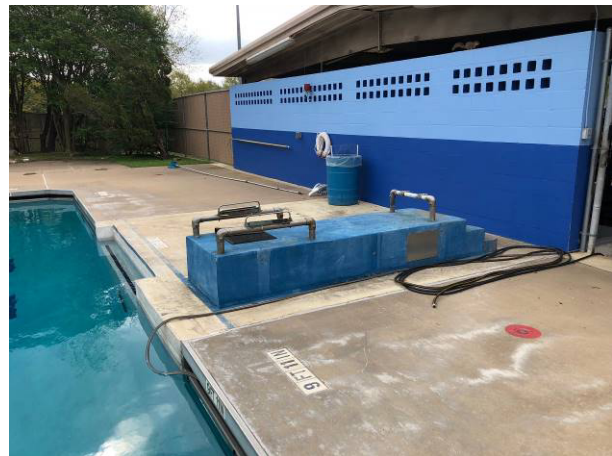
However, access around the pool does not meet Section 265.186 of the Texas Administrative Code near the old diving board platform. The platform creates a structure that could potentially be used as a diving platform and restricts emergency access around the south side of the pool. The pool deck should have a minimum width of 6 feet to meet post 10/01/99 pools.

Remove the 1-Meter dive stand. Verify with a structural engineer that removal of stand does not impact the structural slab for the pool piping tunnel below. Replace pool deck in the demolition area.

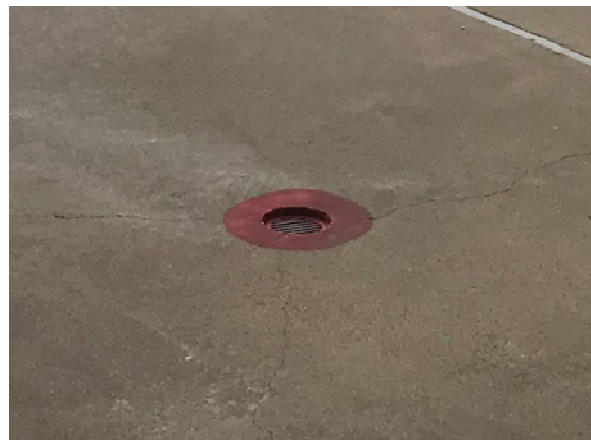
Area drains are located in the pool deck, evenly spaced and offset approximately 6 ft. behind the pool edge and two locations within the pool deck at shade structure location. There are numerous deck drains that have sunk where the drain grate cover is below the surface of the deck concrete. These areas are outlined in red and pose a risk as a tripping hazard. In addition, there is concern of a potential failure of drainage piping under the pool deck.

Pressure test pool deck drainage piping. If leaks are found, replace all deck drainage piping and pool decks.

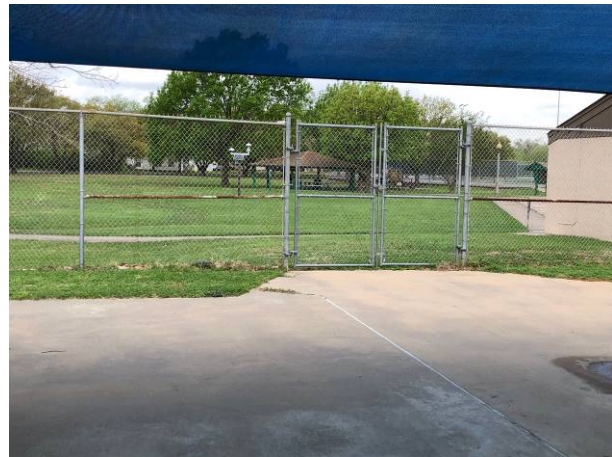
The pool enclosure is approximately 8 feet tall and the material is chain-link. Section 265.200 of the Texas Admirative Code requires the enclosure to be a minimum of 6 feet tall for this type of facility, be designed so that it is not readily climbed and have no openings in the enclosure of which a 4-inch sphere can pass.

The height and material of the fence meets the intent of the current code, however there are several sections that include a mid-rail which could potentially be used to climb the fence. There are also areas located on the bottom of the fence that show greater than 4" openings.

Closing the 4" openings and removing the mid-rails on the chain-link fence is recommended to comply with the intent of Section 265.200 of the Texas Administrative Code.

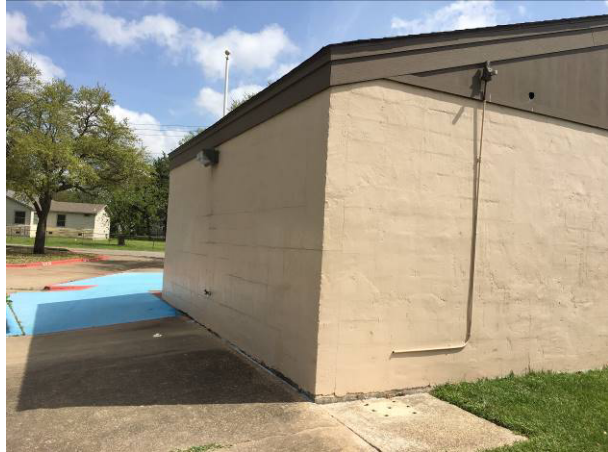
The exterior walls of the building show signs of movement. This is evidenced in the appearance of cracking along the mortar joints of the concrete masonry. The exterior cementitious skim coating of the building is showing signs of aging, including this cracking and discoloration and water infiltration along the cracking. The siding portions of the exterior are in reasonable condition, though one hole was observed on the south side.

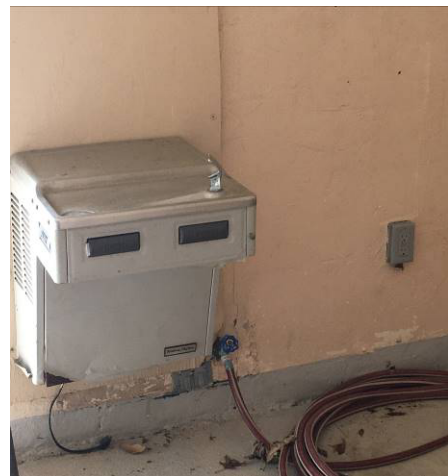
This review did not include an assessment of concealed wiring systems but only items observed on building exposed surfaces. No power outlets were observed in either restroom or shower area. In the area of the water fountain, an outlet was observed below the fountain and adjacent to a hose bib. This outlet is not a ground-fault interrupter and is thus not compliant with code, as it is within 5 feet of a water source. Electrical panels are located within a closet off the guard room and appear to have appropriate clearances. Building lighting is working and is adequate for the room functions. However, no exit signs or emergency lighting are present.

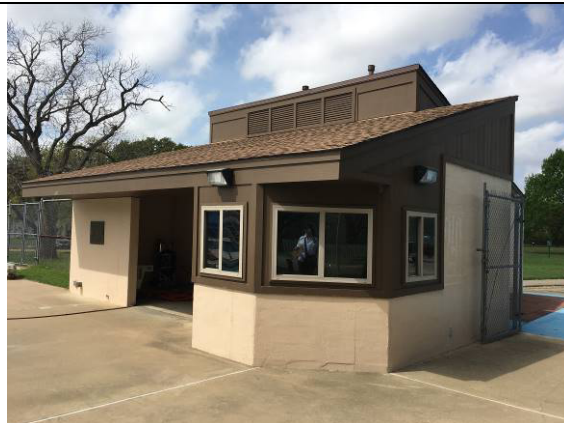
1. The admission window is not accessible.

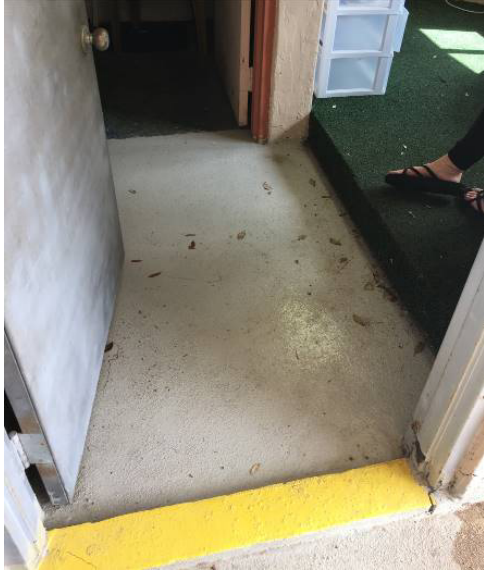
<p>2. Curbs within the building cause the guard room and shower areas to be inaccessible</p>

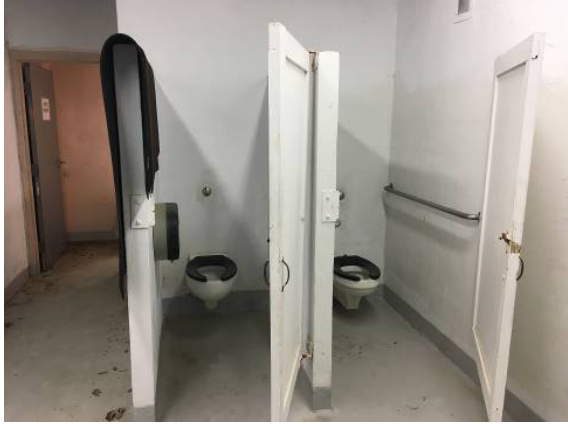
<p>3. There is no toilet stall in either restroom that complies with accessibility requirements.</p>

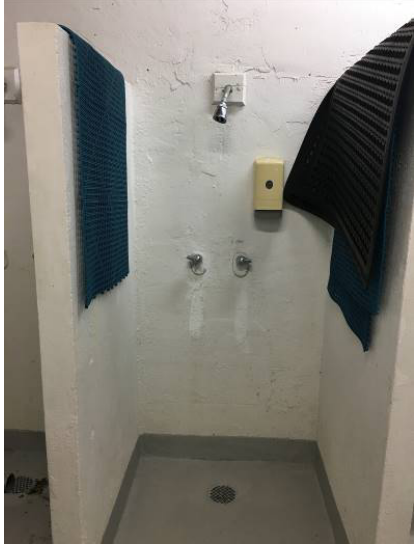
<p>4. Though shower stall size could comply, the showers are missing the appropriate plumbing arrangement and fixtures as well as seating that is required for accessibility.</p>

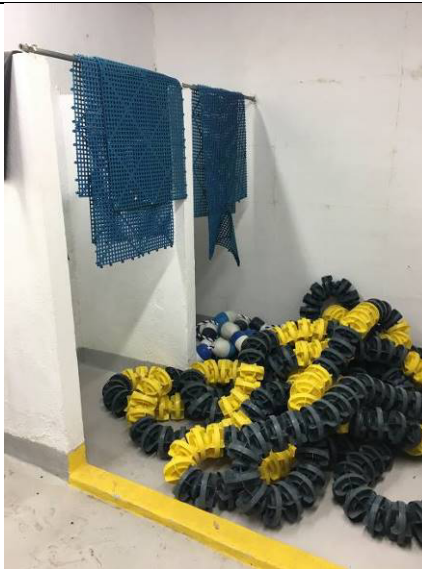
5. Showers are missing the necessary clear floor area in front of the showers for wheelchair access.

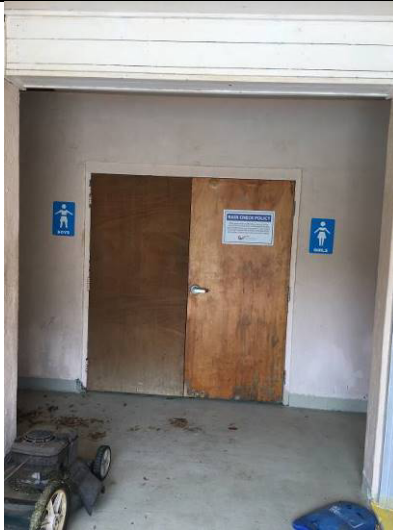
6. Doors to the restrooms do not meet the necessary push and pull clearances.

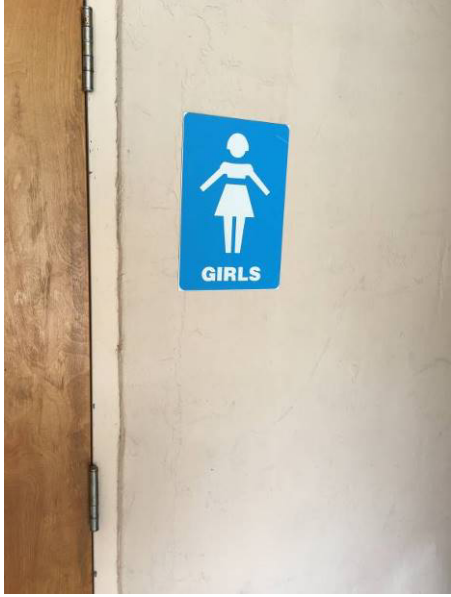
<p>7. Restrooms signage is not compliant in graphics, placement, and is missing the required Braille.</p>

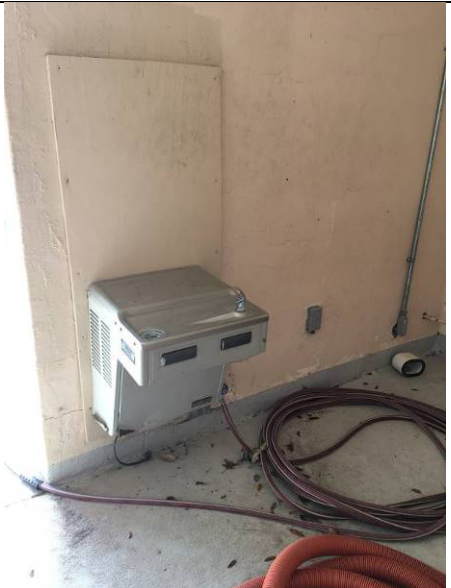
<p>8. The water fountain is required to accommodate high-low access by having 2 units; only one unit is provided.</p>

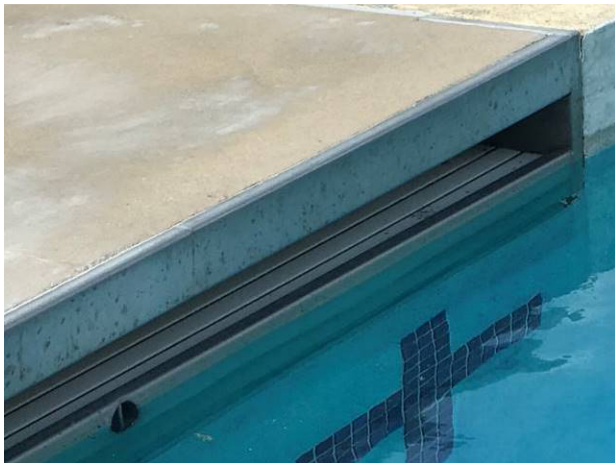
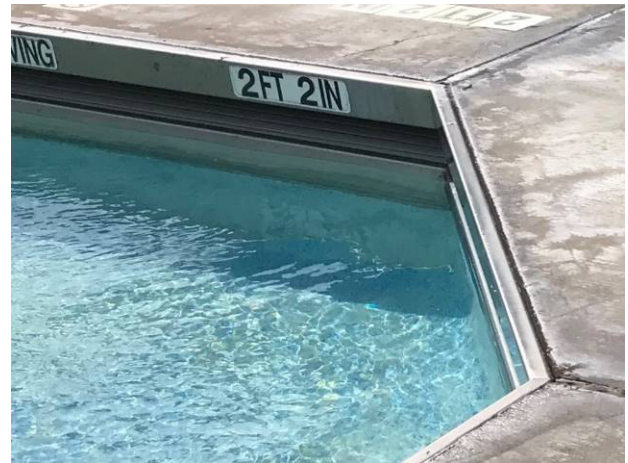
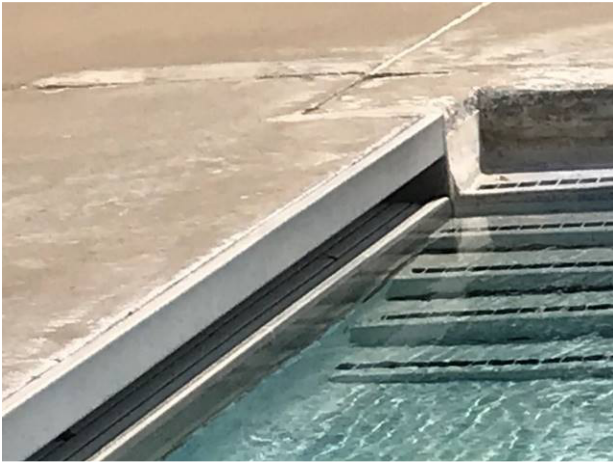
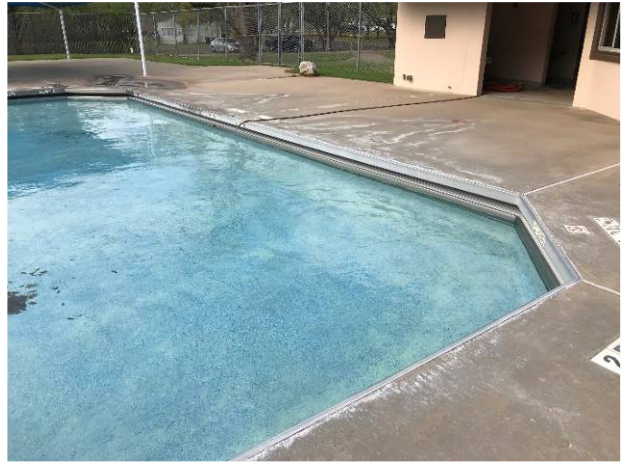
The Lap/Recreation Pool perimeter overflow system is a fully recessed stainless-steel gutter system with an integral pressure tube for return water. The stainless-steel gutter was retrofitted into this pool in 2002 along with updates to the pool concrete, main drains, filter room piping and pool finishes.

Due to the excessive daily water loss and consistent wet spots on the pool deck, its logical to assume that a portion of the water loss is due to leaks in the pool gutter. The likely location is the pressure tube providing filtered and chemically treated water back to the pool. Typically, leaks in stainless steel gutters can be found at weld joints, change of direction locations and flange locations.

At the time of my review, water level in the pool was approximately 1 ½" to 2" below rim overflow condition.

The gutter pressure tube and all connecting piping (suction and pressure) should be pressure tested to confirm all leak locations. Deck removal will likely need to occur to repair leak points. Any welding repair to the stainless-steel gutter should be performed by a qualified welder experienced with stainless steel pool gutters

Opinion of probable cost: \$25,000 (does not included deck replacement)

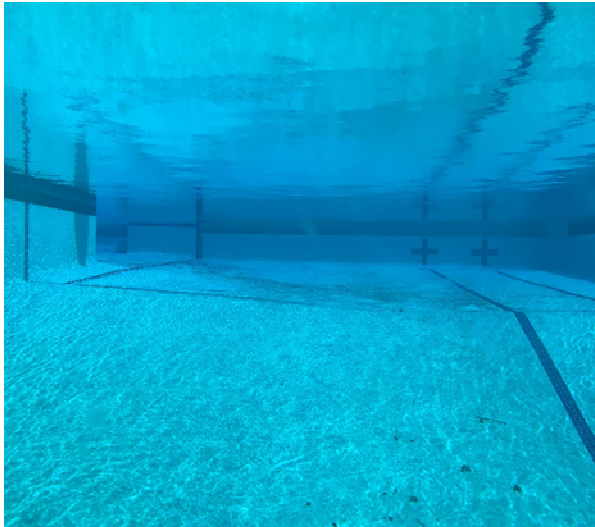
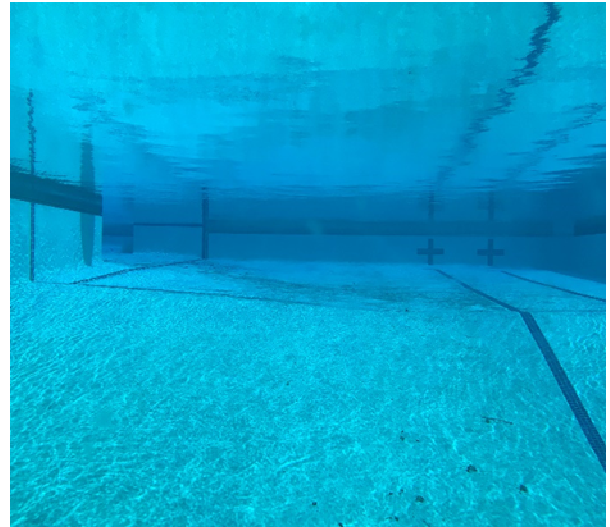
The original pool shell was constructed in 1979 and renovated in in 1993 & 2002. It should be noted that the current life expectancy of a concrete pool shell is approximately 30 to 40 years. The pool was full of untreated water at the time of my visit. Therefore, my inspection of the pool shell and finish was minimal. Pool staff reported that the pool loses an estimated 200,000 to 225,000 gallons of water a month. This calculates to 6,700 to 7,500 gallons a day or 5+ gallons a minute.

Pool drawings provided by city staff indicate that the pool experienced extensive concrete crack and joint repair in 1993. Additionally, the pool was originally designed with floor inlets. All floor inlets were “capped and abandoned” in 2002.

Pool staff also relayed that the pool expansion joints have been a concern for pool leakage.

The pool finish could not be observed since the pool was full of water. Staff relayed that the plaster finish is questionable and needs to be replaced. Typically, plaster finishes for outdoor pools last 8 to 10 years based upon water quality and proper chemical balance.

Due to the age and current condition of the existing pool structure, Counsilman-Hunsaker recommends draining the pool, remove the plaster finish to the bare concrete pool structure (methods may include sandblasting, hydro-blasting, or other mechanical abrasive means) and consult a structural engineer to inspect the structural integrity of the pool. Hammer testing or borings may be required to determine potential voids under the pool shell.

Opinion of probable cost: \$5,000 (Structural Inspection)
\$50,000+ (Epoxy injection/crack repair & mud jacking)

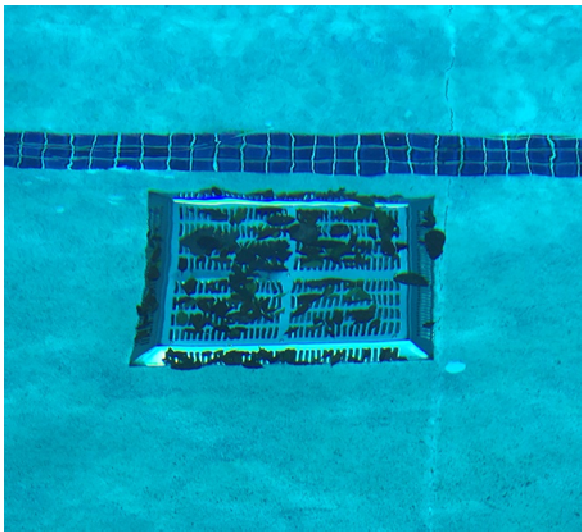
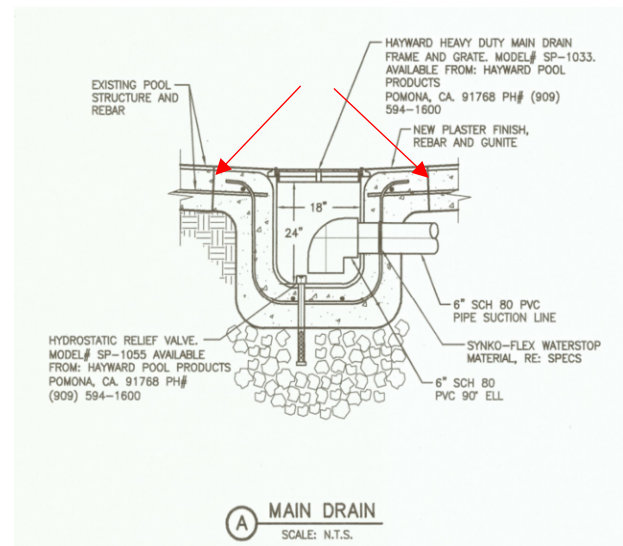
The main drains in the Lap/Recreation Pool could not be inspected due to the pool being full of untreated water. The drain covers appear to be the Hayward SP-1033 installed as part of the 2002 renovation. Please note, these main drain covers are not VGB (Virginia Graeme Baker) compliant. All pool main drains in public pools are to be compliant per the Virginia Graeme Baker Pool and Spa Safety Act (VGB) ASME/ANSI A112.19.81 signed into Law on December 19, 2007.

The main drain replacement detail shown below taken from the 2002 renovation drawings does not show water stop at the concrete cold joint. Unless this was addressed during construction, this could be contributing to the loss of water the pool is experiencing.

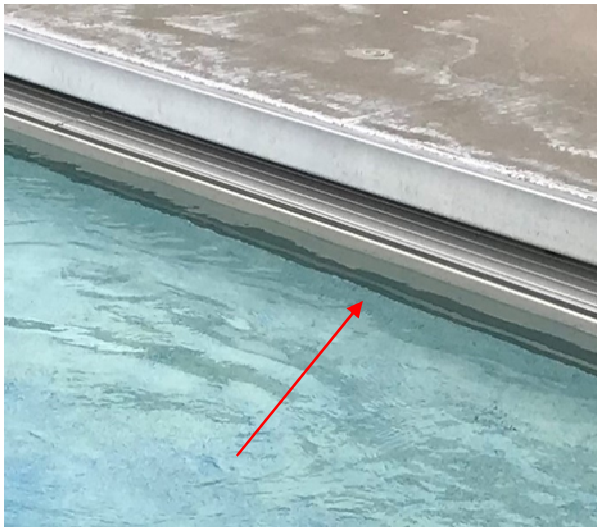
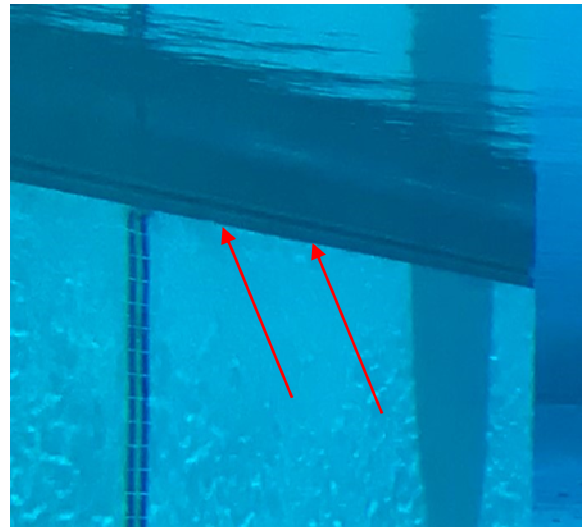
The Lap/Recreation pool water is treated and returned to the pool through a pressure tube integral to the pool gutter system. The pressure tube consists of multiple 5/16" holes around the perimeter of the pool at the base of the gutter introducing treated water back to the pool. This limits treated water distribution to areas near the pool gutter often starving the center of the pool of chemically treated water, particularly during high bather load. Pool staff noted that a wet area on the pool deck was related to a leak in the pressure tube on the stainless-steel gutter system.

Pool drawings provided by city staff note that all floor inlets were "capped and abandoned" in 2002. It is not indicated how these inlets were capped and verified as "water tight", to avoid future leakage. The original piping was cast-iron and the potential exists that this piping has now corroded to the extent that it has collapsed and created leak points and/or voids under the pool slab.

Pressure test stainless-steel gutter pressure tube system to pinpoint leak locations. Typically, leaks occur where the gutter changes direction, weld joints, and flange locations.

*Opinion of probable cost: \$3,500 (Leak Detection)
 \$12,000+ (Leak Repair)*

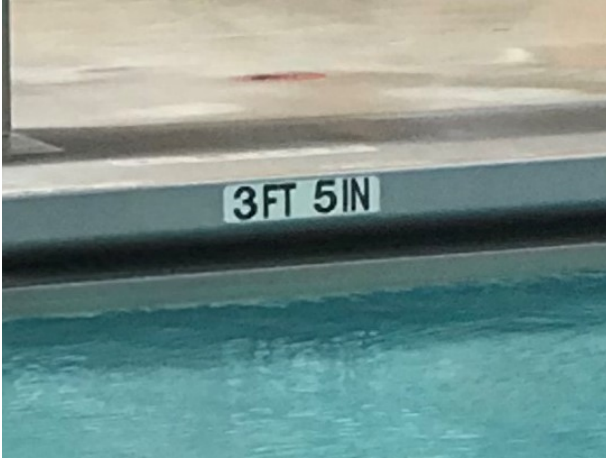
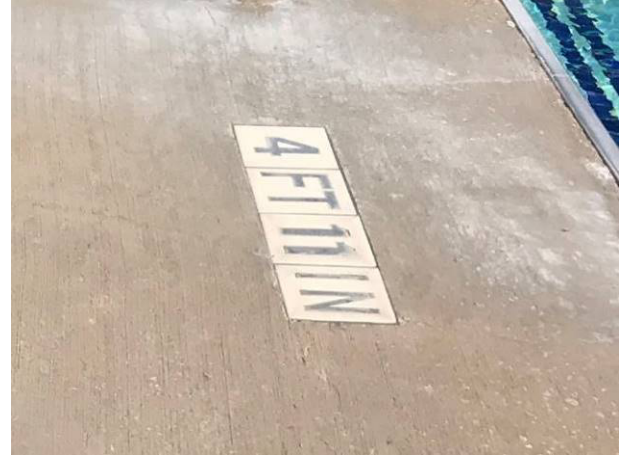
Horizontal depth markers are 6" x 6" tiles with 4" lettering located on the pool deck behind the recesses gutter. No diving markers are located on the pool deck at depths of 5'-0" and less. Vertical depth markers are located on the face of the stainless-steel gutter.

No action needed. Current depth markers meet all code and safety requirement.

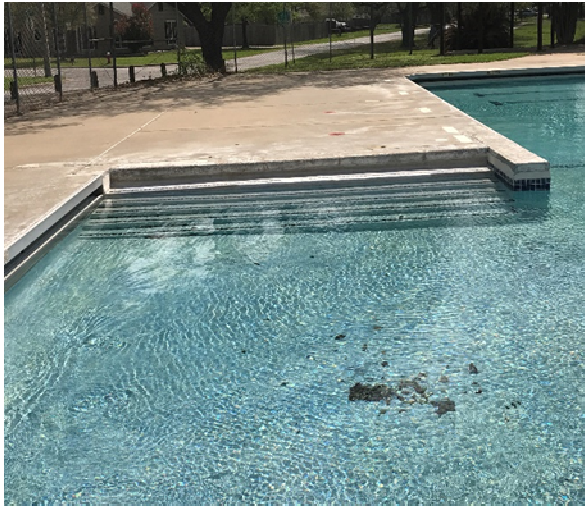
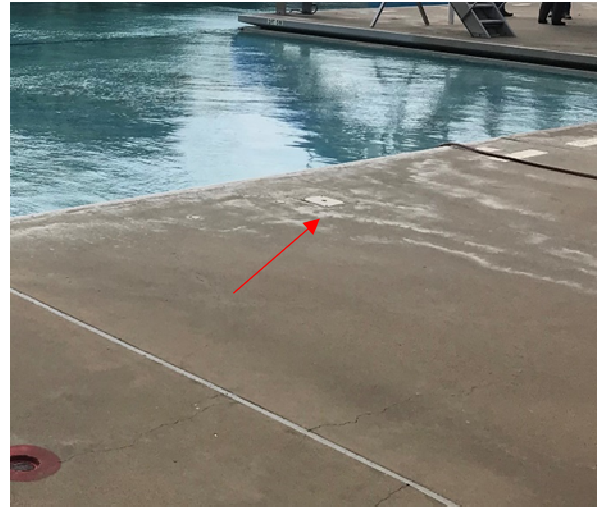
The Lap/Recreation Pool is equipped with four (4) sets of grab rails and one stair location with two entry rails. Pool Ladders and rails were removed and stored at the time of my review.

The only means of ADA compliance was a hydraulic handicap lift that was stored at the time of my review. Per the ADA requirements, any pool with a perimeter length more than 300 Linear Feet must have two (2) means of access. This can be accomplished by adding a third rail to the entry steps, adding a second pool lift or a portable stair.

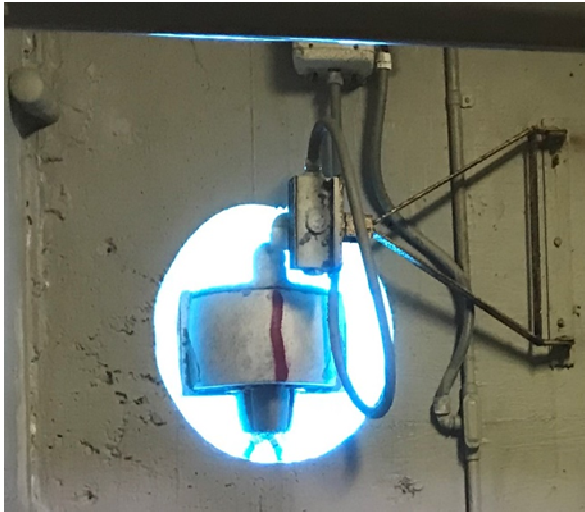
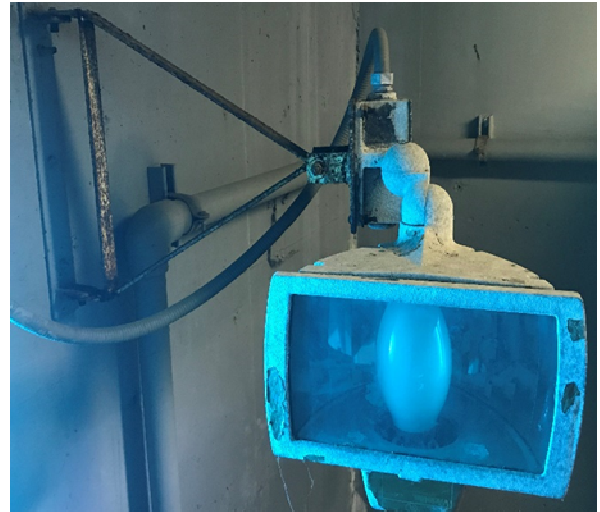
The Lap/Recreation Pool is equipped with one underwater light located at the deep end of the pool. The light is a dry-niche style light located within the filter room pump and piping pit. The view port for the light is watertight with no visible leaks. The light swing arm is operational and functions as designed. Pool staff relayed that the light is operational and is used occasionally.

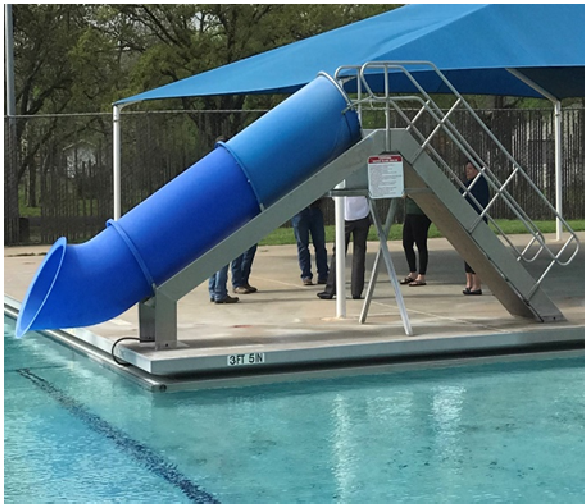
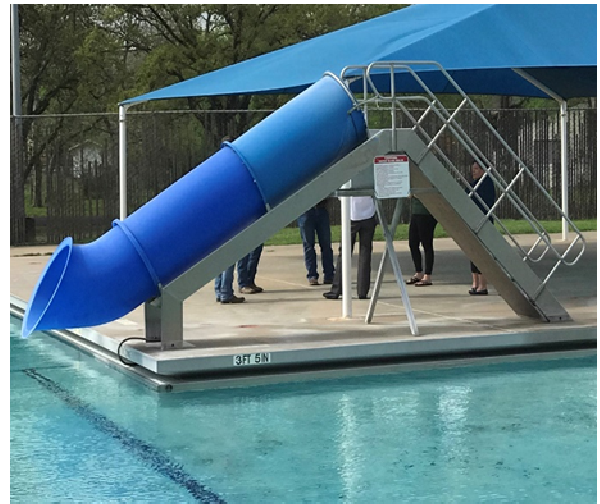
The Lap/Recreation pool is equipped with one (1) small closed flume waterslide. This waterslide is in the shallow area (4'-0") of the pool. The waterslide appears to be in good condition. Water is supplied to the slide via a pressure hose tapped into the stainless-steel gutter pressure tube supply system. The slide steel is required to be grounded per NEC 680. No grounding wire was visible.

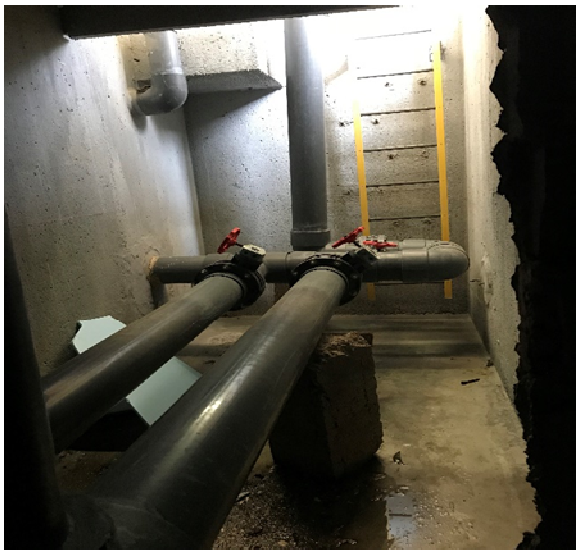
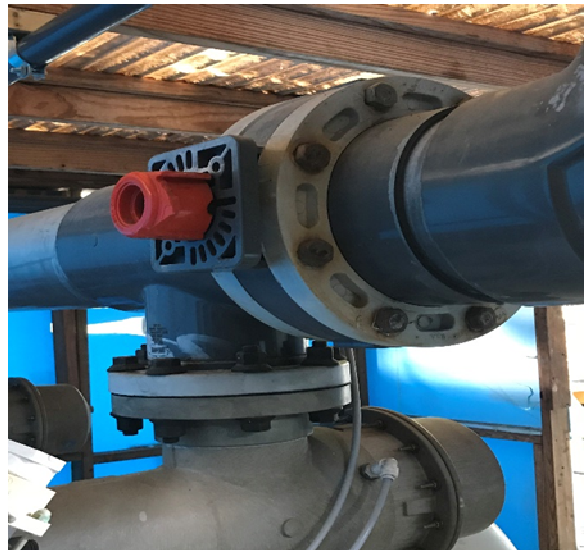
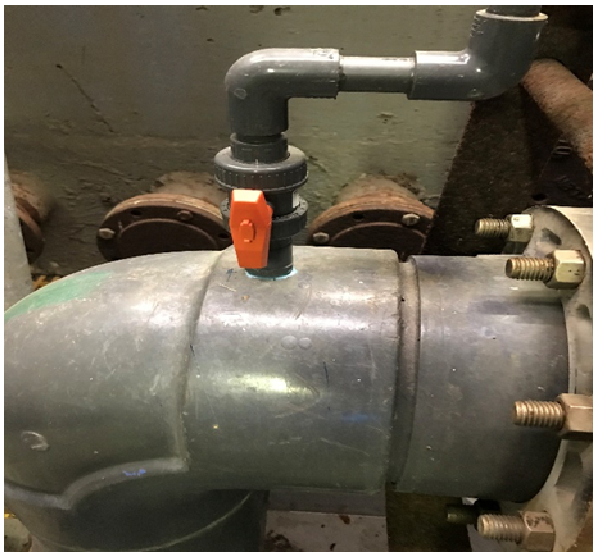
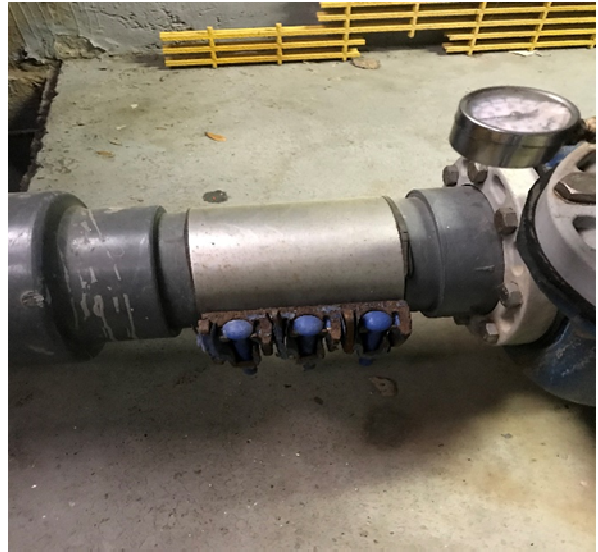
The visible piping in the mechanical/filter area was observed to be in fair condition. It is assumed this piping was placed in 2002 during the renovation. There are numerous locations where the piping has been compromised with drilled holes chemical monitoring and injection. Drilled holes generally lead to leaks over time. Additionally, there are multiple locations where repair couplings have been used. Repair couplings are designed to be a temporary fix until permanent pipe replacement can be installed. The piping in the mechanical/filter area was not color coded and did not have directional flow arrows. Per Texas Administrative Code, *"The piping system shall have direction of flow arrows indicated on the pipes."*

Overall, the filter room valves appear to be in working condition. There is one valve on the filter face piping that requires a new handle. Additionally, all valve hardware is corroding and replacement is recommended. Hardware on the repair couplings also need to be replaced.

Replace all valve, flange and repair coupling hardware with stainless steel hardware.

Replace valves as needed.

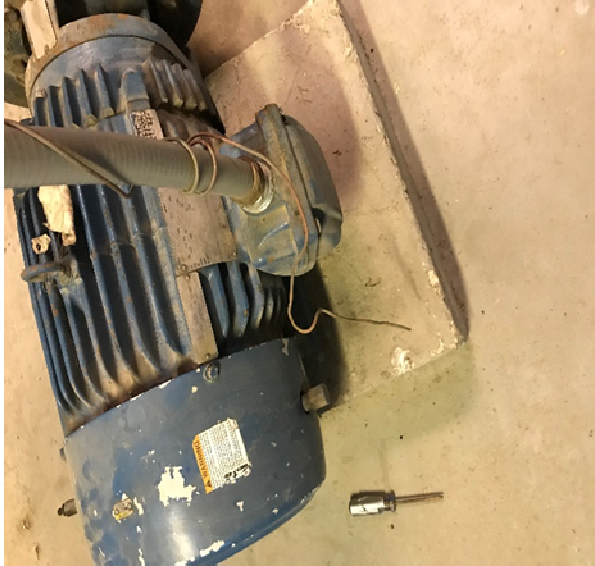
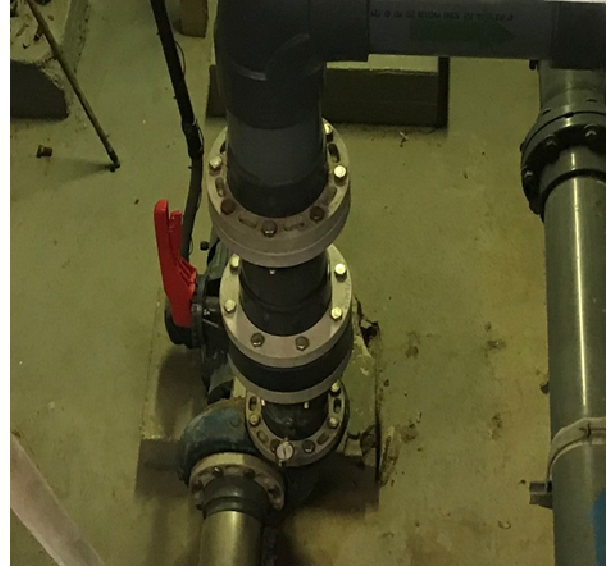
The filtration area is equipped with one (1), 1750 RPM, 208/460 Volt, 3 phase, 700 GPM, 70 TDH 20 HP recirculation pump. The pool pump motor was running warm, which is normal for a TEFC pool pump. No vacuum gauge was present on the intake side of the pump. The pump has a bonding wire wrapped around the electrical conduit mounted to the pump electrical box. Pool pumps are required to be bonded per NEC 680.

With the replacement of a new recirculation pump, it is recommended to provide a variable frequency drive (VFD) to the pump to increase pump efficiency and provide energy savings. A VFD should be a product manufactured for the commercial aquatics industry like a Pentair Acu-Drive (Danfoss) or a H2O-Technologies Smart Pump Control System (SPCS).

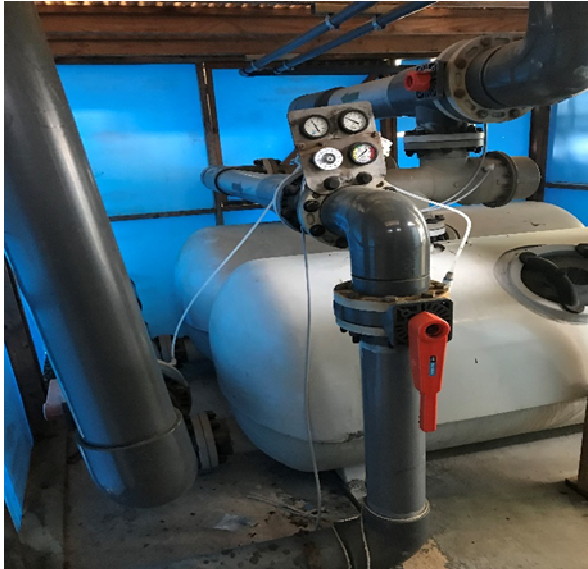
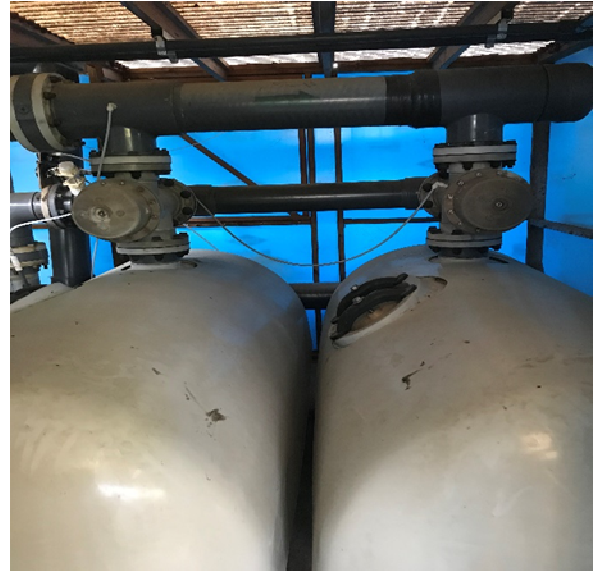
Currently, the filtration system consists of two (2) 48x84 horizontal high rate sand filters originally manufactured by Stark and now supported and produced by Paragon. The filters appear to be in good condition and according to pool staff, operate as designed. Pool staff was uncertain as to when the filtration sand was last replaced. Typically, filter sand is replaced every 10 years.

If the filter sand is older than 10 years, it is recommended to replace the sand. After filter sand is removed, carefully inspect the filter laterals to confirm no cracks or material failures. It is also recommended to replace the manway gaskets at the same time the sand is replaced.

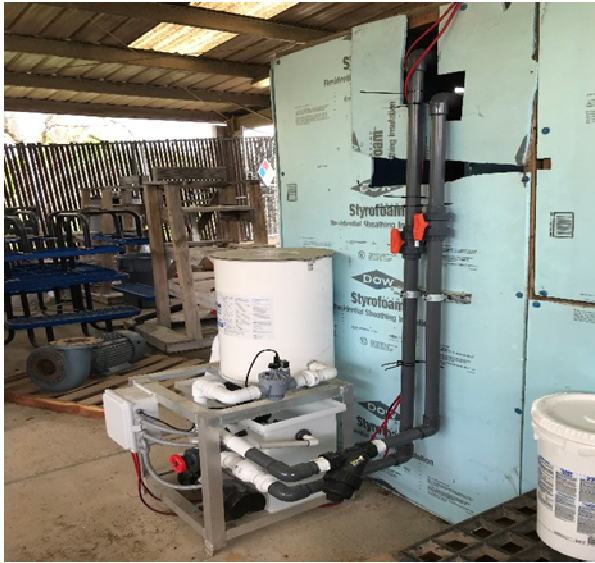
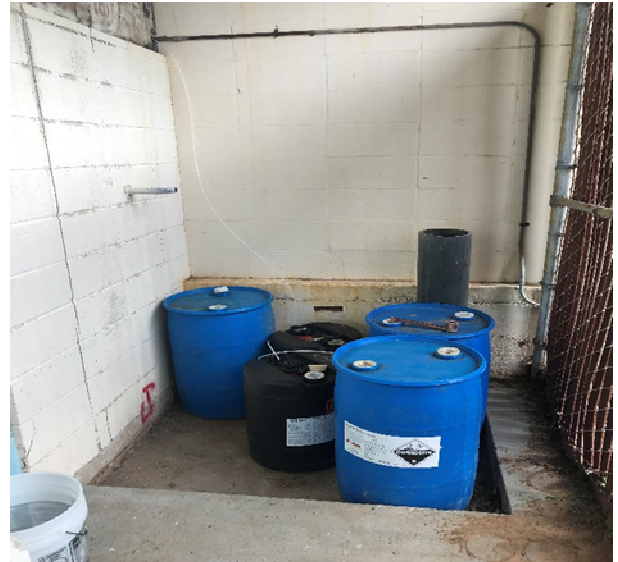
Currently, the pool sanitizer is Calcium Hypochlorite (dry chlorine) that is fed with a new Accu-Tab Model 3150 Chlorination System. The pH is controlled with muriatic acid that is pumped with two peristaltic pumps located next to the chemical controller. The chemical controller is a Chemtrol PC2000 which appears to be working as required.

Maintain probe life by cleaning with a soft tooth brush and dish detergent. It is also recommended to have extra probes in preparation of eventual probe failure.
