Exterior Envelope
Assessment

**Brazos County
Administration
Building**

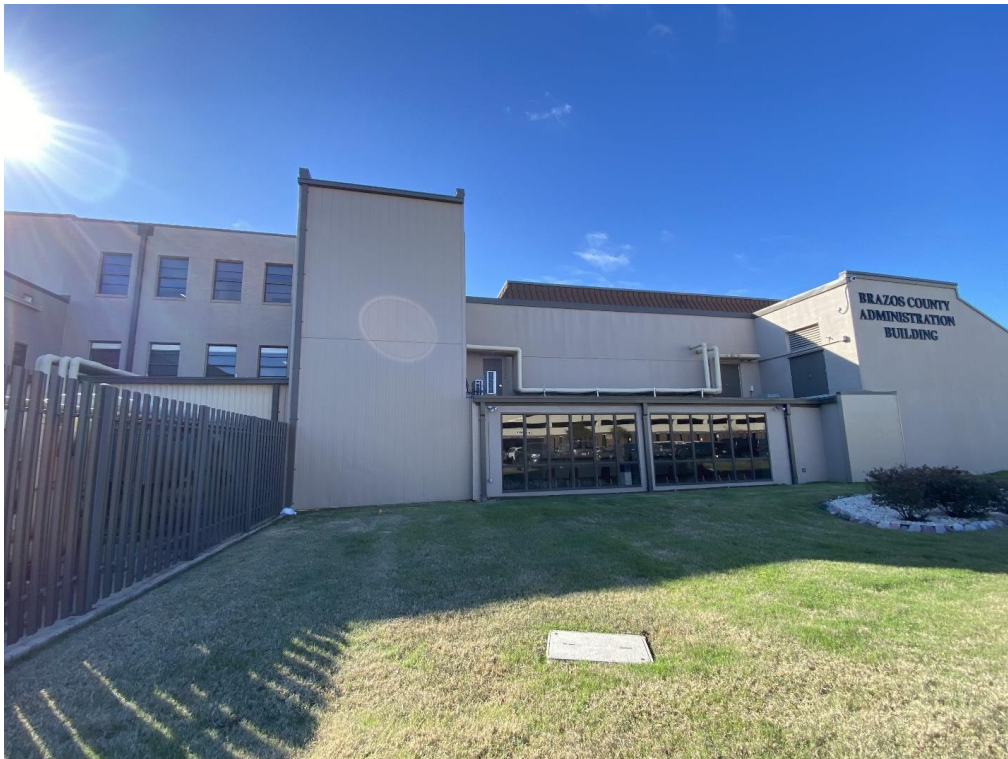
TABLE OF CONTENTS	2
ABBREVIATIONS	3
REPORT DEFINITIONS.....	3
PROJECT DATA	4
HISTORY	5
SITE PLAN	6
EXECUTIVE SUMMARY	8
OBSERVATIONS	9
RECOMMENDATIONS.....	12
PHOTOS.....	15
EXHIBIT A.....	36
EXHIBIT B.....	37
EXHIBIT C.....	38
EXHIBIT D.....	39

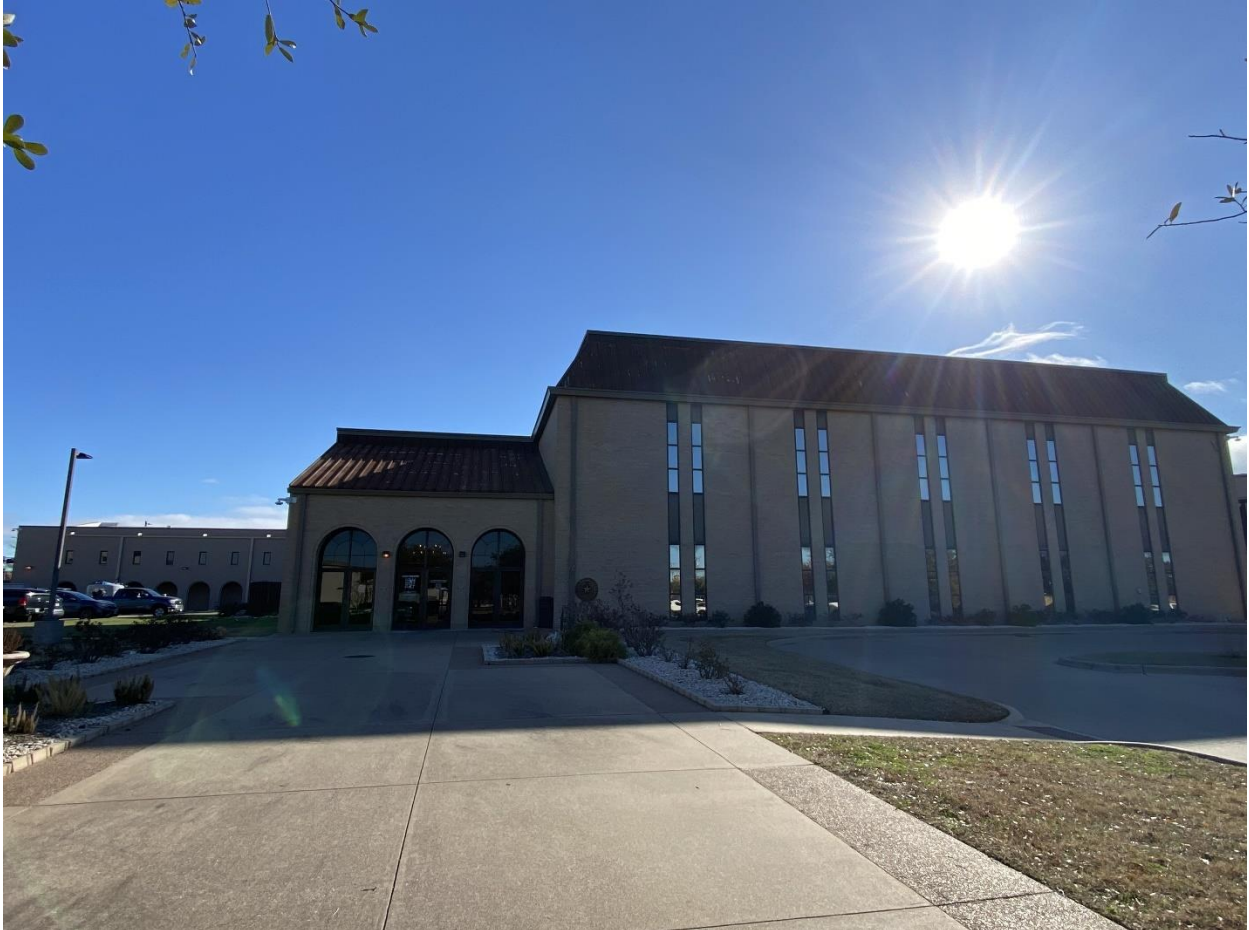
Construction Team:	Unknown	Design Code:	Unknown
Project Manager:	Unknown	Wind Speed:	Unknown
Architect:	Calhoun, Tungate & Jackson	Importance Factor:	Unknown
Contractor:	Unknown	Exposure Cat:	Unknown
Complete:	1970s	Levels:	3
Building Use:	Administrative	High Rise:	No
Storm Damage:	Damages appear from building age, not storm related	Approximate SF:

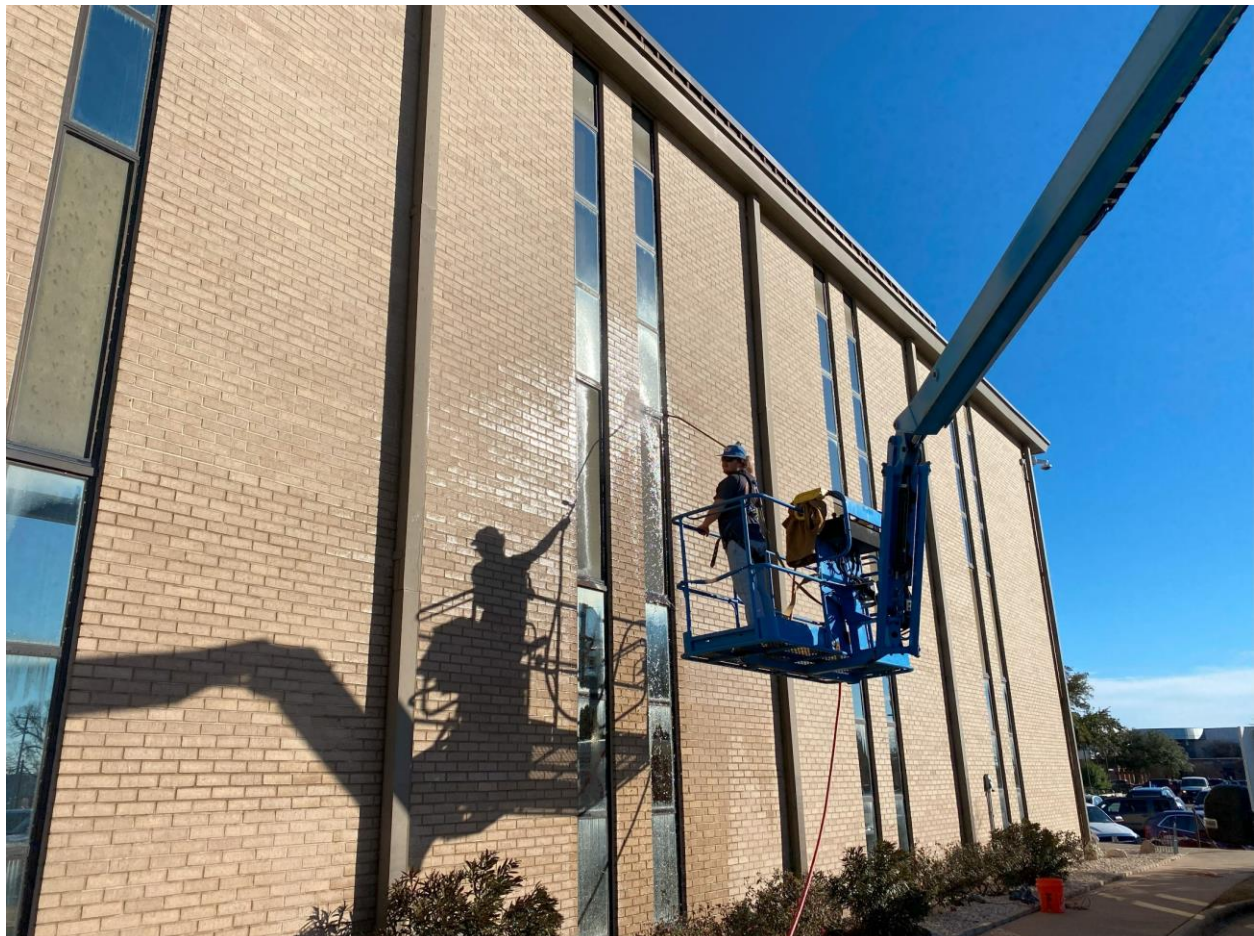
Zero/Six Consulting, LLC (ZSC) was commissioned in January of 2024 to perform a stage three facility evaluation of the building envelope with emphasis on the north wing and sanctuary windows (as they are planning to be replaced in the near future) and provide a written narrative outlining findings of the assessment and recommendations of repairs. This report is that narrative, but it alone is not an adequate vehicle to direct future remedial services. All future construction remedial activities should be master planned and described via detailed construction documents.

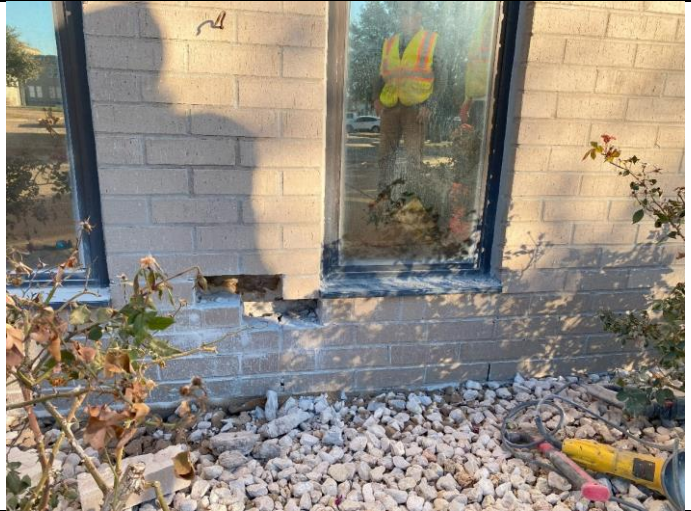
No waterproofing observed at sub-wall

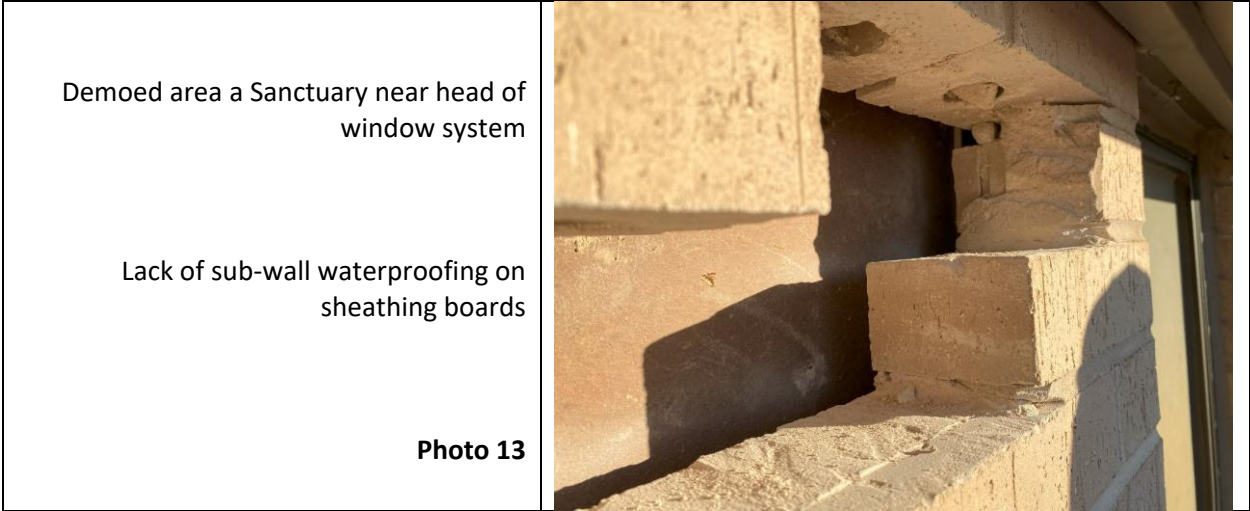
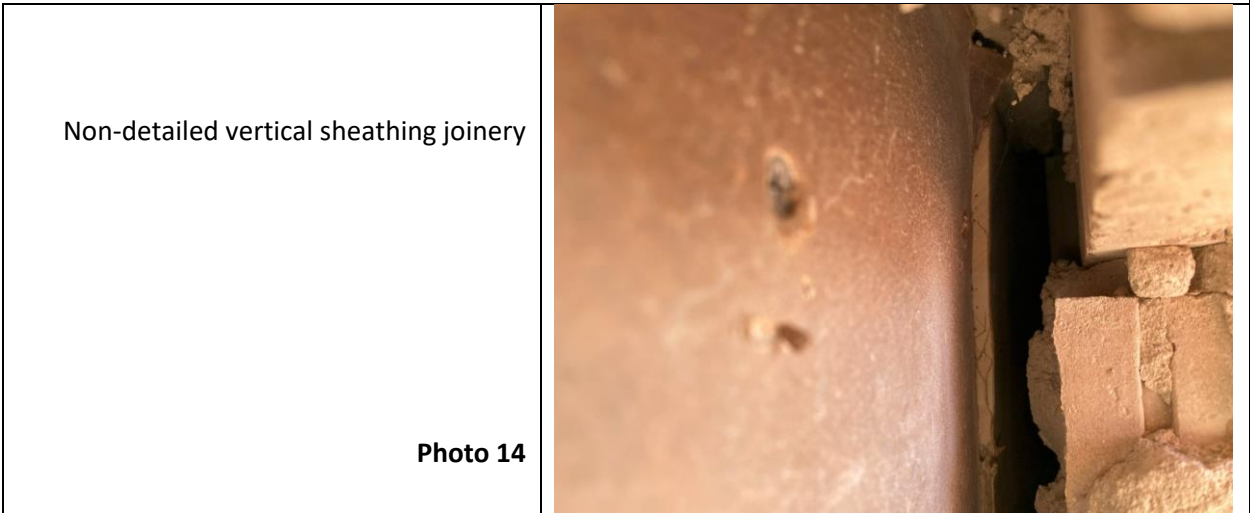
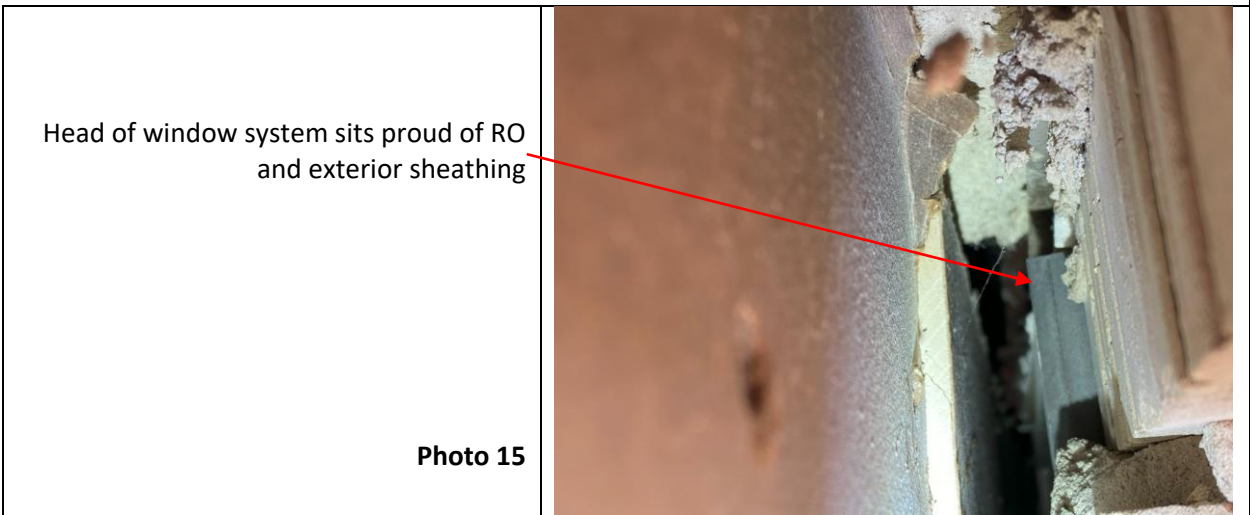
Typical windowsill condition at Sanctuary

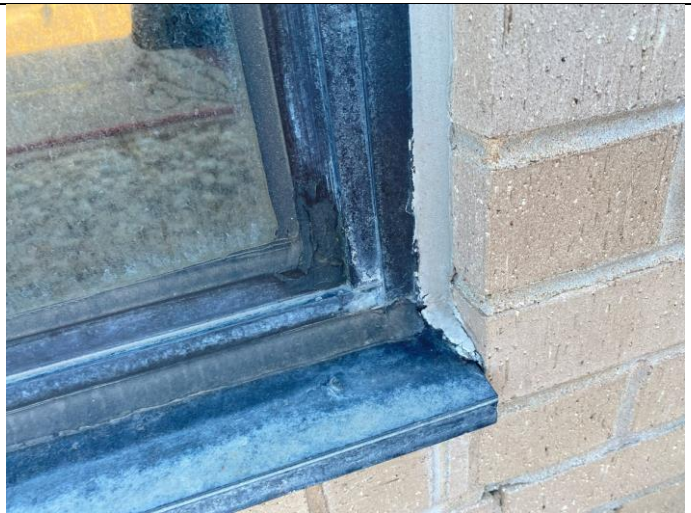
Wet seal detailing with deteriorated sealant joints observed

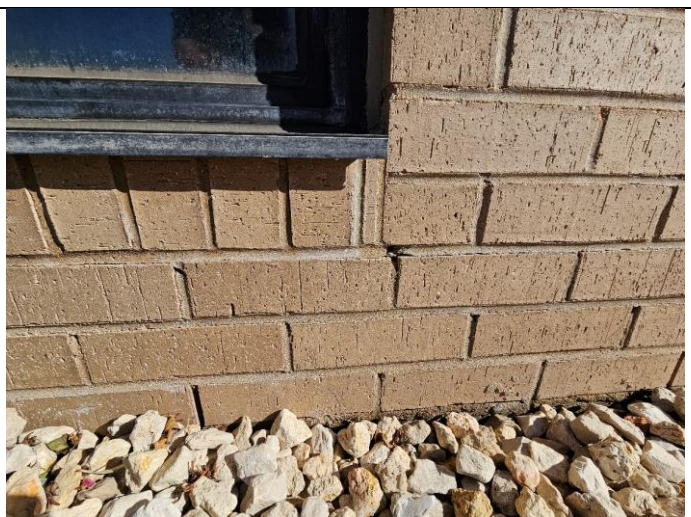
Voids in masonry observed adjacent to window systems

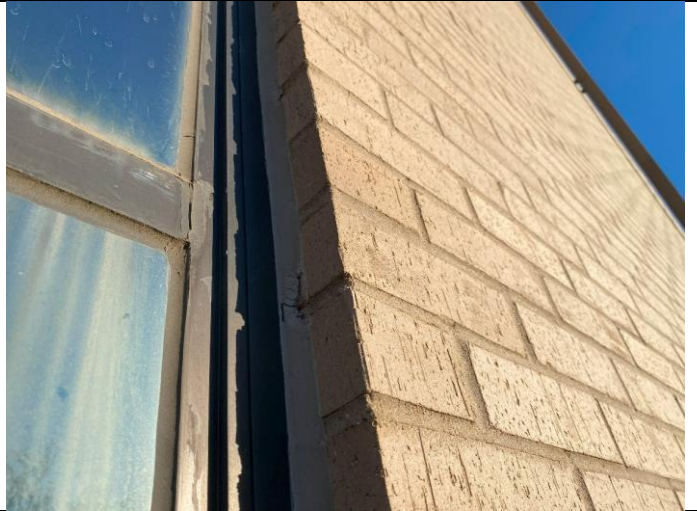
Failing sealant joinery observed at heads
of window system

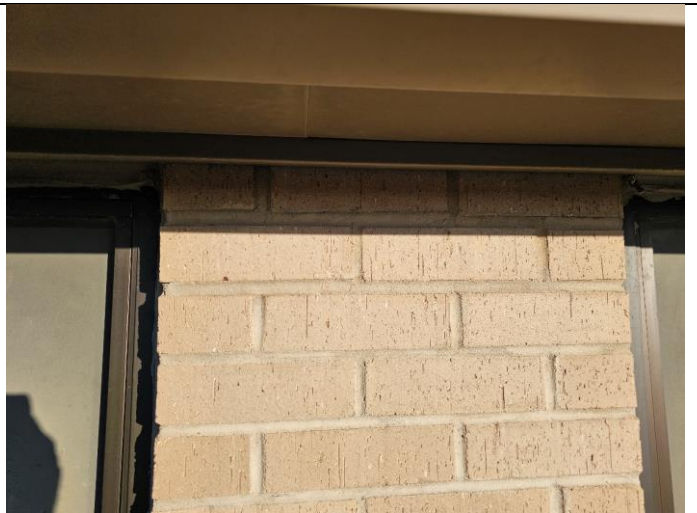
Failing sealant joinery at window head

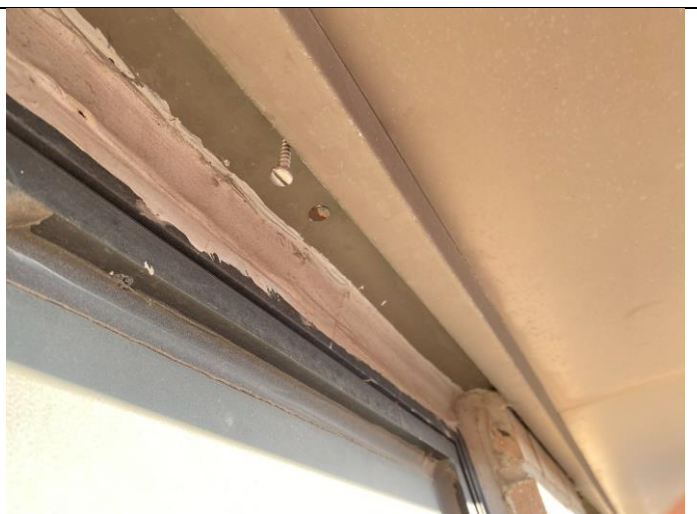
Nozzle testing ongoing at North Wing,
west elevation

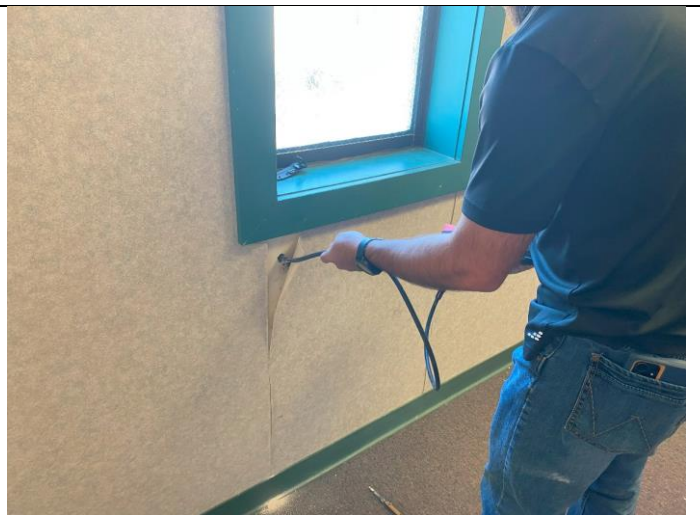
Borescope utilized to check for any leaks,
none observed

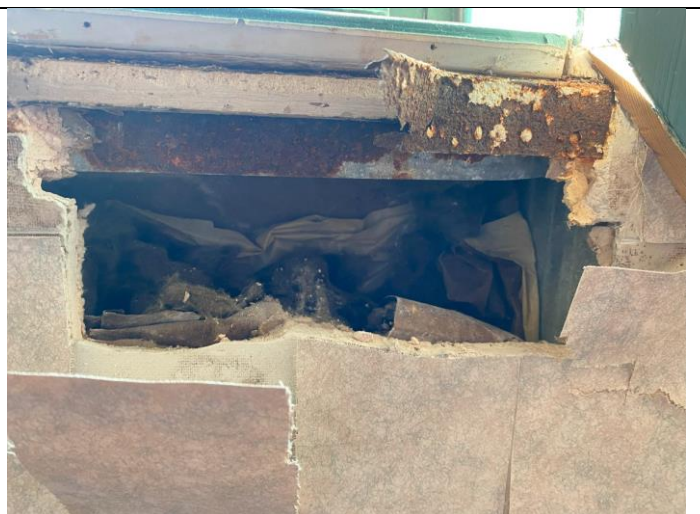
Interior access holes opened by ZSC
revealed a large amount of organic growth
in wall insulation

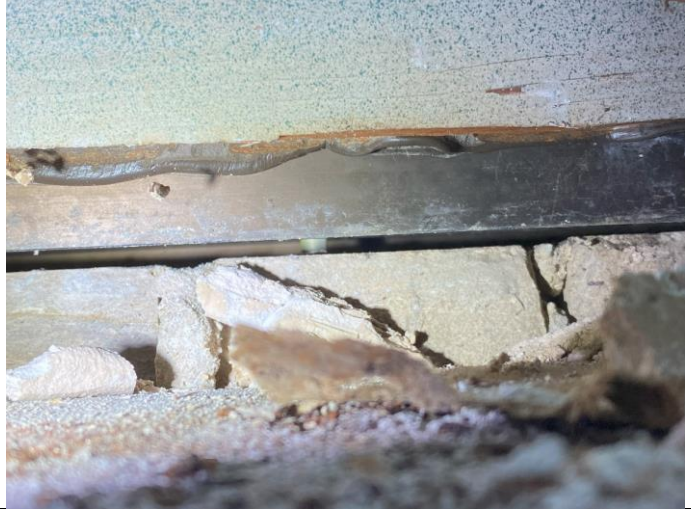
Windowsill observed anchored directly into masonry beneath window system

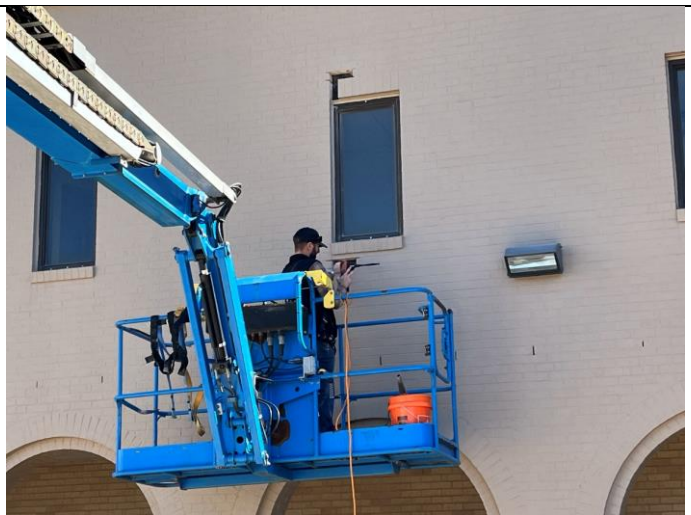
ZSC utilizing a borescope into the sub-wall cavity

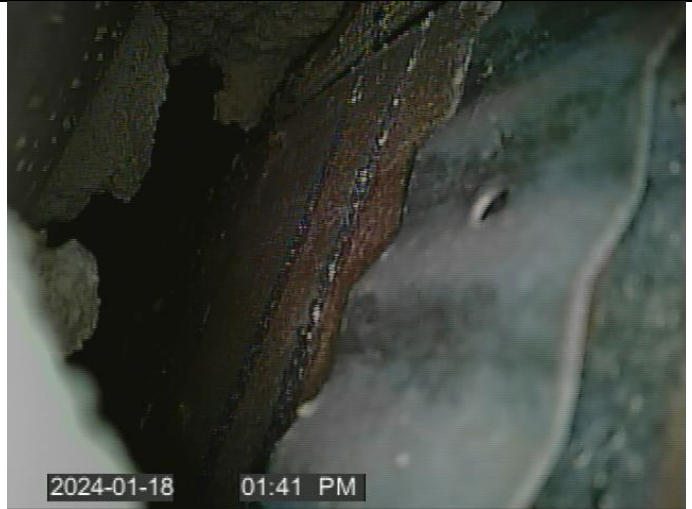
Shelf angle at head of window appear to be stripped in with a mastic or damp-proofing

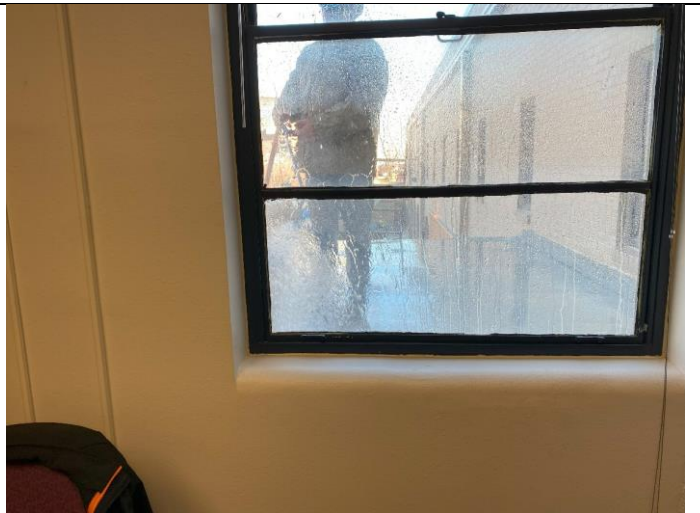
Nozzle testing ongoing at area between
North Wing and Sanctuary (over low roof)

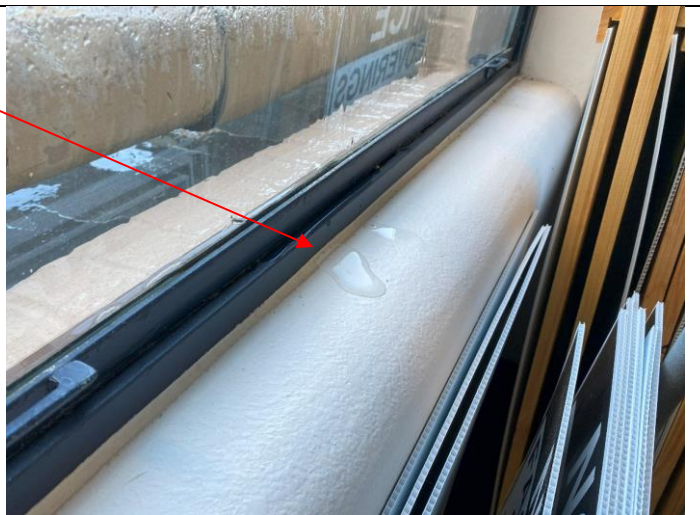
Moisture intrusion observed via sill pans

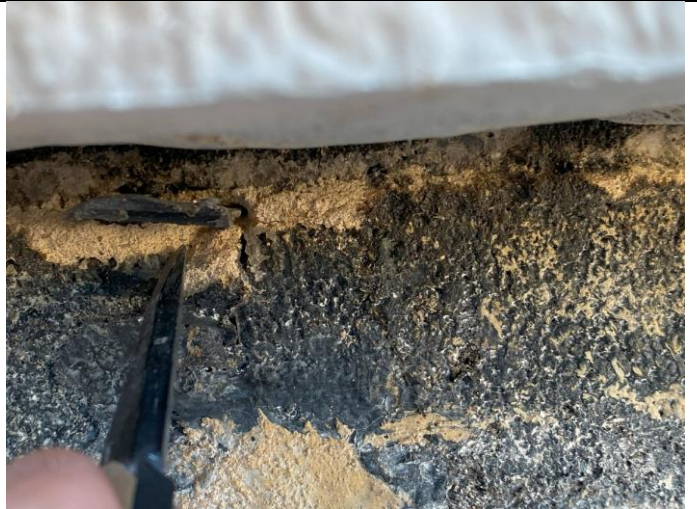
Perimeter and window system sealants observed in poor condition

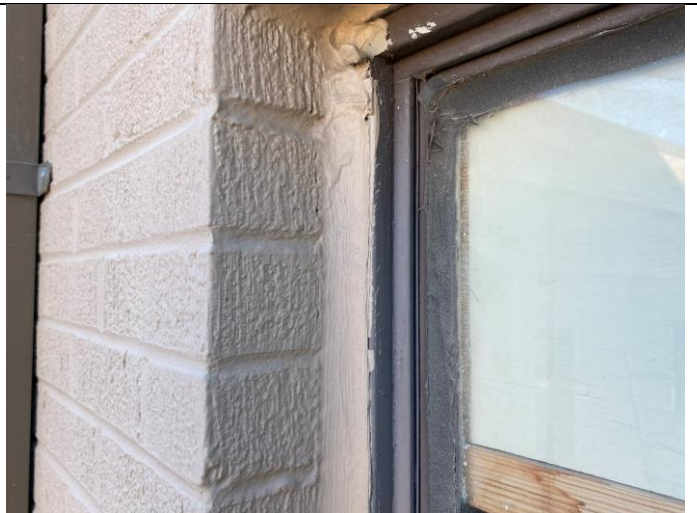
Cracking and signs of failing at head window perimeter joinery

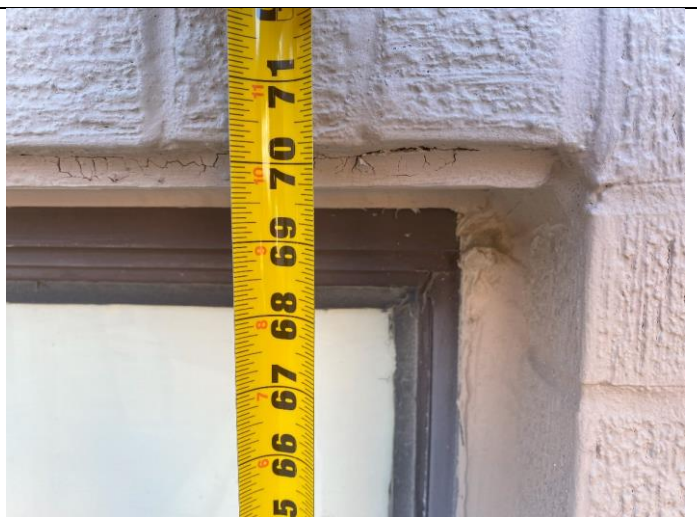
Wet seal detailing appears at the end of its service life

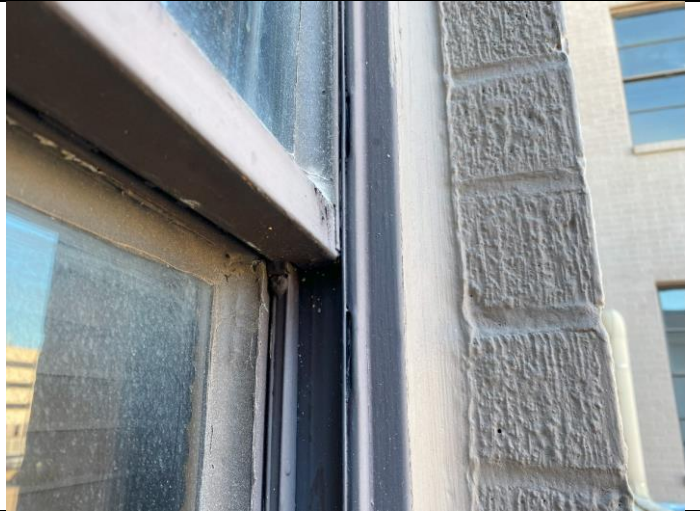
Numerous cracks and chips observed in operable window frames. Screws were utilized to make the windows in-operable

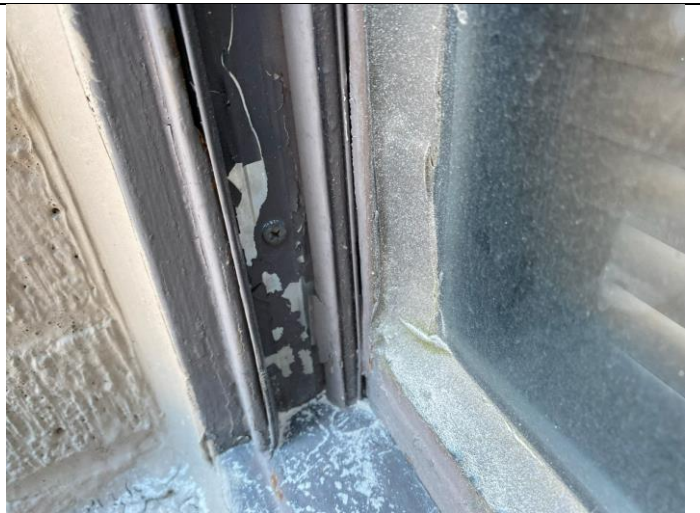
Deteriorated perimeter sealant joinery at sill of windows

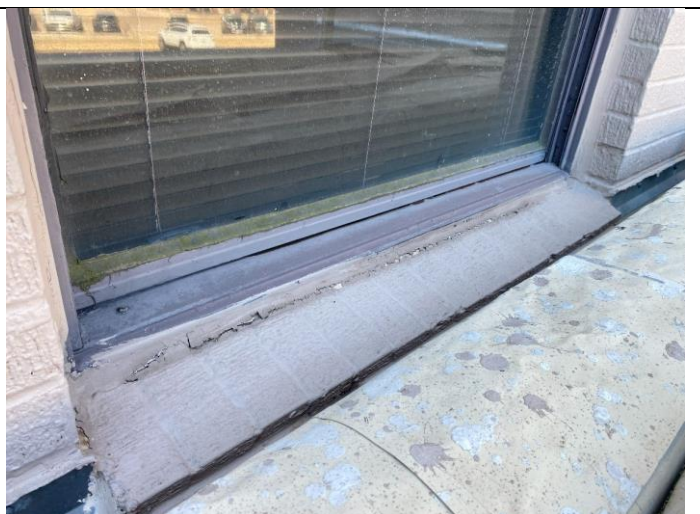
Typical view of cracking along mortar joints

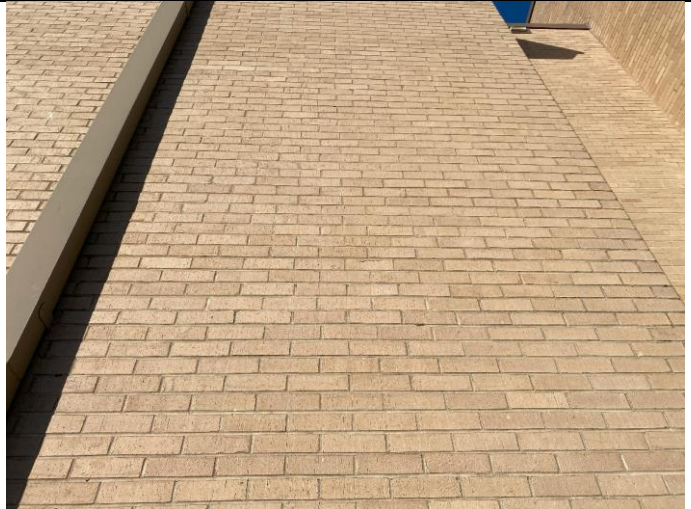
Close-up of masonry and mortar joinery cracking

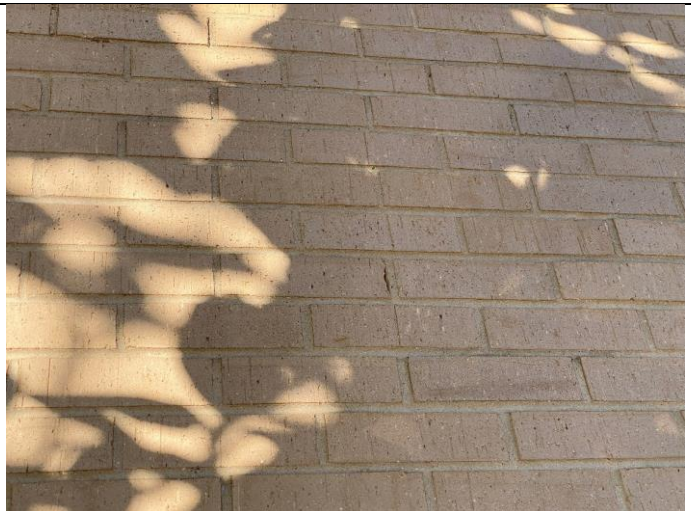
Void in mortar joint

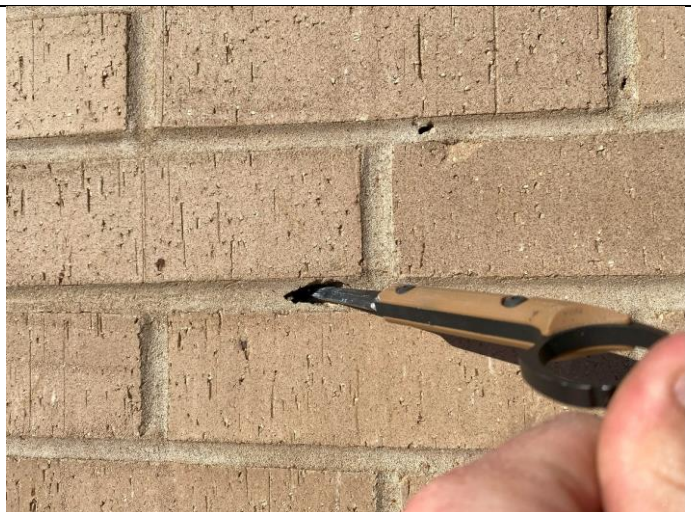
Deteriorating/Failing sealant control
joinery in masonry walls

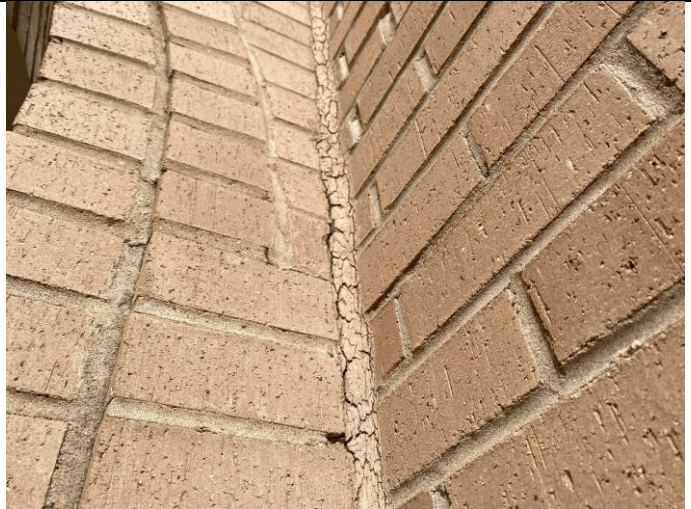
Deteriorating sealant joinery at window
systems

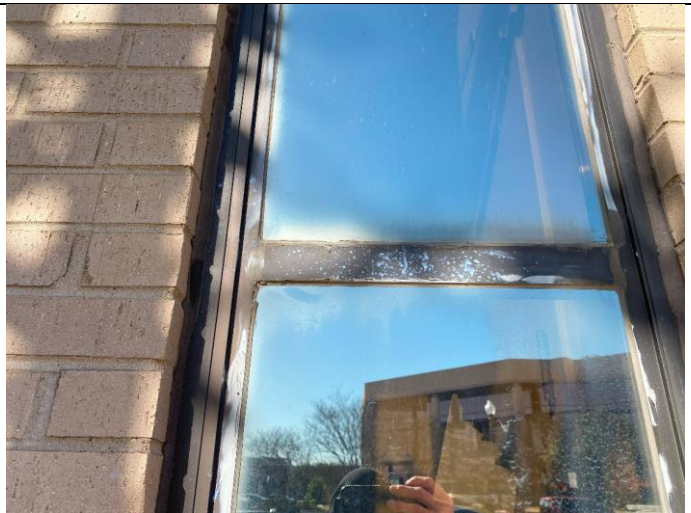
Deteriorating sealant joinery at window
perimeters

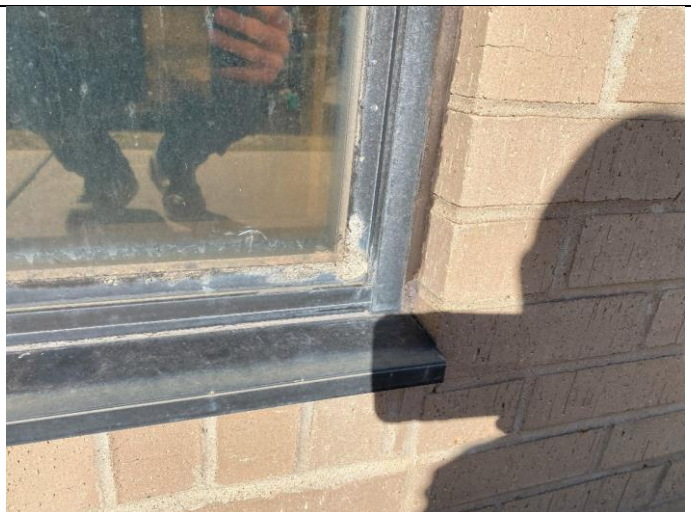
Window perimeter sealant joinery in poor condition

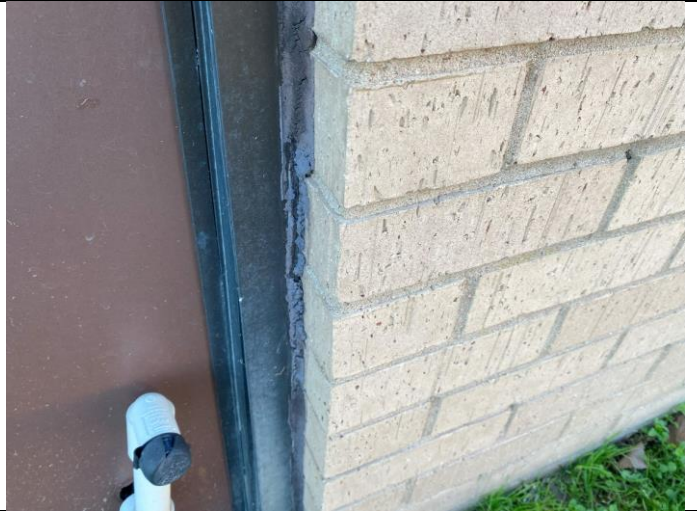
Hole in glazed in panel in window system, located at north wing north stair tower

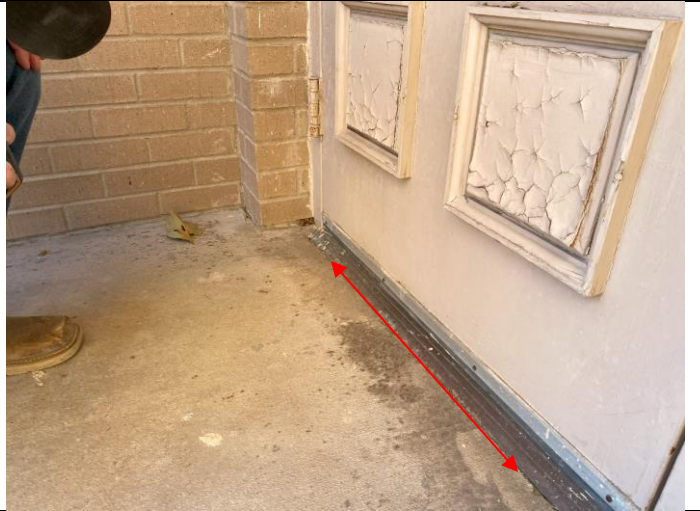
Missing sealant detailing between sleeve and piping at penetration

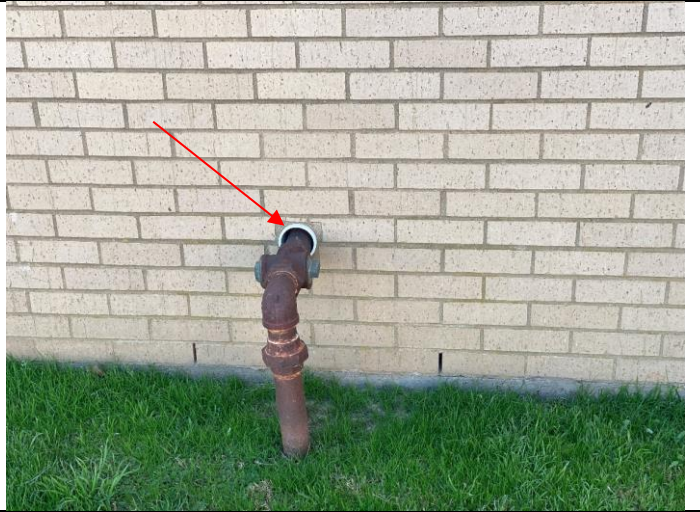
Inadequately detailed wall penetration

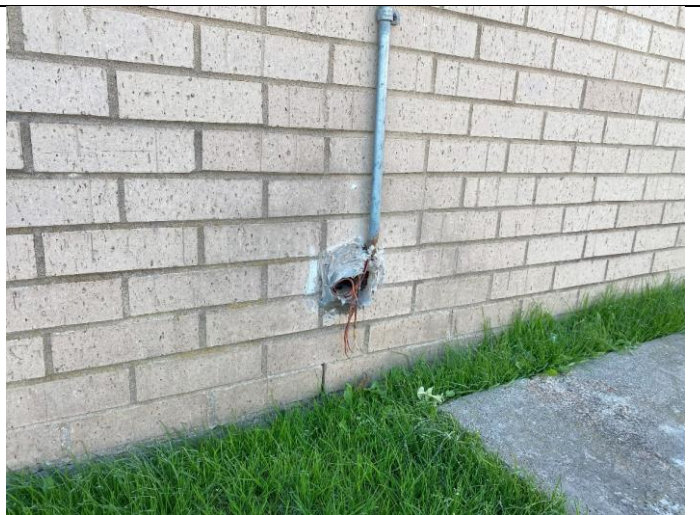
Masonry weeps potentially obstructed by landscaping

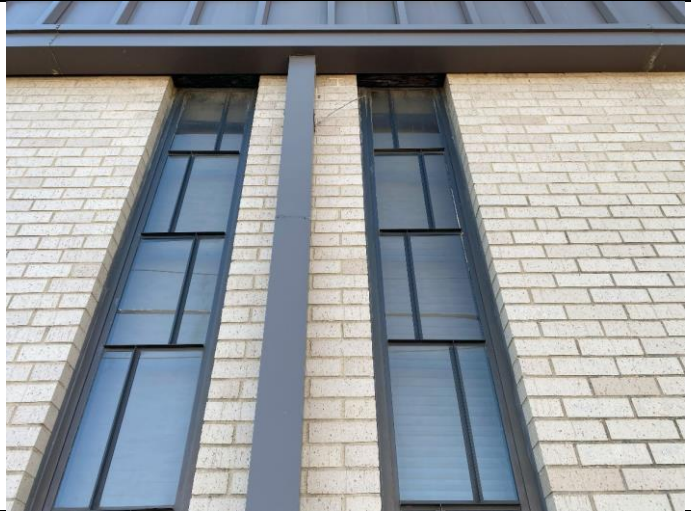
Staining plaster beneath sheet metal
fascia at east elevation

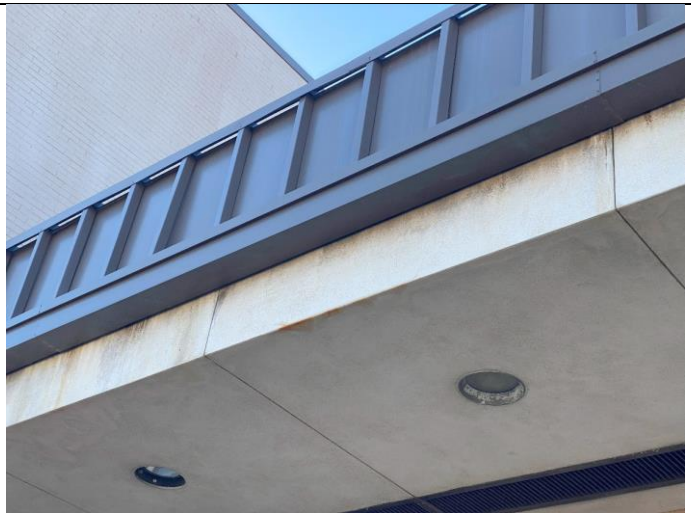
Corroded window systems along south
elevation

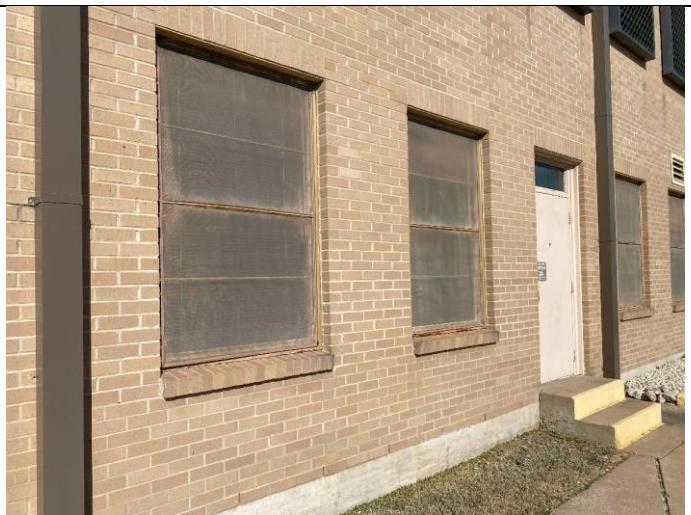
Corroded shelf angle

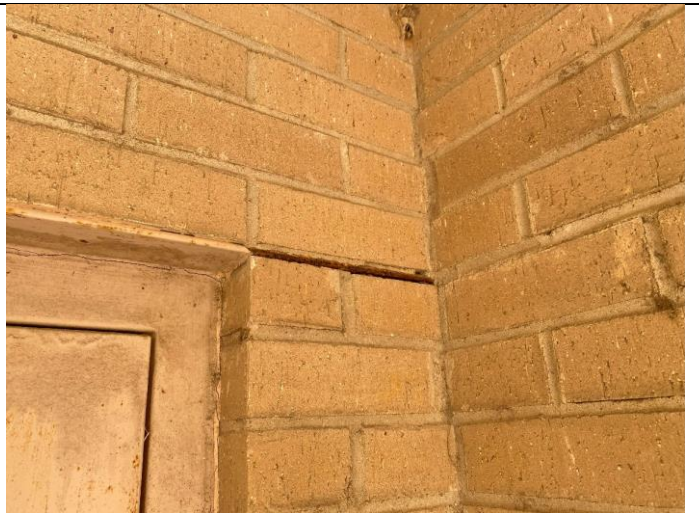
Corroded shelf angle at south elevation
(west facing) exit door

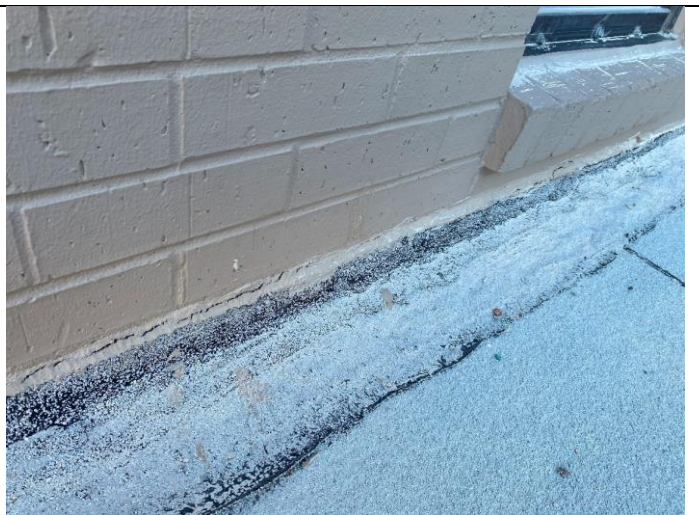
Inadequate roof termination at north
elevation low roof (north wing rise-wall)
