**BUILDING AND STANDARDS COMMISSION
STAFF REPORT**

June 21, 2021

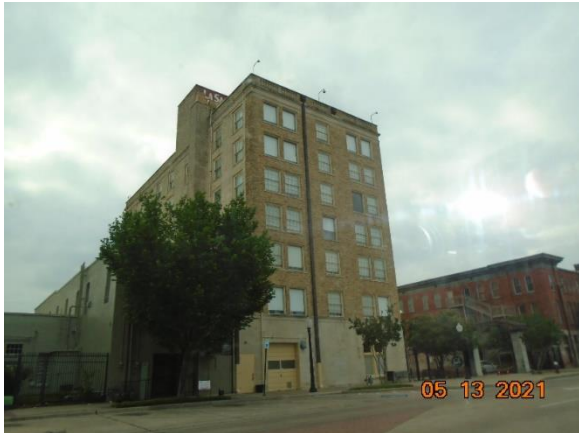
More wood window sashes have been removed on West side

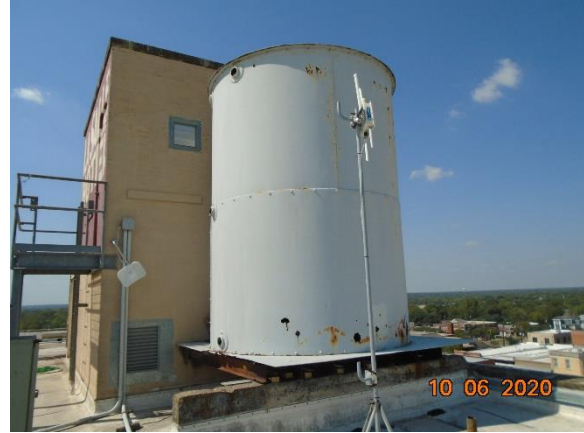
Roof mounted water tank, not in use, has rust.

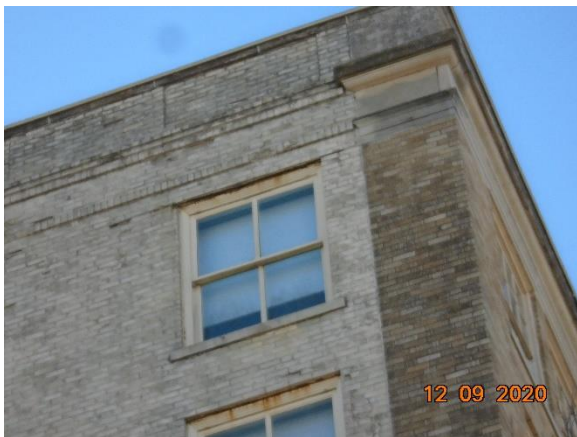
Fire rated steel windows on North façade.

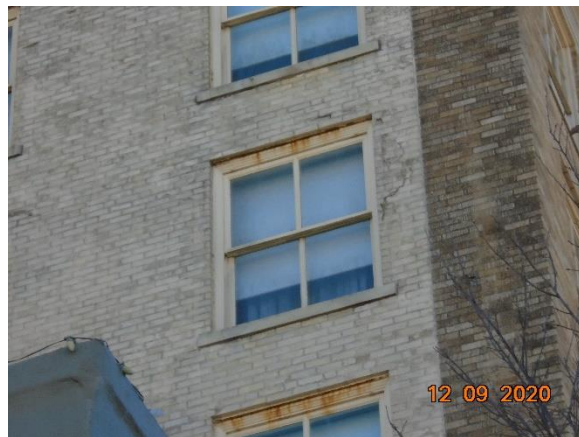
Steel lintels are rusting and possibly causing masonry damage.

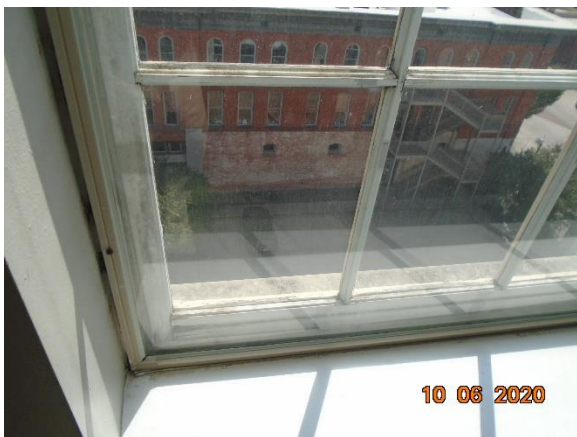
Interior view of interior storm window system and Wood sash with moisture damage

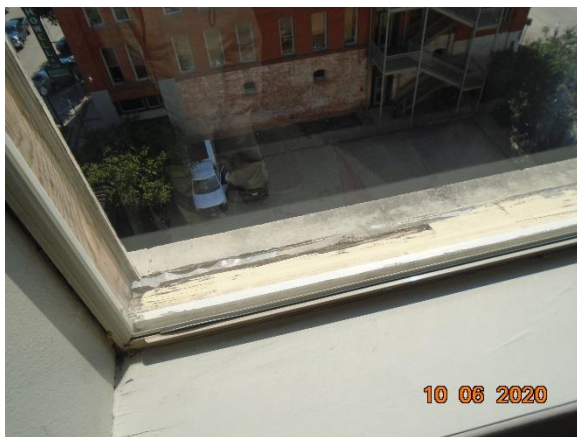
Window opening missing wood sashes and with only interior storm window

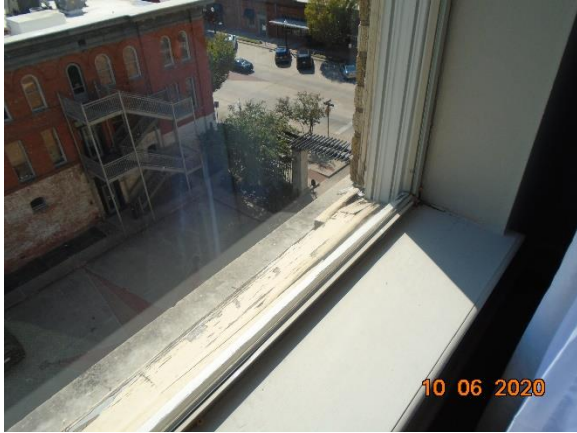
Exterior wood sill water damage/deterioration

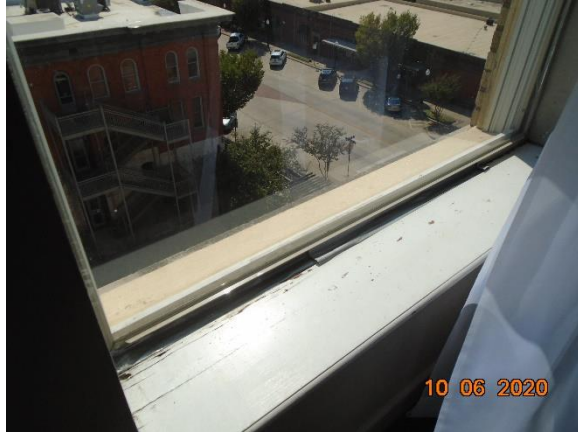
Interior wood window sill water damage

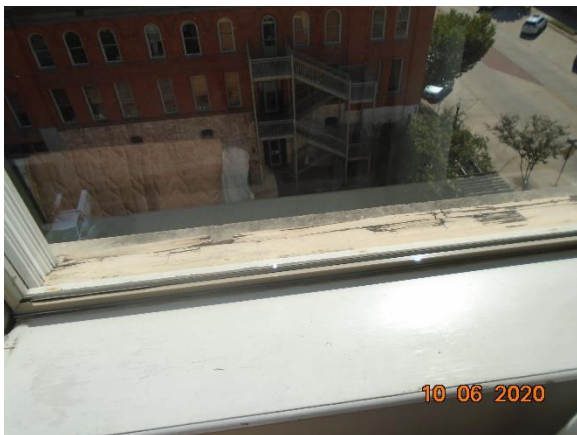
Another view of exterior window sill rot

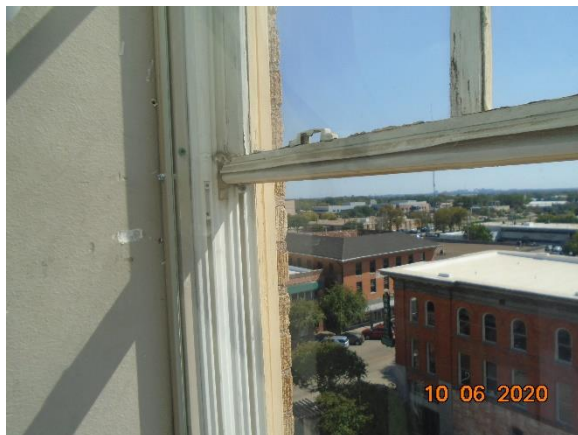
Window missing lower wood sash

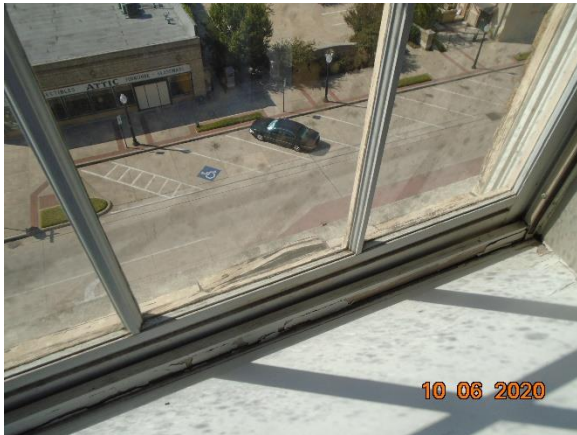
Interior guest room window

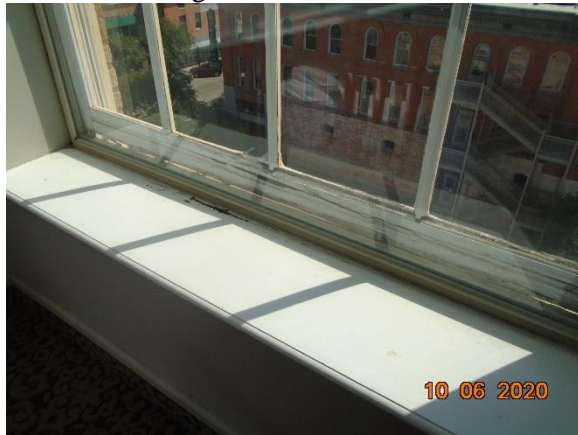
Interior guest room window with damage

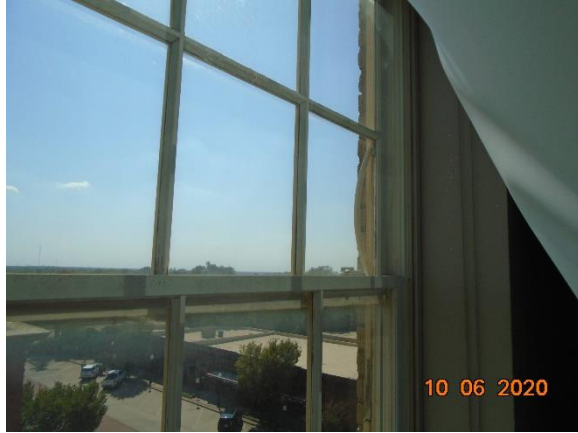
Window mullions loose

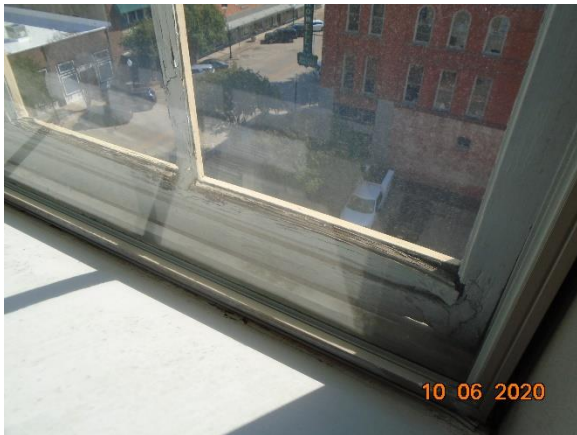
Rot in lower window sash

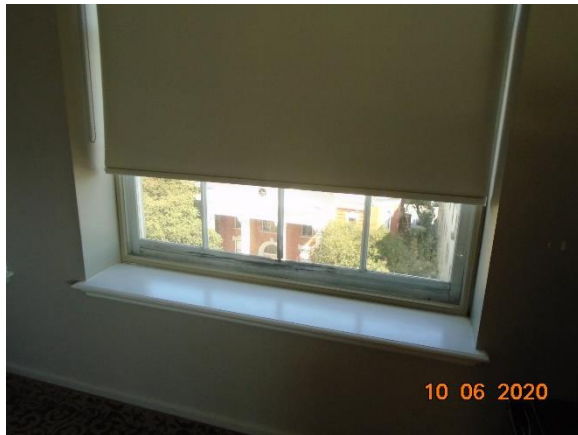
View from inside guest room, rotten window sash

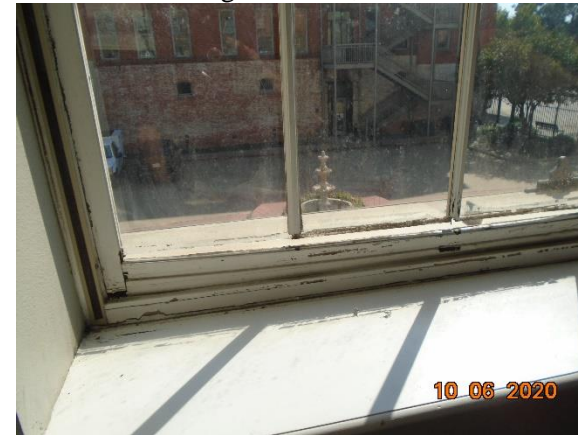
Interior – sash and sill damage

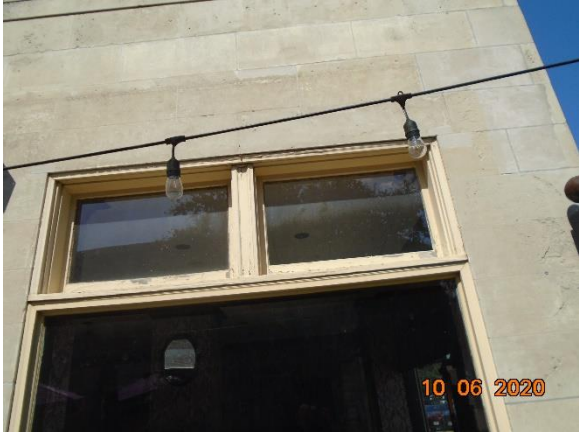
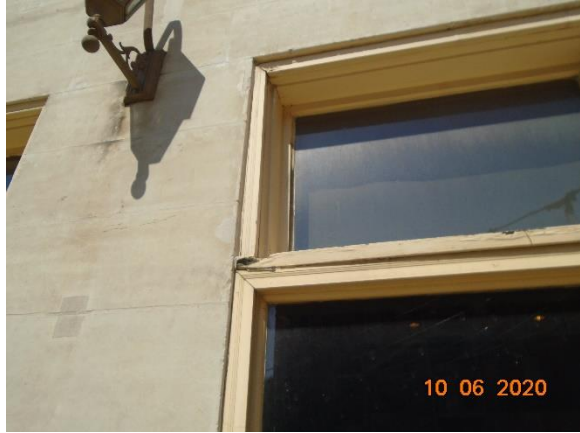
First floor wood store front windows and transoms. Rotten wood that has since been repaired/replaced.

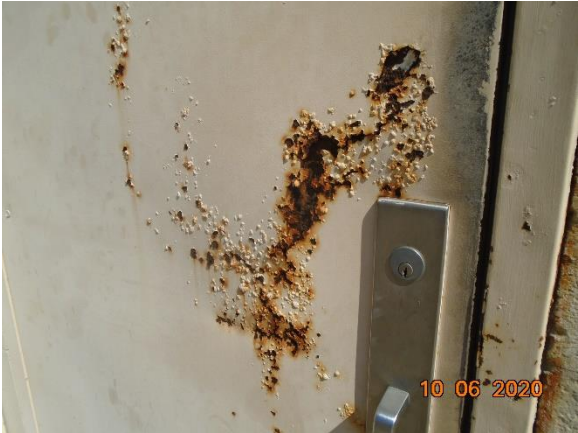
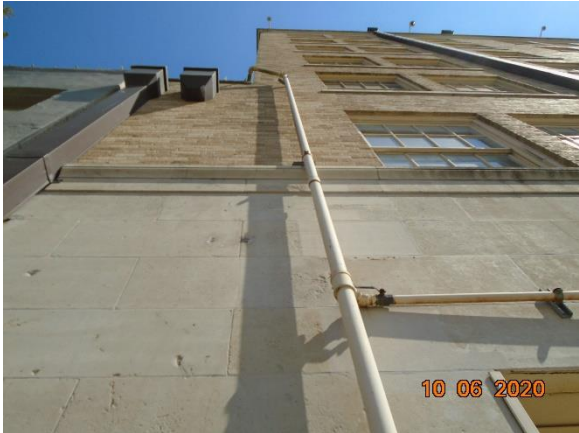
Rusty exterior door that has since been replaced. Loose gas line that has since been secured.

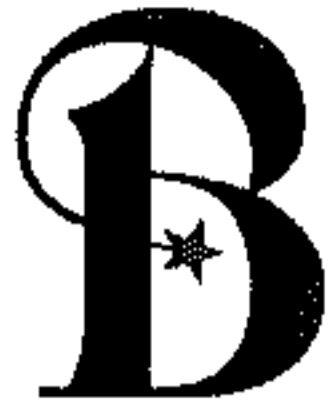
CITY OF BRYAN
The Good Life, Texas Style

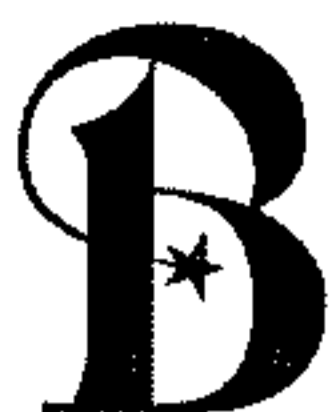
CITY OF BRYAN
The Good Life, Bryan Style.

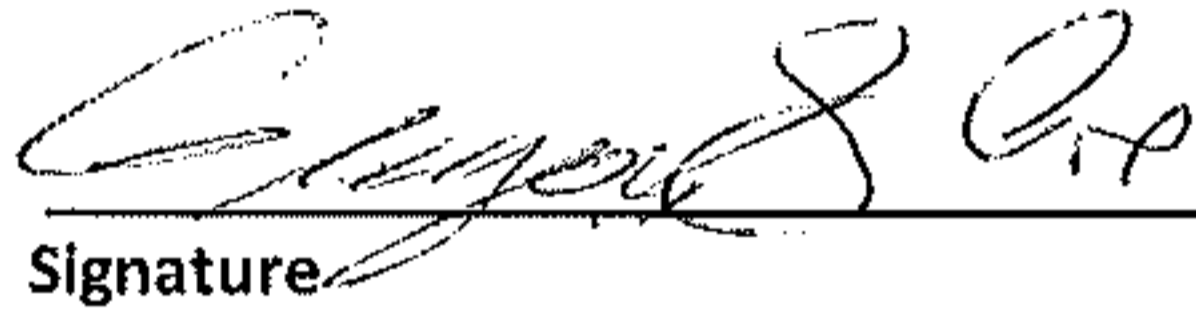
2. It has been determined upon inspection and investigation that the structure is not dangerous, unsafe, or a hazard to public health as defined by the City's Code of Ordinances.

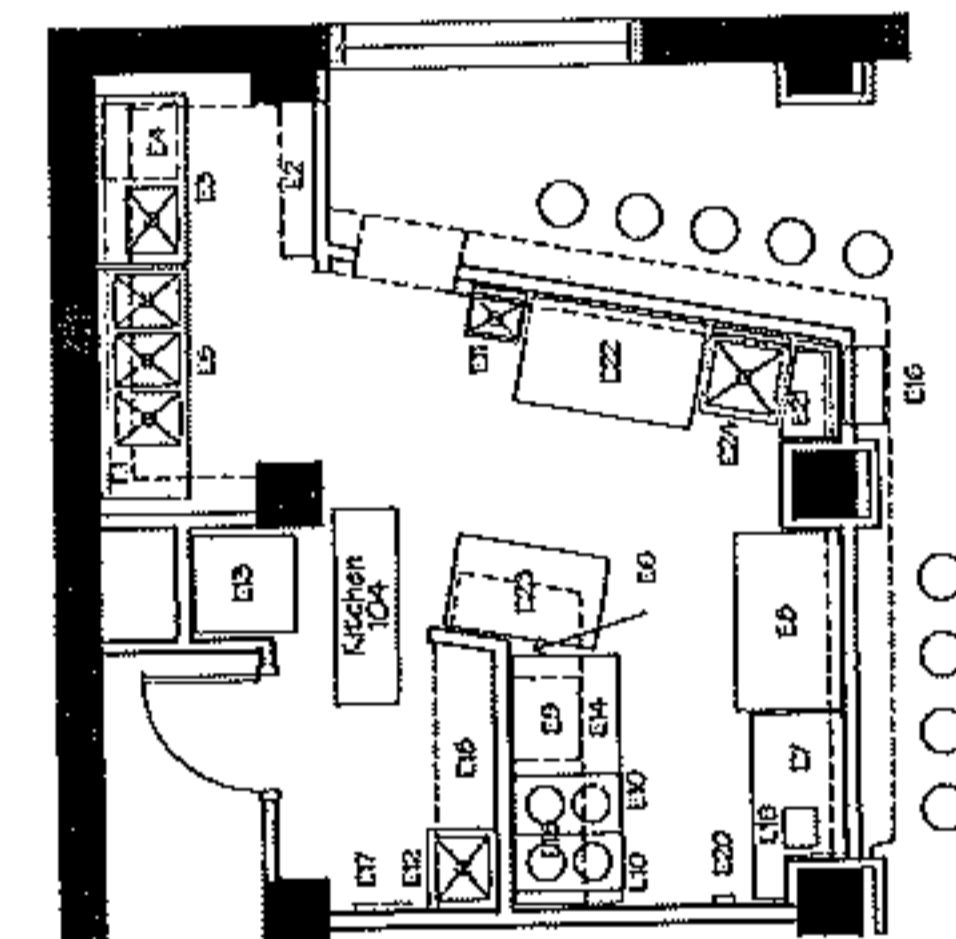
2 | Kitchen Equipment Schedule

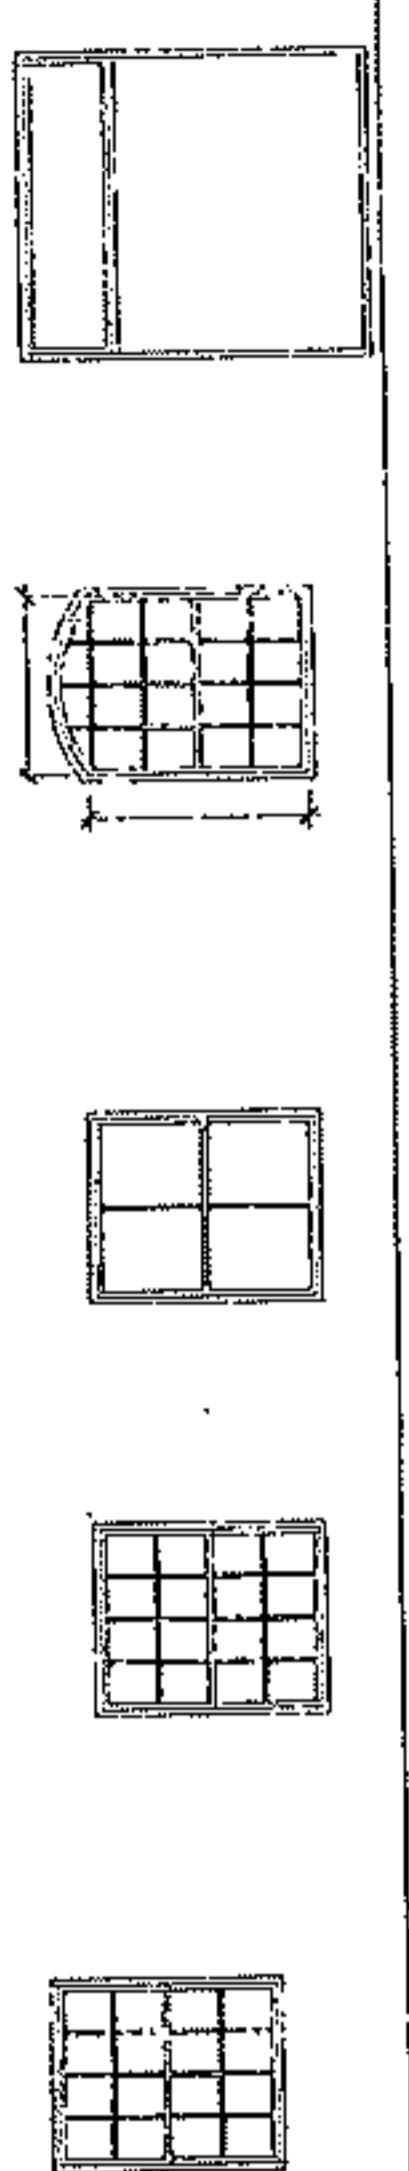
Type A
Location 1
Exterior Fixed Transom over doors
replace frame & paint

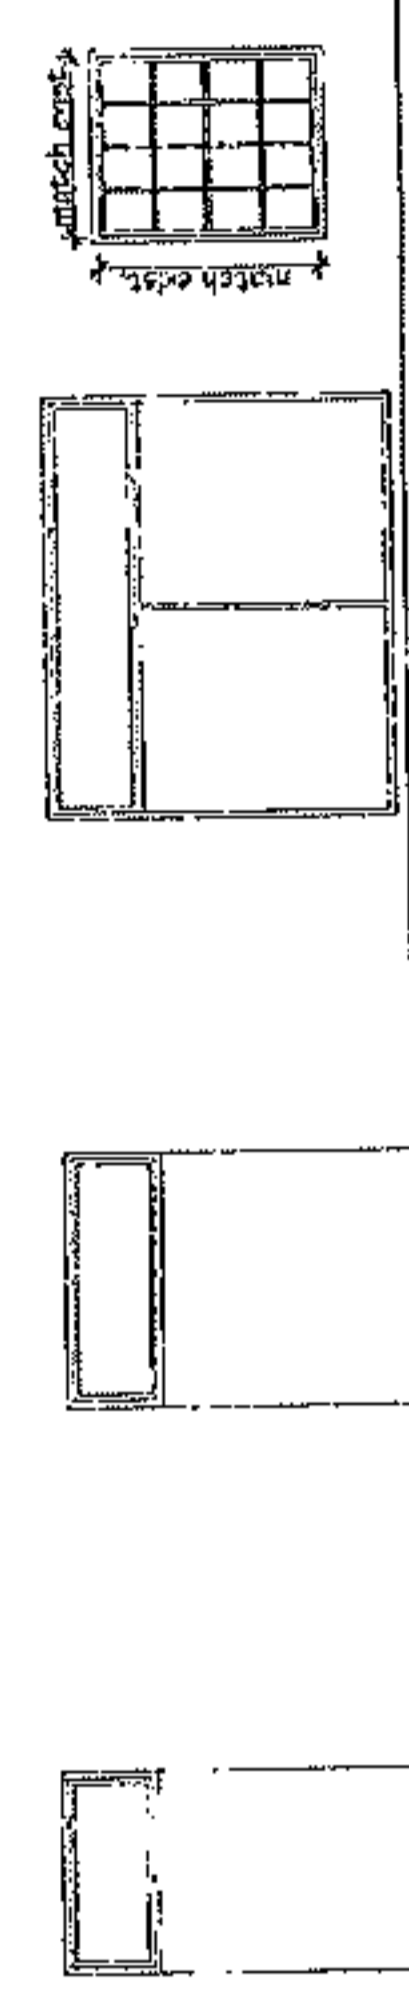
Type F
Location 1
Exterior Fixed Transom over doors
replace frame & paint

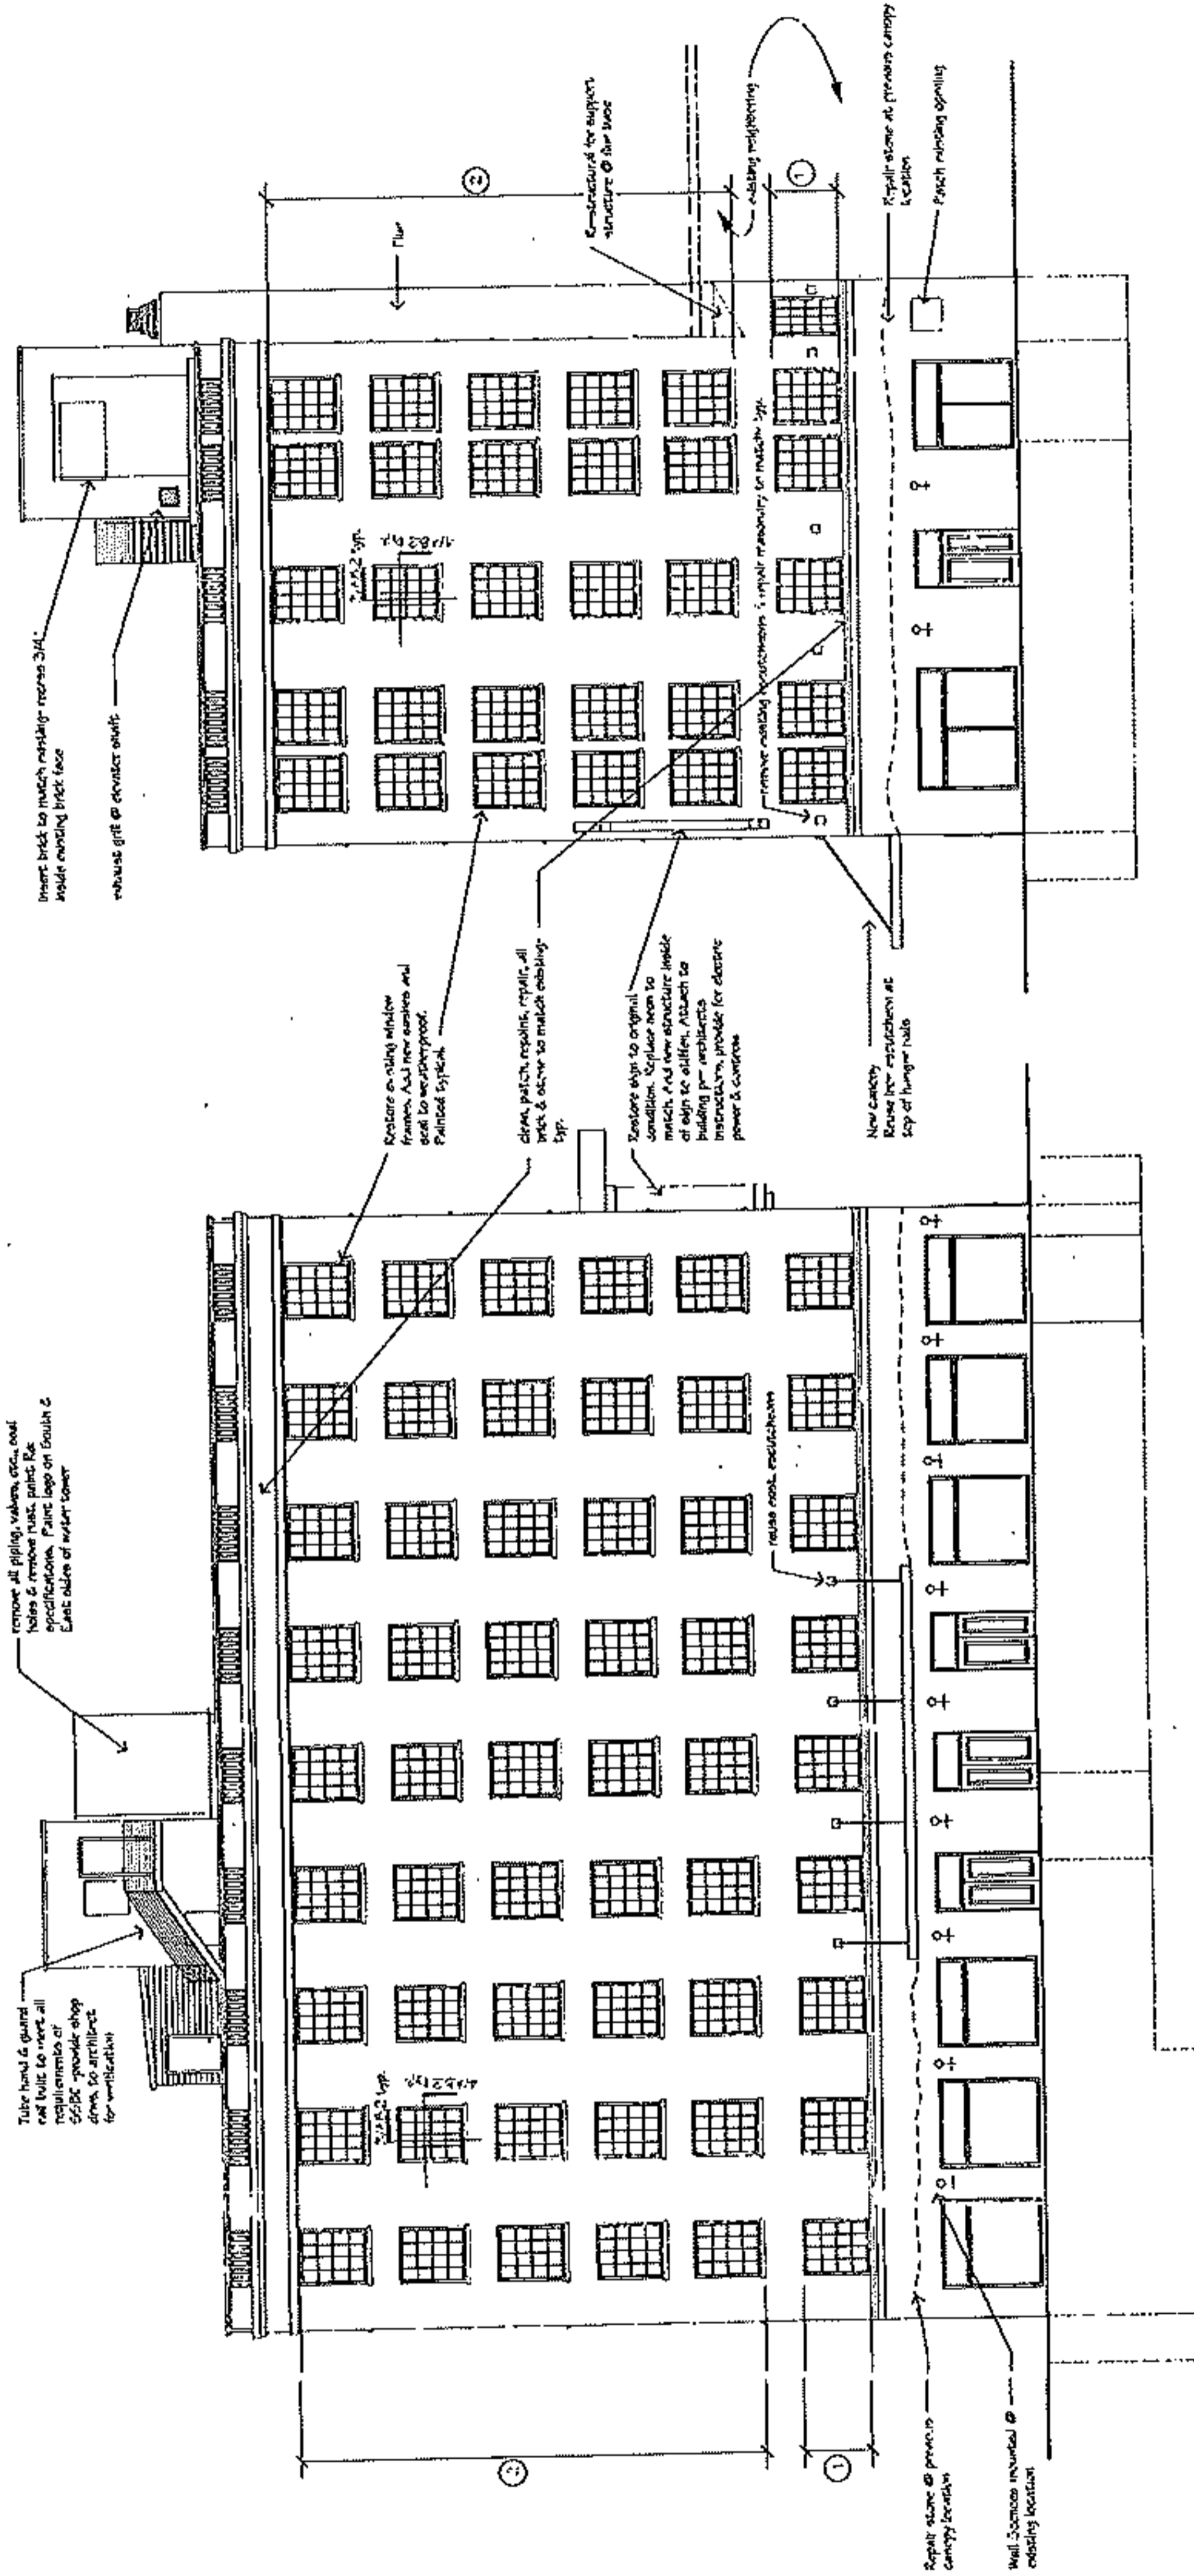
- Review Notes
- Remove existing trim and mill two stories with bottom window frames and mill in necessary. Replace trim pieces of mill in place to match original window. Glass to be single pane, frame and mill to match.
 - Frame up Note #1 with masonry and floor.
 - Refract, replace galvanized window frames and mill in necessary. Replace trim pieces of mill in place to match original color of glass to match old frame glass, as far as possible.

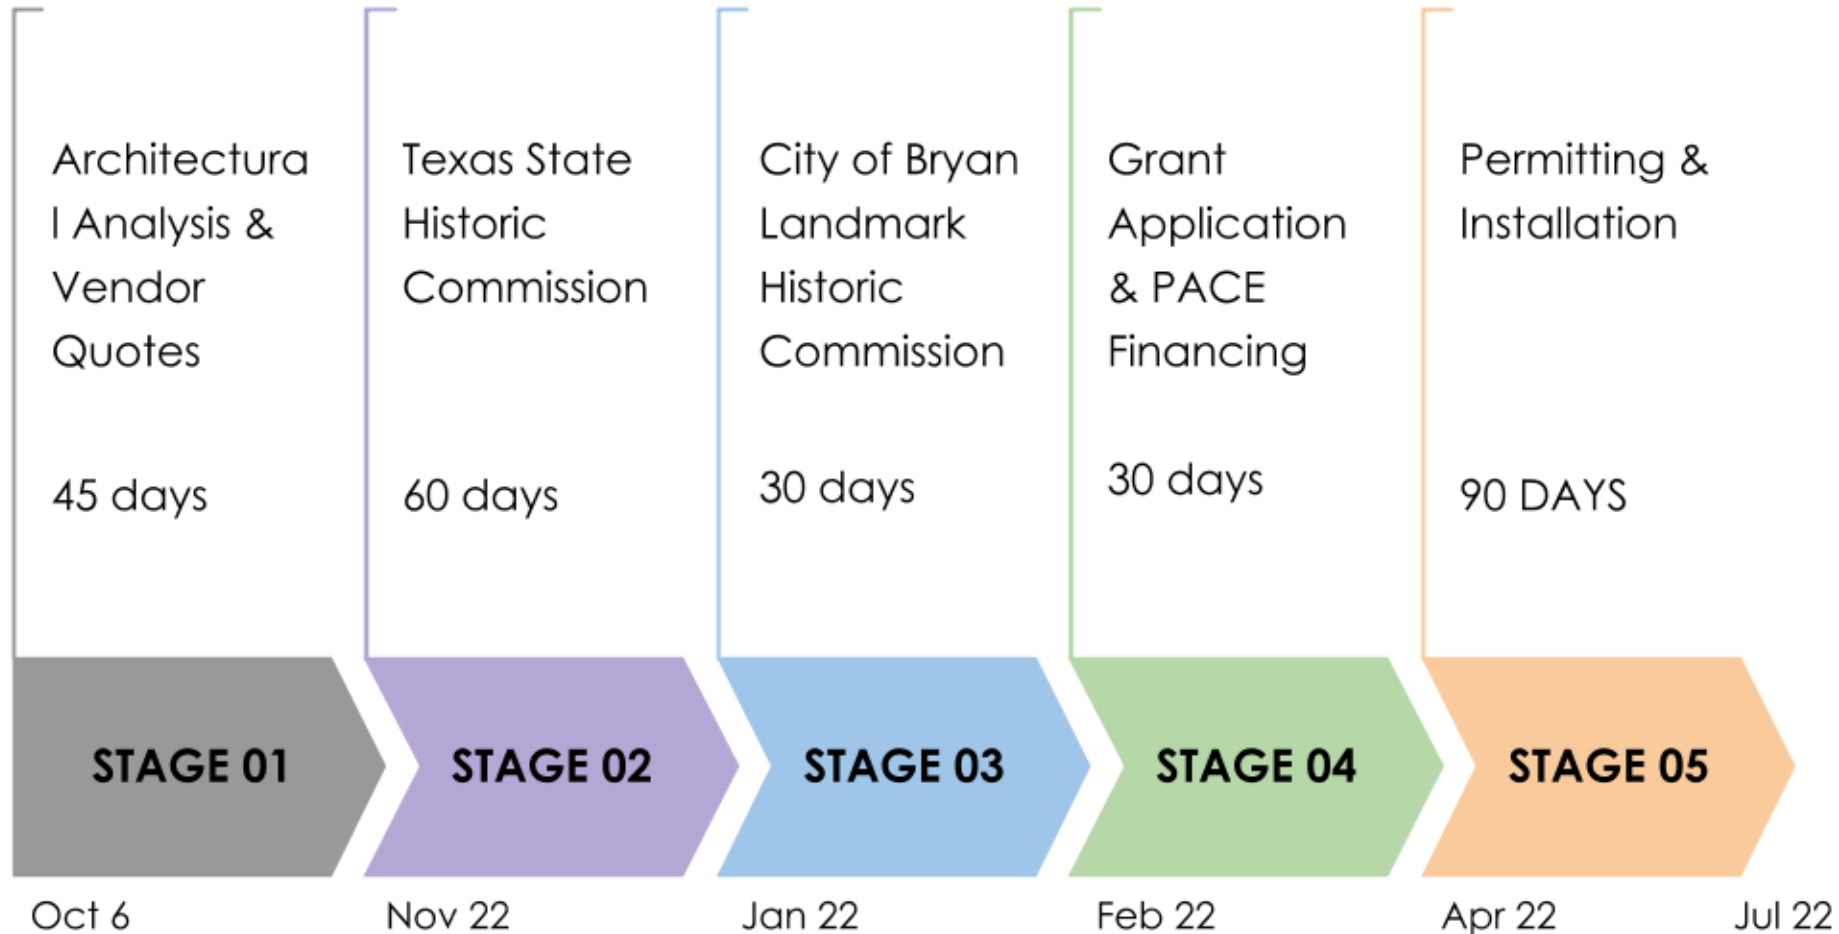
Window Replacement Projected Cost

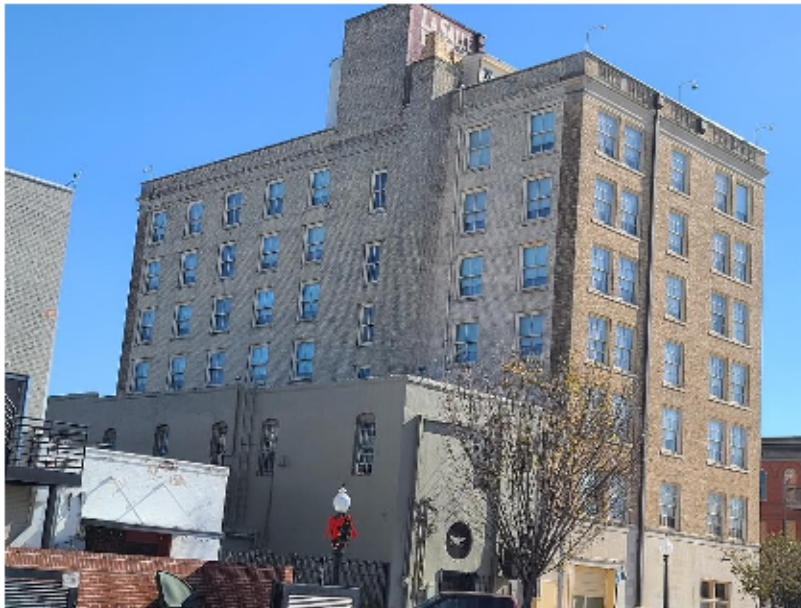
TECHNICAL CONSIDERATIONS:

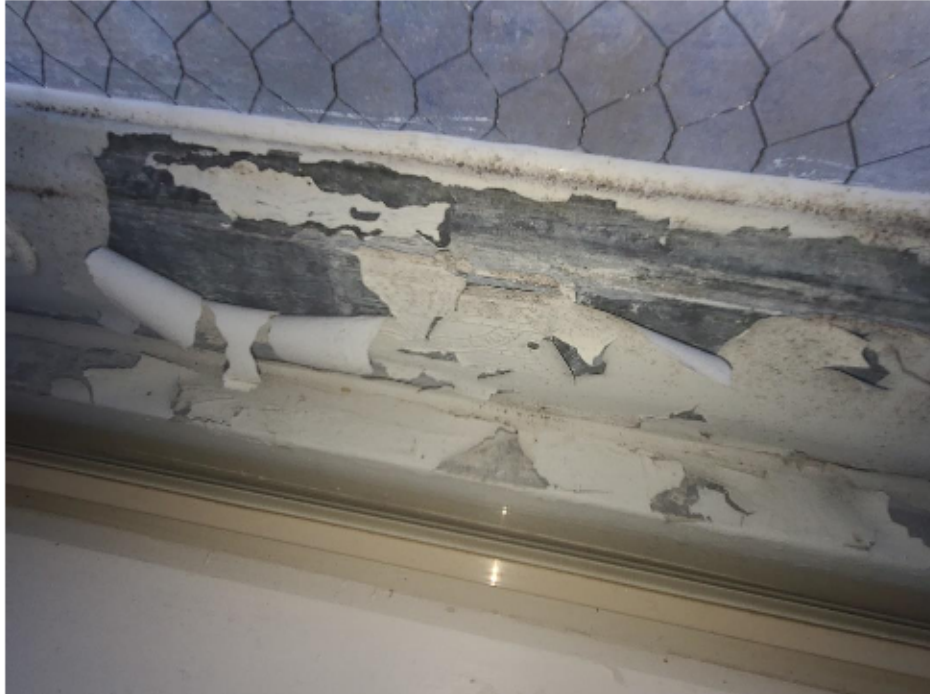
Note: Even though the paint finish has been compromised, there is no rust or corrosion on the inner surfaces of the steel framed windows.

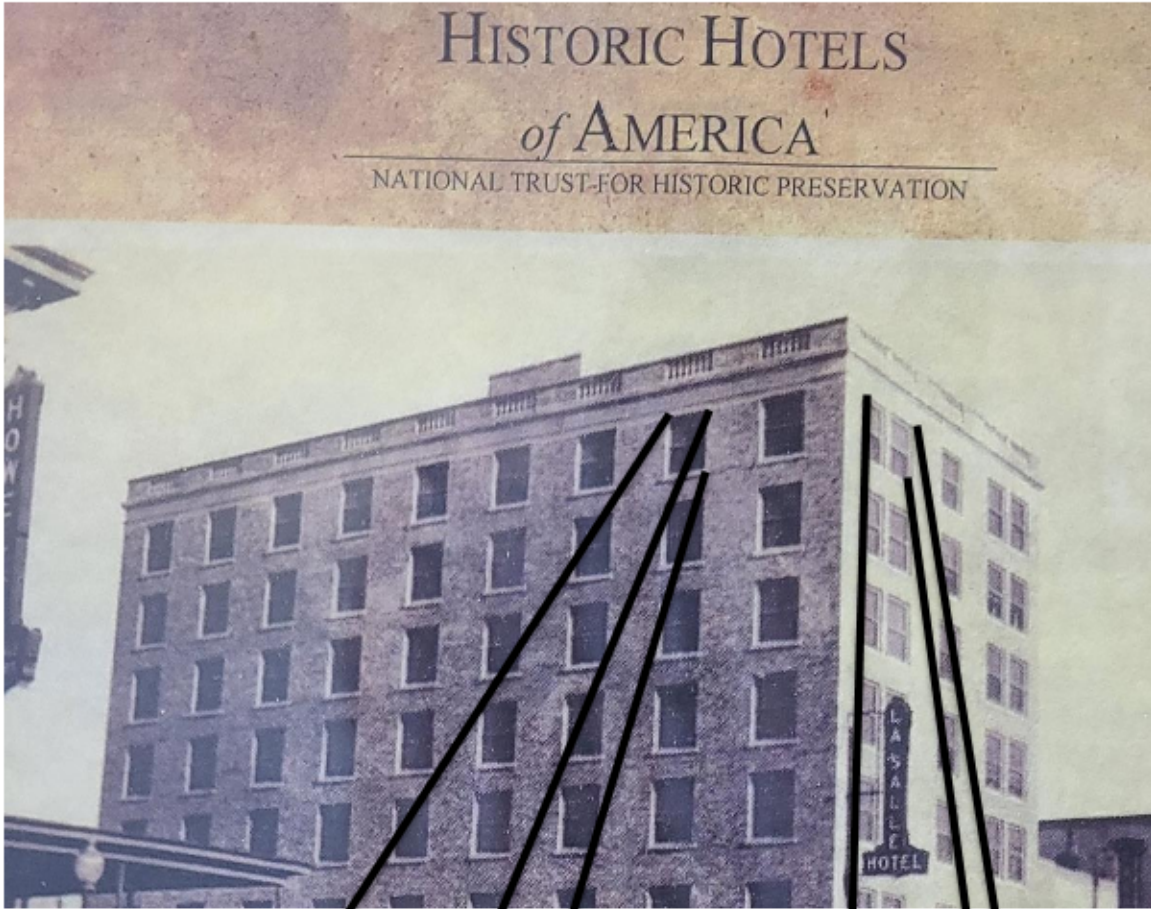
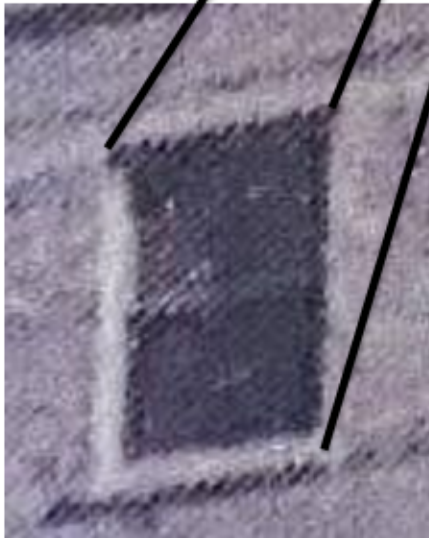
South facing window.

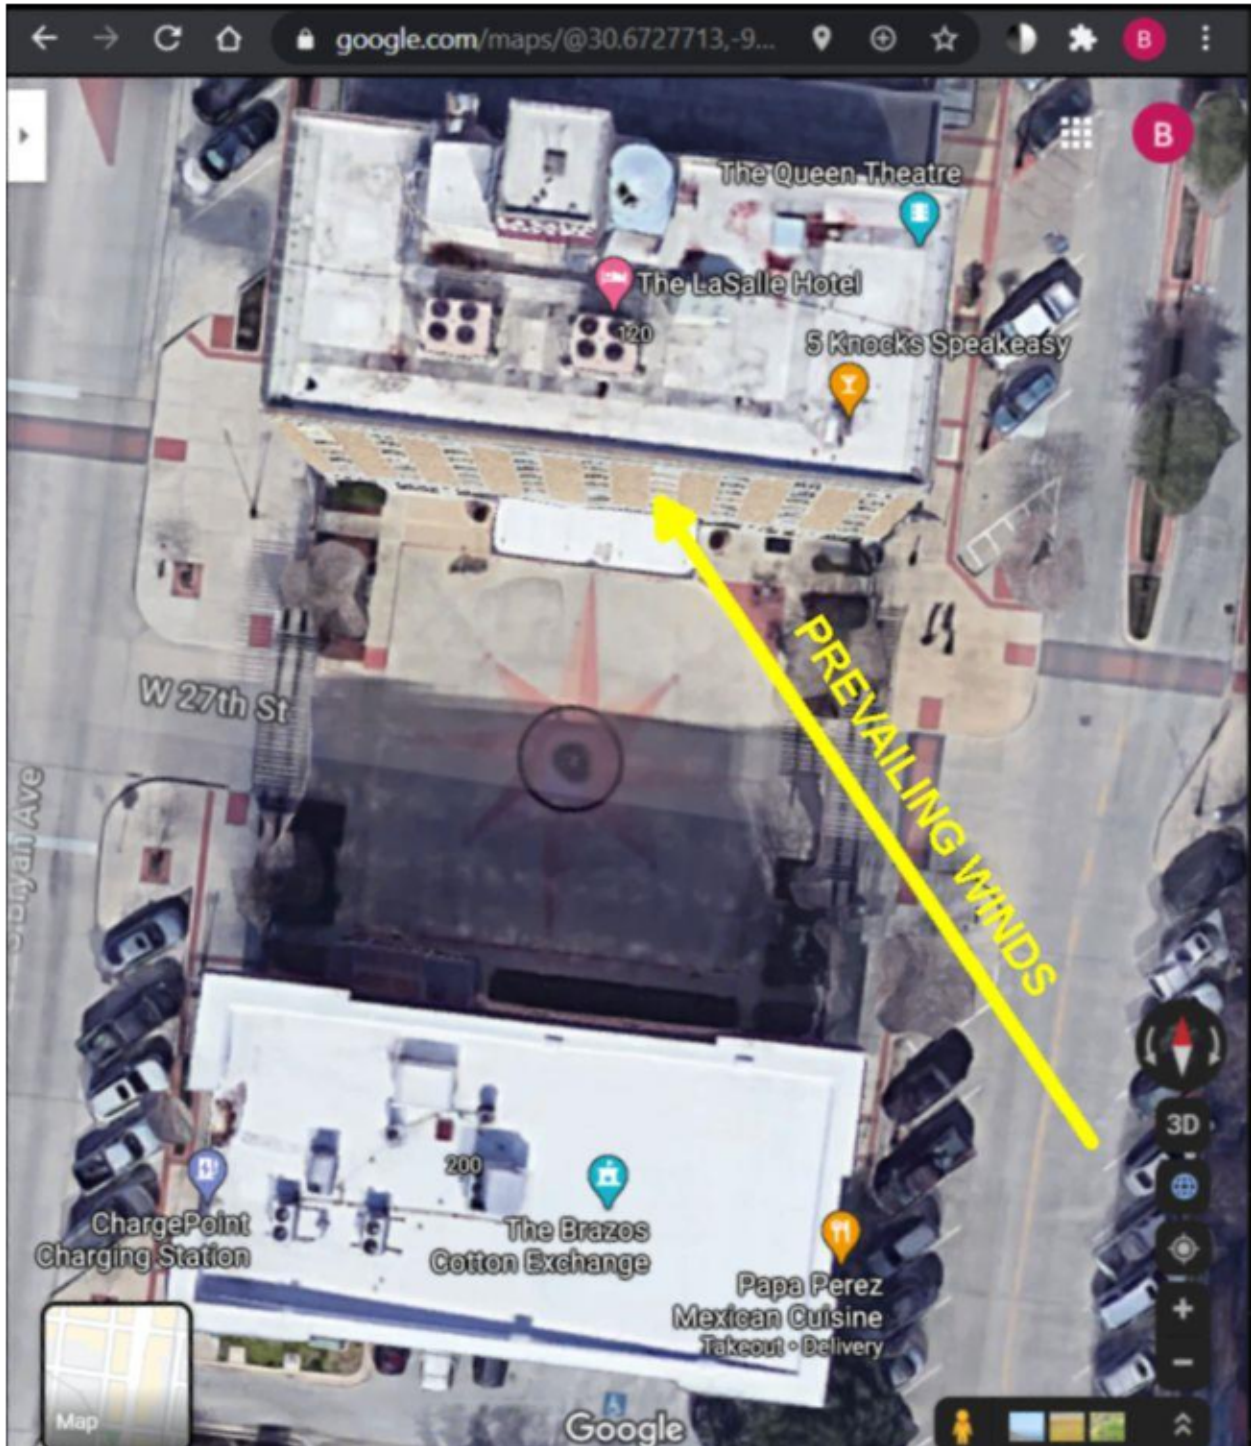
Note the deterioration of the 1998 wood framed windows on the south elevation in the following photos:

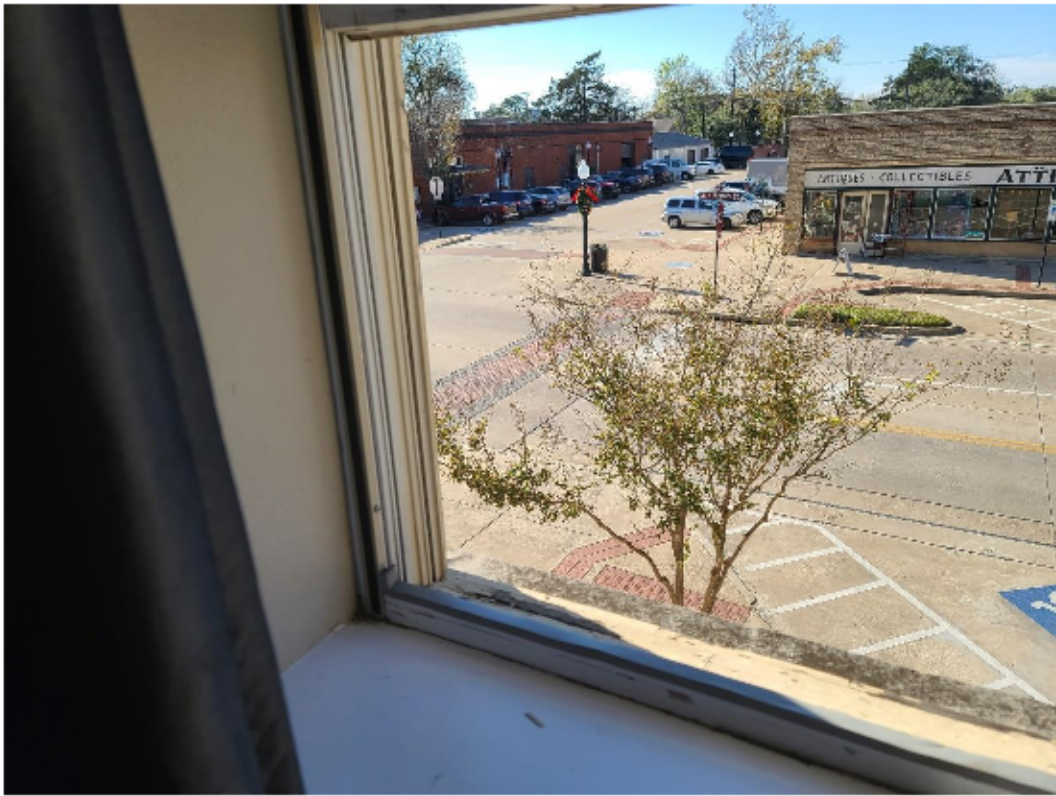
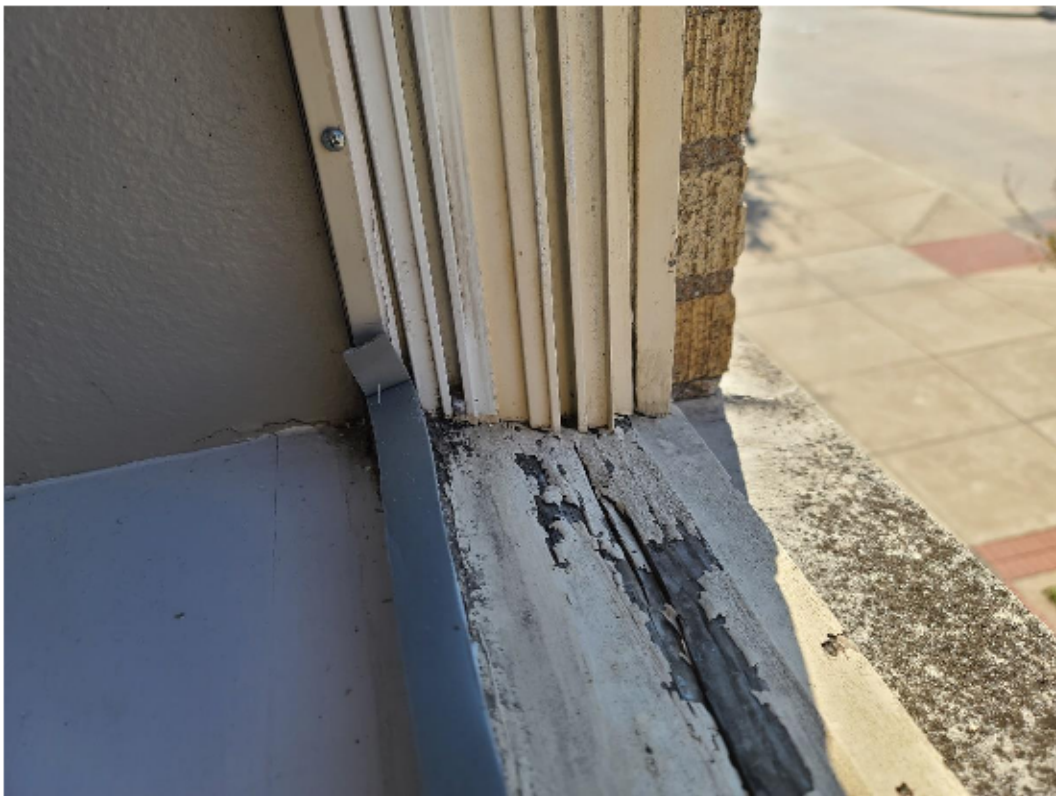
COMPARABLE BUILDING IN HISTORIC DOWNTOWN BRYAN

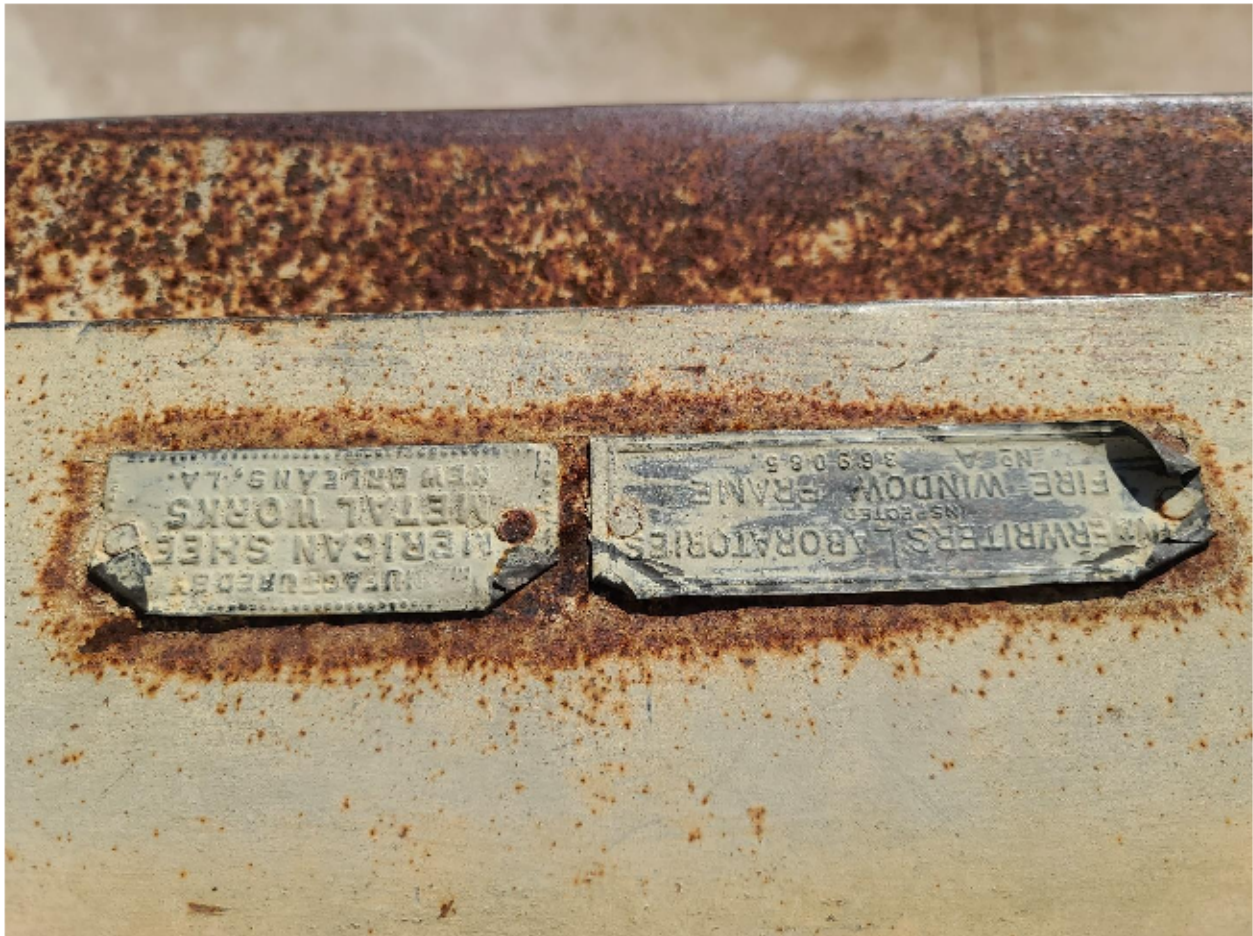
Manufacturer's metal labels on the steel framed window sill in the Varisco Building.

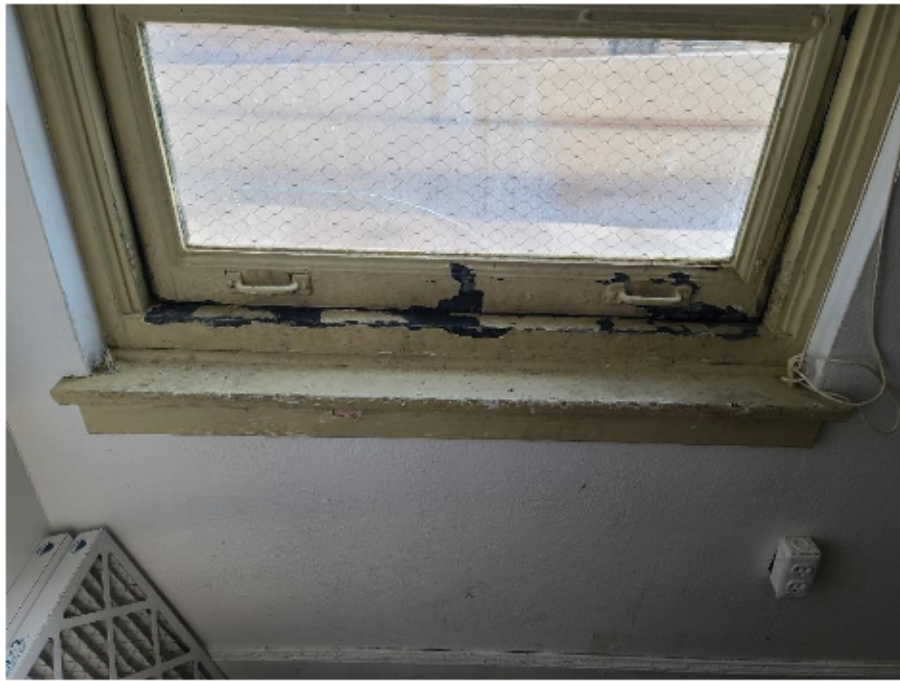
One of the windows on the south side of the Varisco Building. This window is still operational. (Note the similar appearance and condition of the La Salle Hotel steel framed windows.)

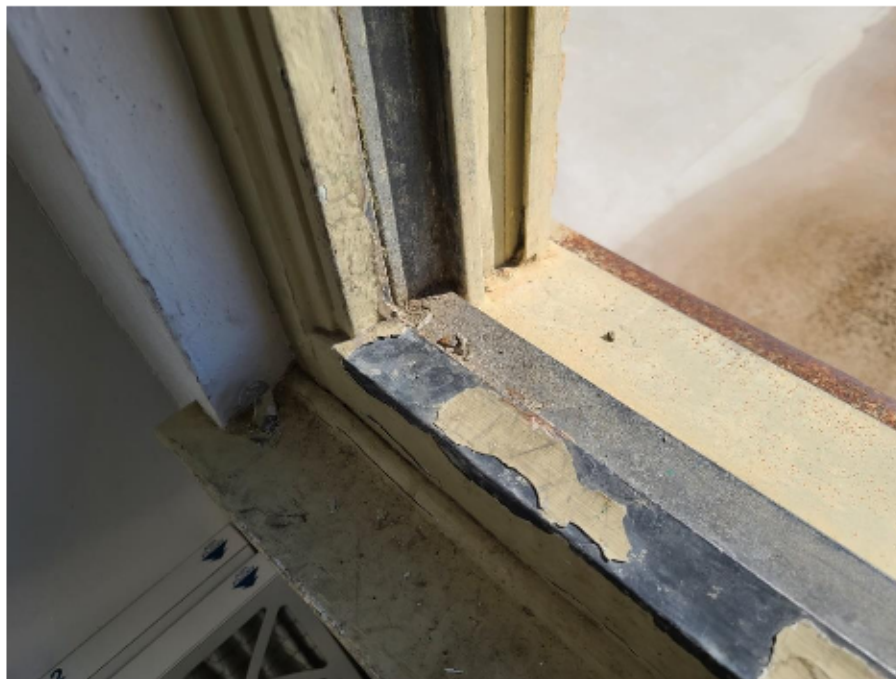
Note the similar “almost flat” sill, and how it is extended over the cast stone sill. The “almost flat” cast stone sill and steel frame does not deteriorate due to water accumulation; whereas a wood framed window sill would be subject to rot)

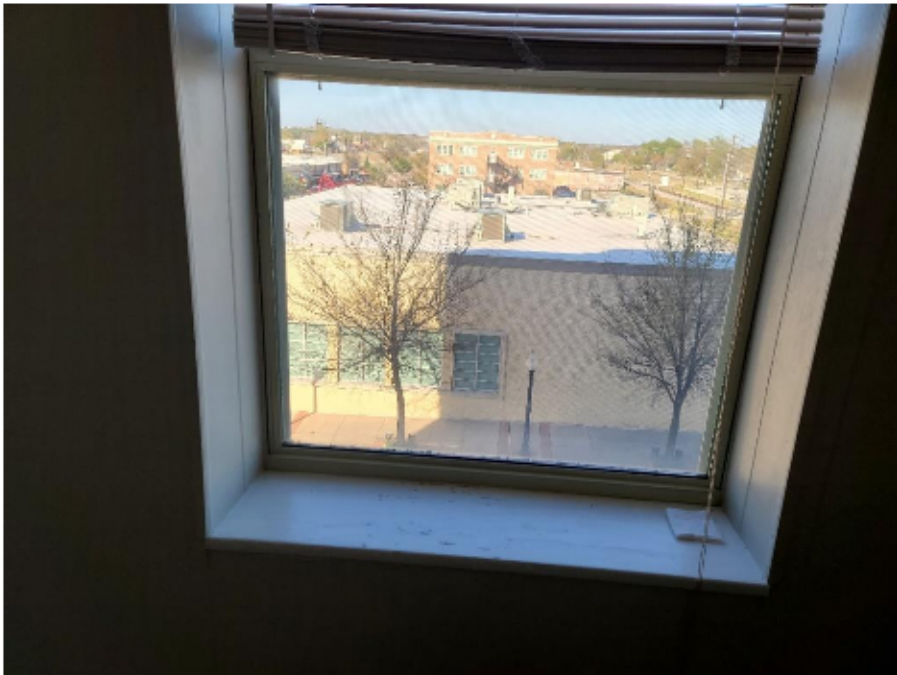
Composite framed window, replacing steel framed windows in the Varisco Building. (Note that this composite material is not subject to wood rot, due to the "almost flat" cast stone sill.)
