**BUILDING AND STANDARDS COMMISSION
STAFF REPORT**

June 21, 2021

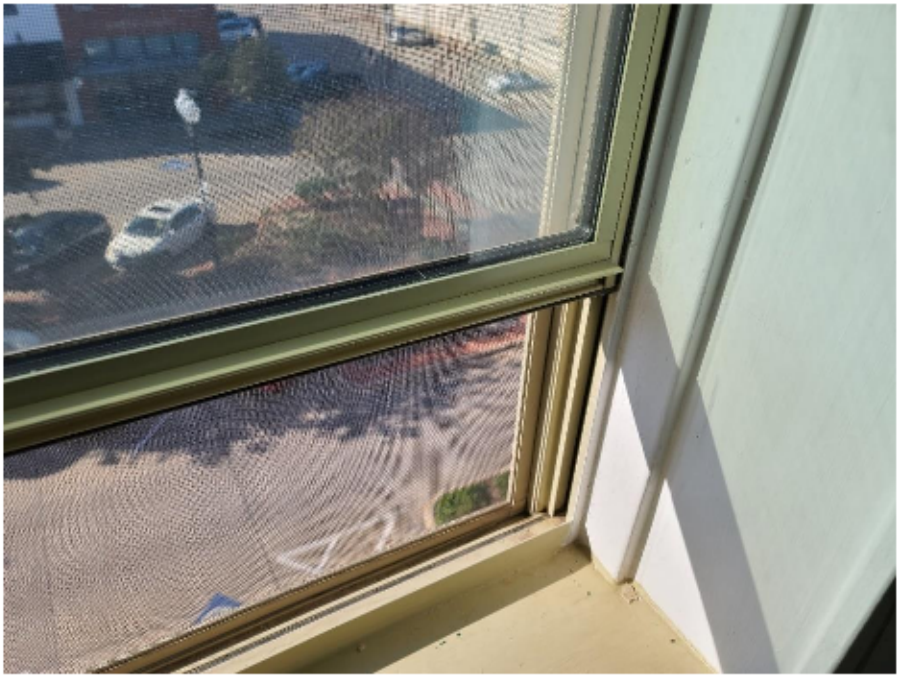
Sill/frame conditions of a typical paintable composite framed window in the Varisco Building (these replaced the steel framed windows in the late 90's.)

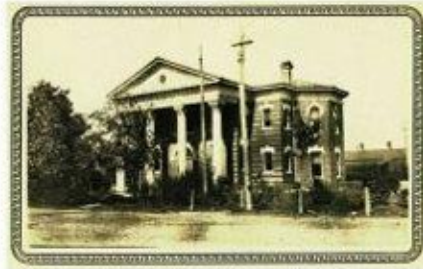
Carnegie History Center
