1 FLOOR
3/4" = 1'-0"

2 ELEVATION VIEW
3/4" = 1'-0"

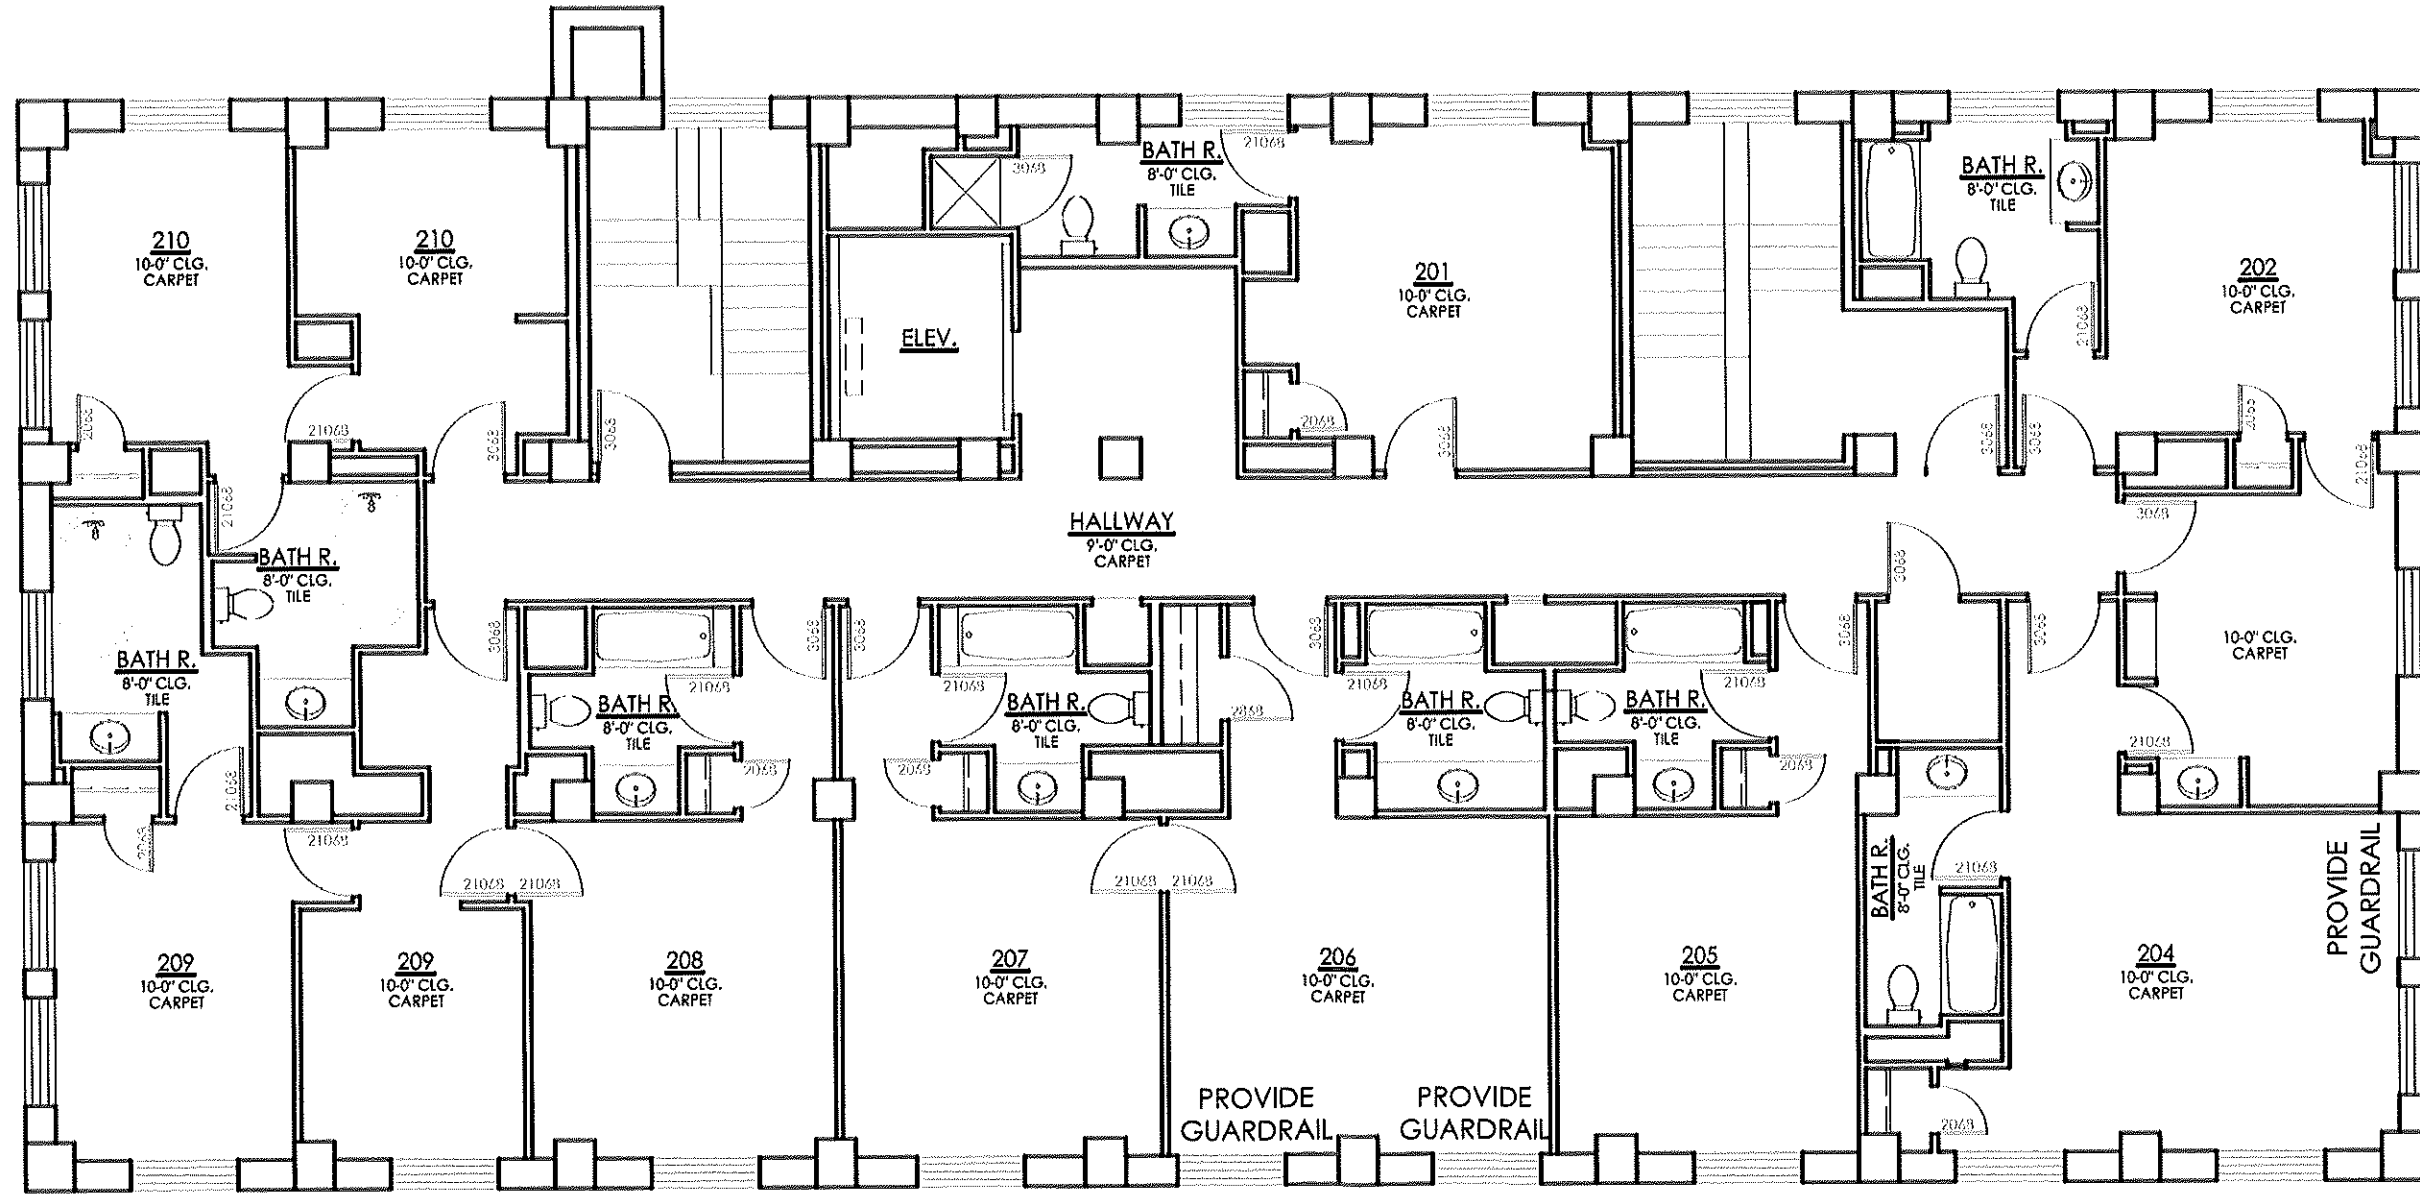
01 2ND FLOOR GUARDRAIL REPLACEMENT PLAN

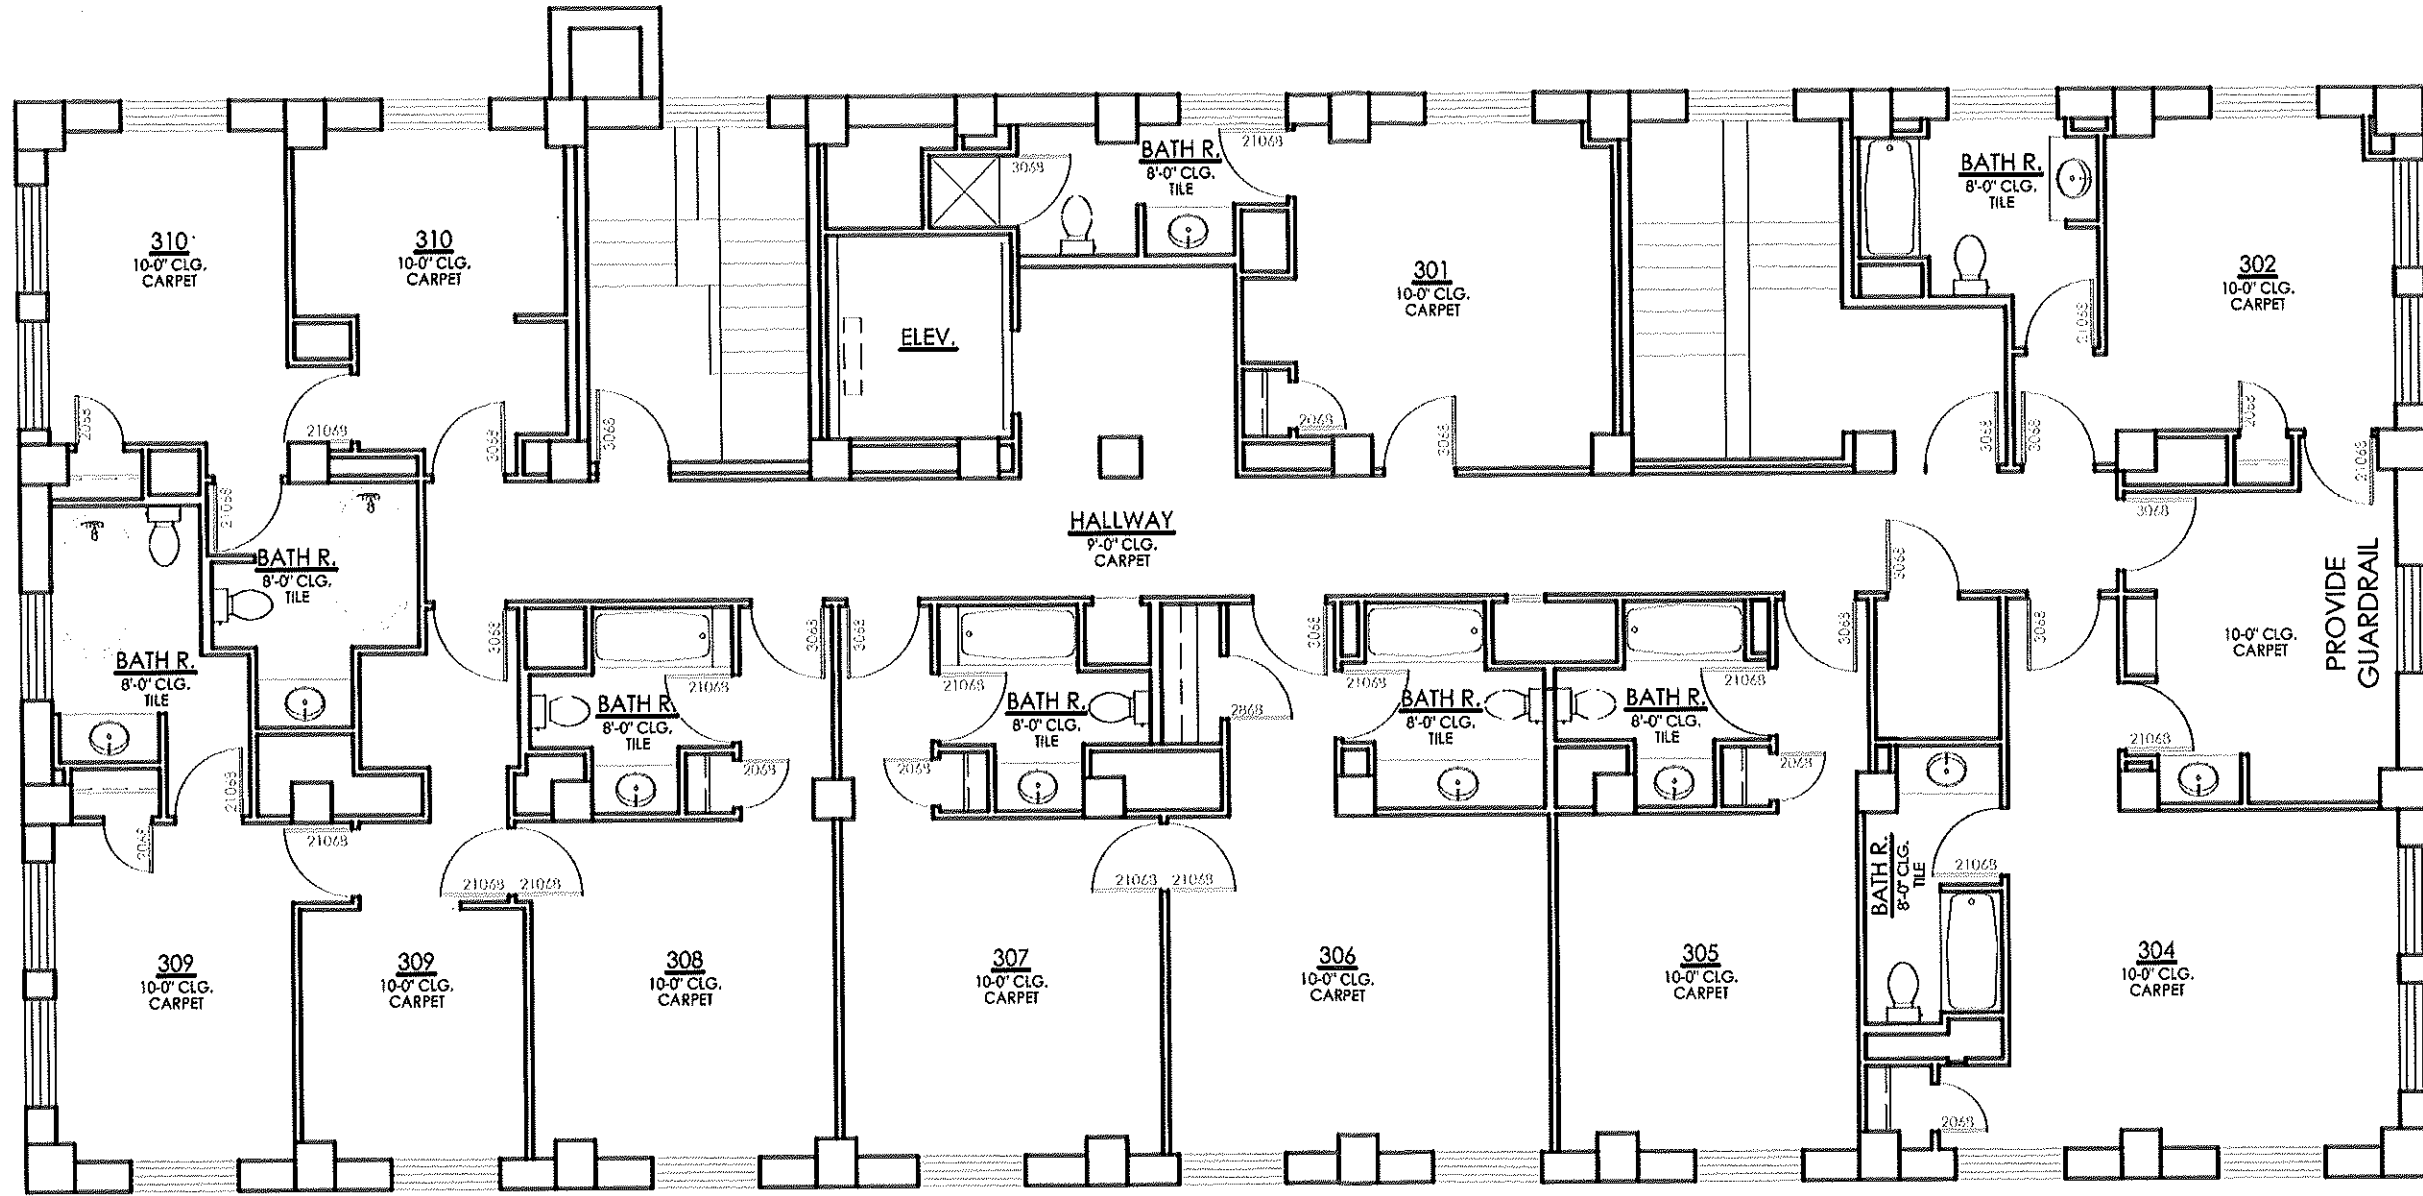
01 3RD FLOOR GUARDRAIL REPLACEMENT PLAN

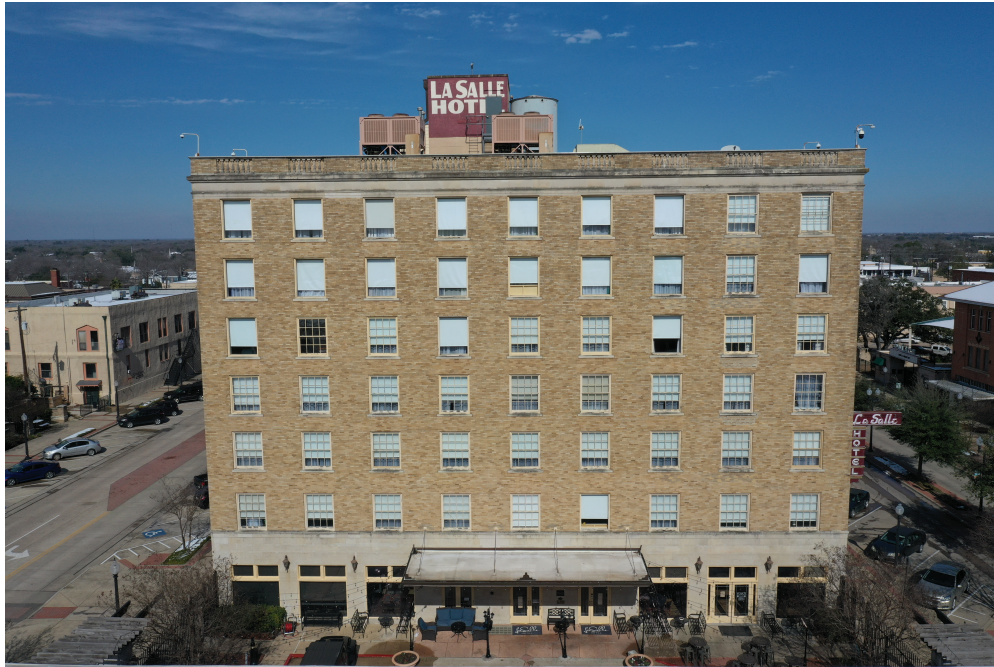
LaSalle Hotel Condition Assessment

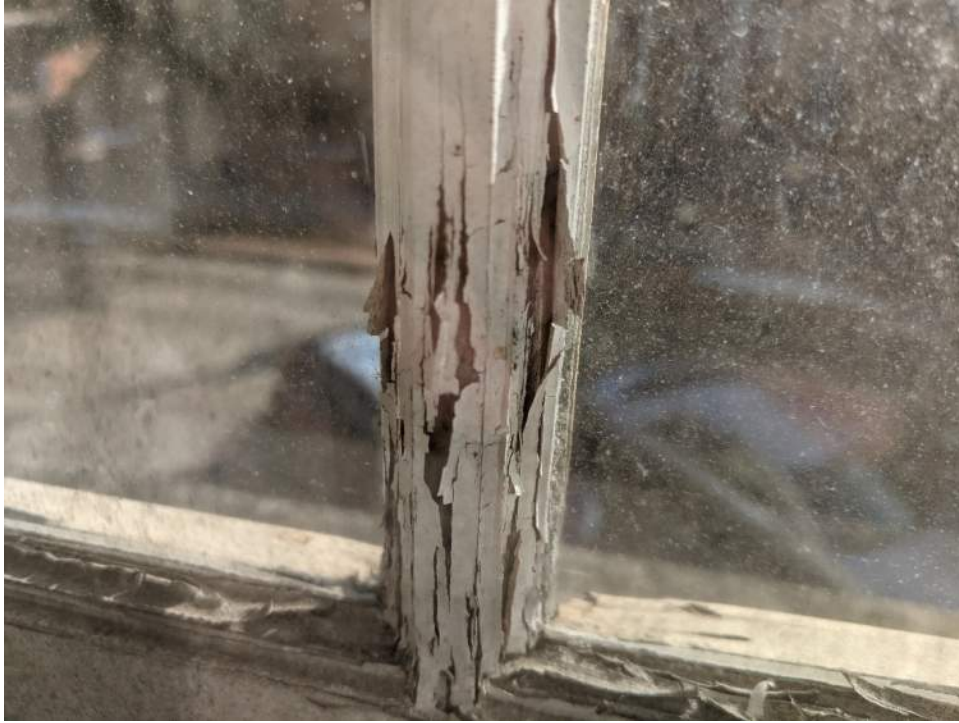
Figure 1 - Wood Rot Penetrating Through Window Sash

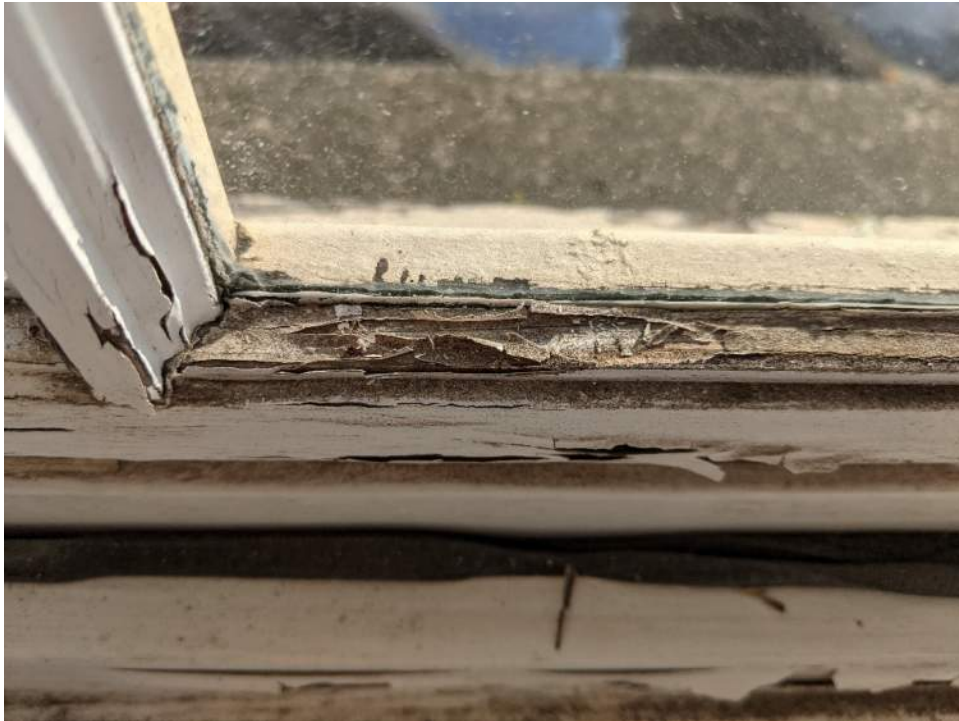
Figure 2 - Wood Rot Penetrating Through Window Sash

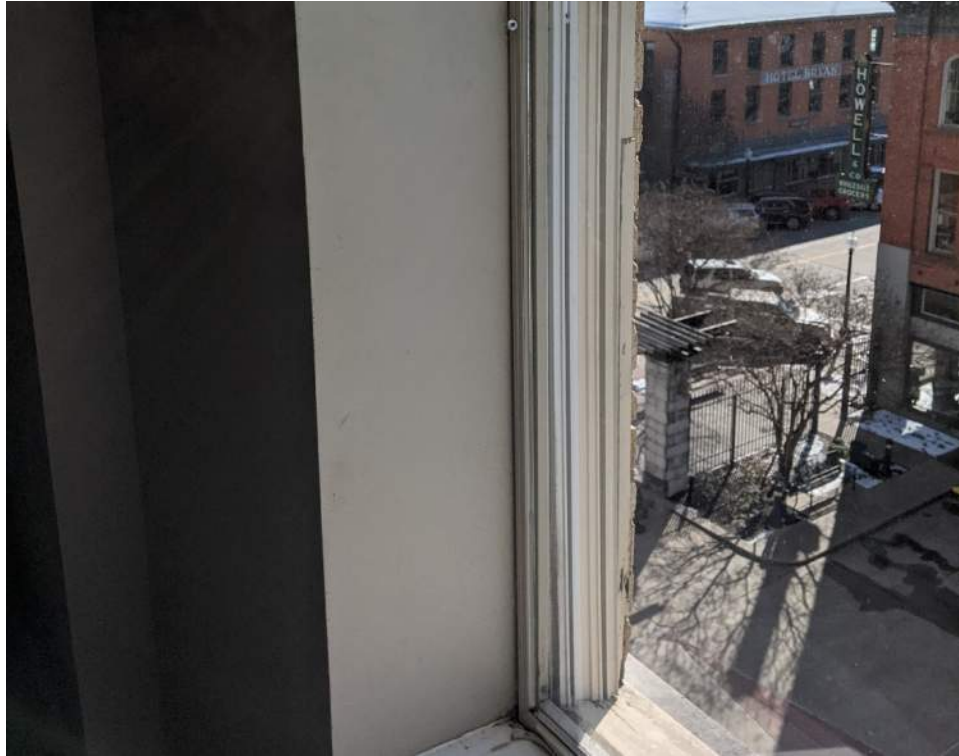
Figure 3 – Example of Inadequate Screw Count

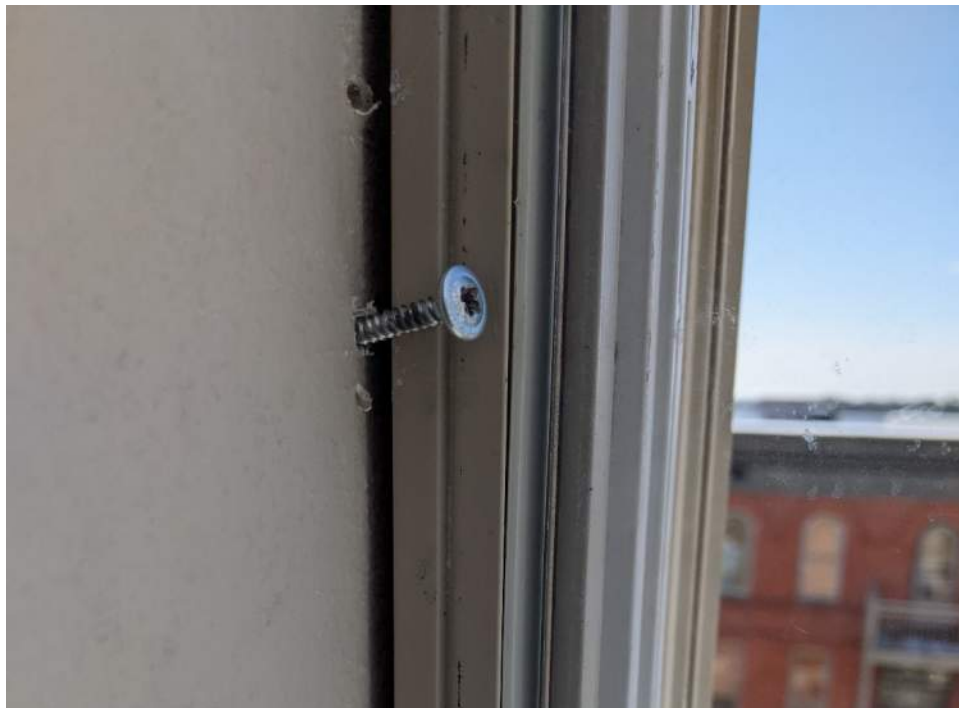
Figure 4 - Example of Screw Missing the Window

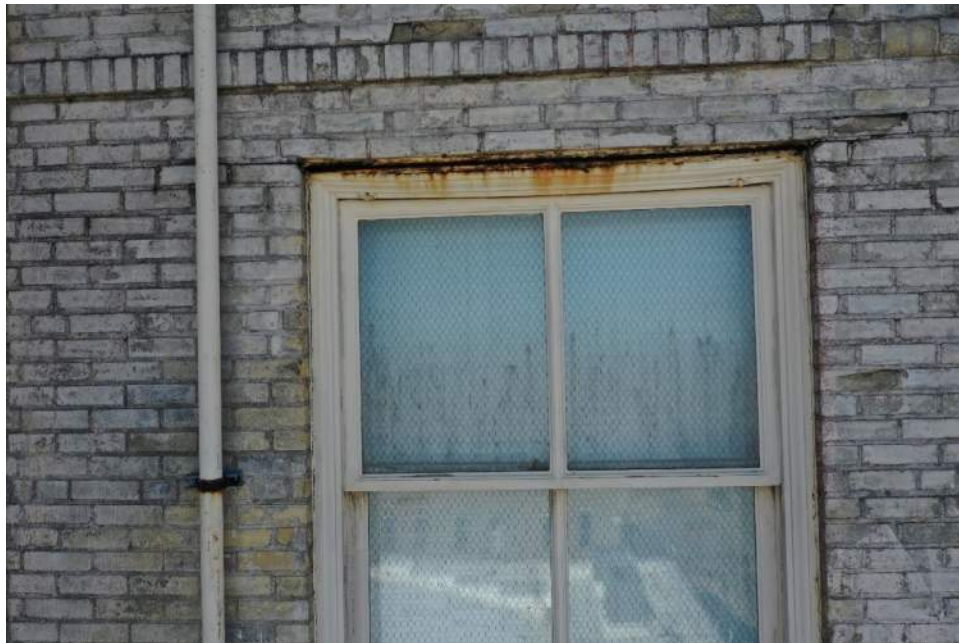
Figure 5 – Example of Rusting at Window Frame

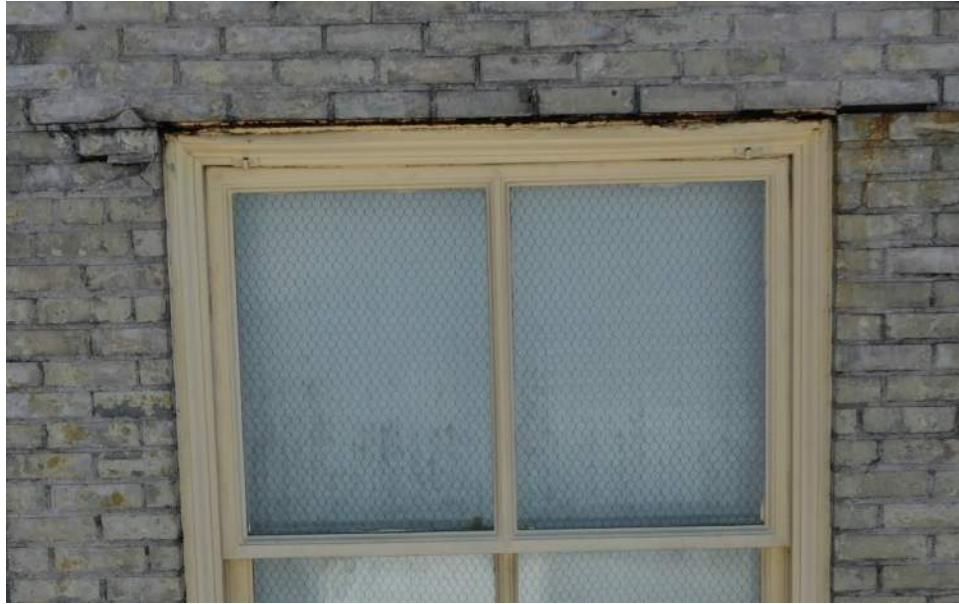
Figure 6 - Example of Minor Cracking Near Lintel, No Signs of Distress Above

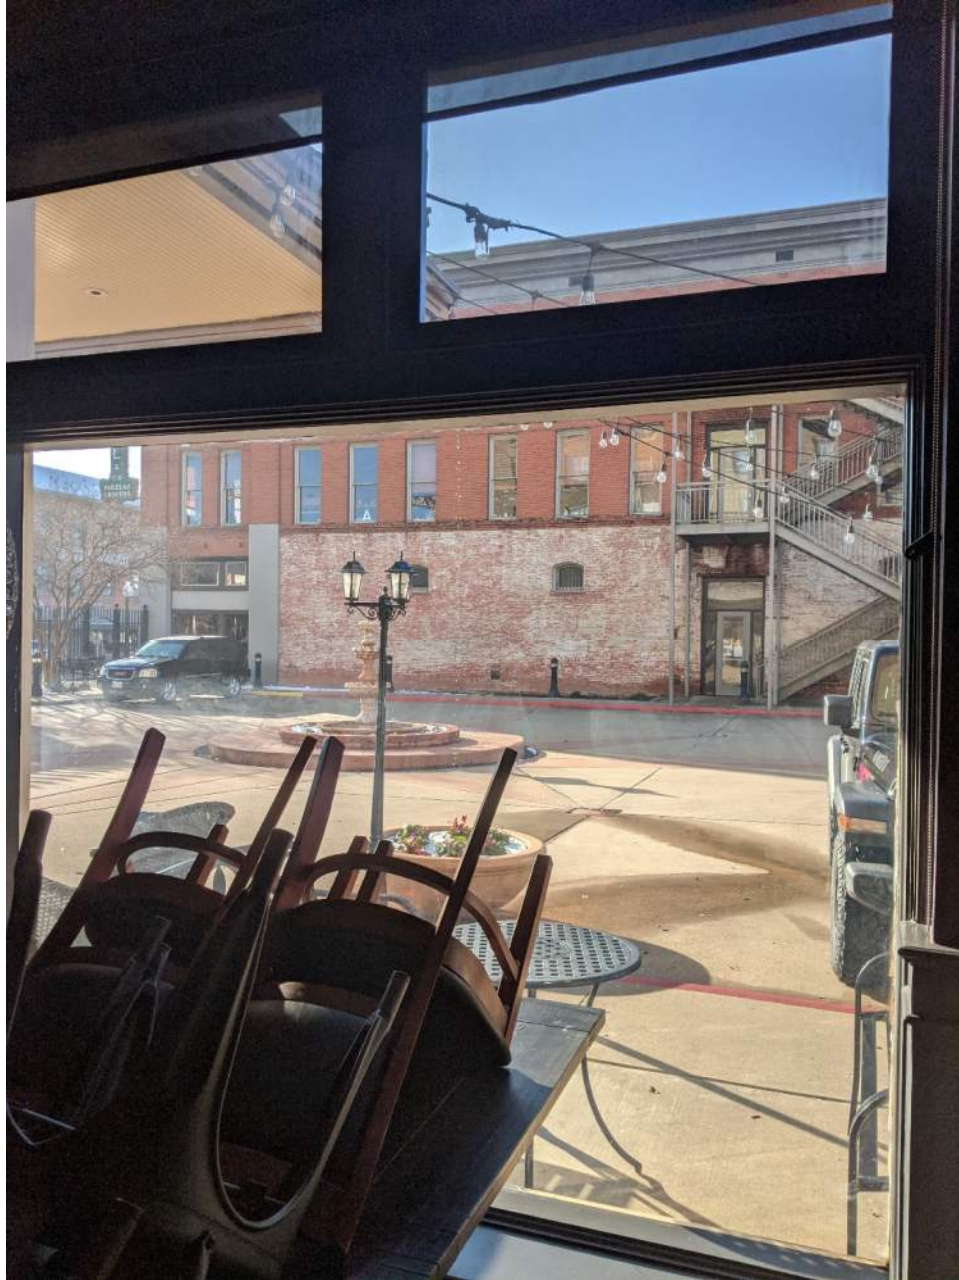
Figure 7 - Example Storefront Window

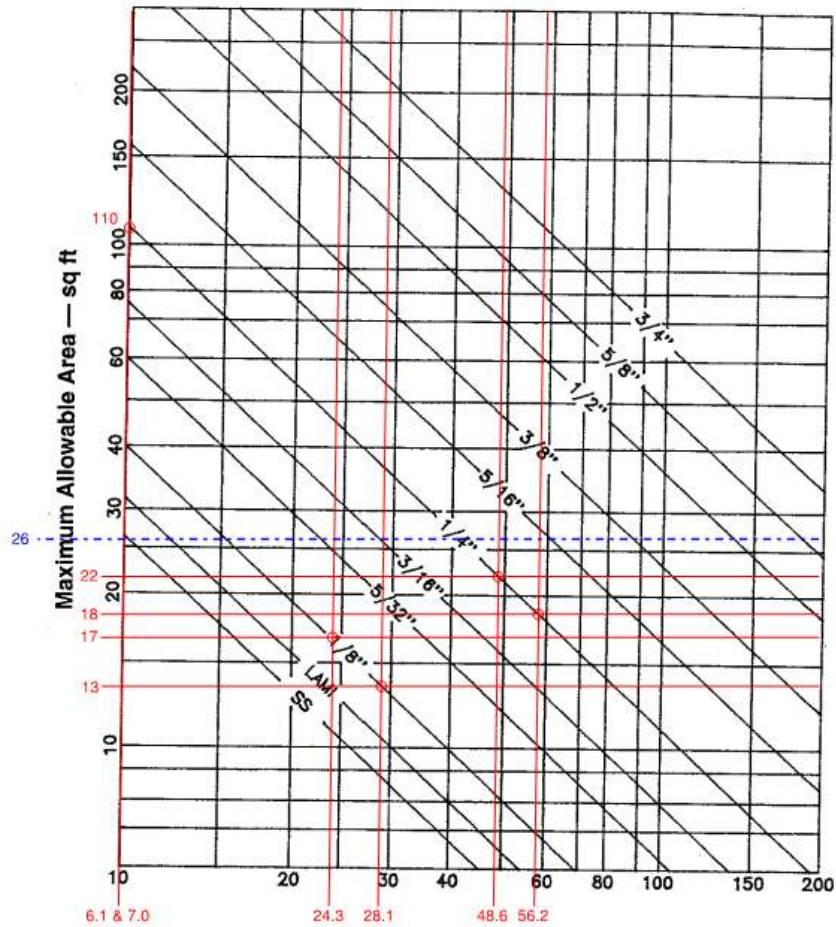
Combined Load Determined from 2405.3.1
And Tables 2405.3A or 2405.3B in psf

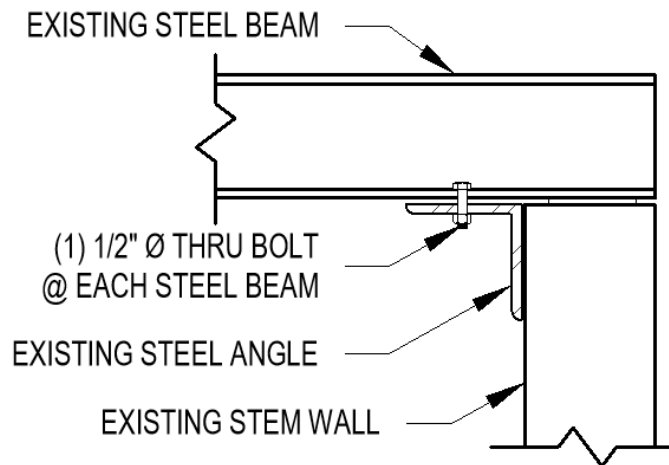
We appreciate the opportunity to assist the City of Bryan on this matter. Please feel free to contact us with any questions.

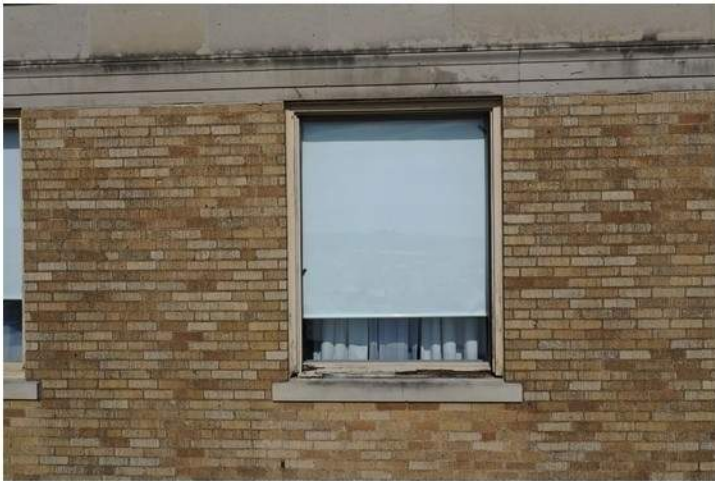
Notes: Wood rot, original window sash missing, poorly connected.

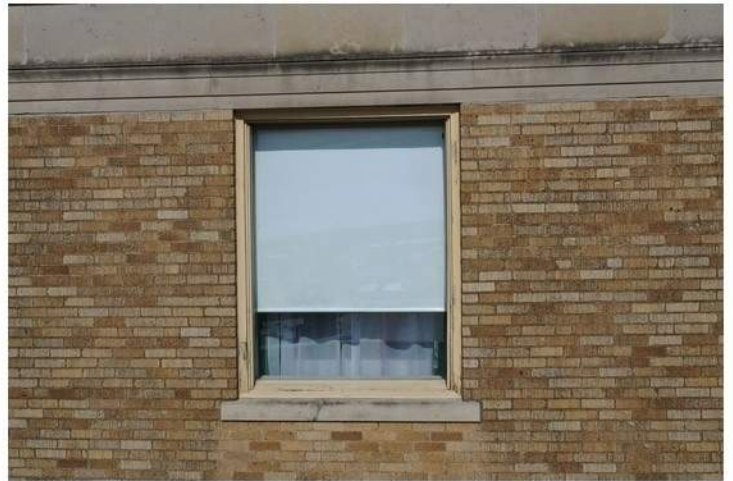
Notes: Wood rot, original window sash missing.

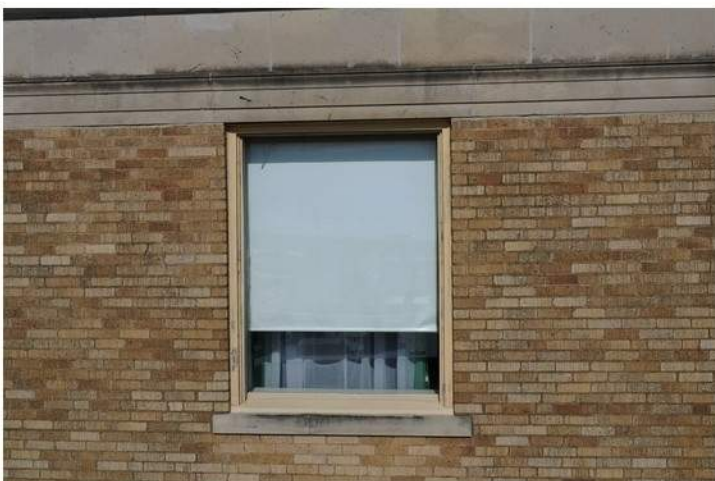
Notes: Wood rot, original window sash missing.

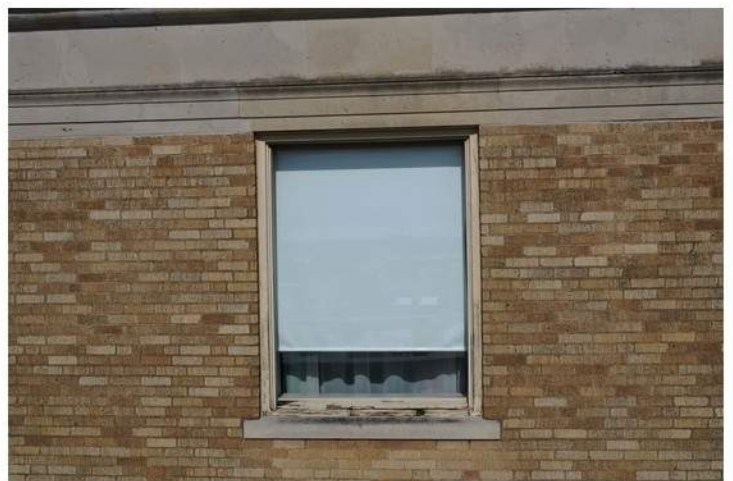
Notes: Wood rot, original window sash missing.

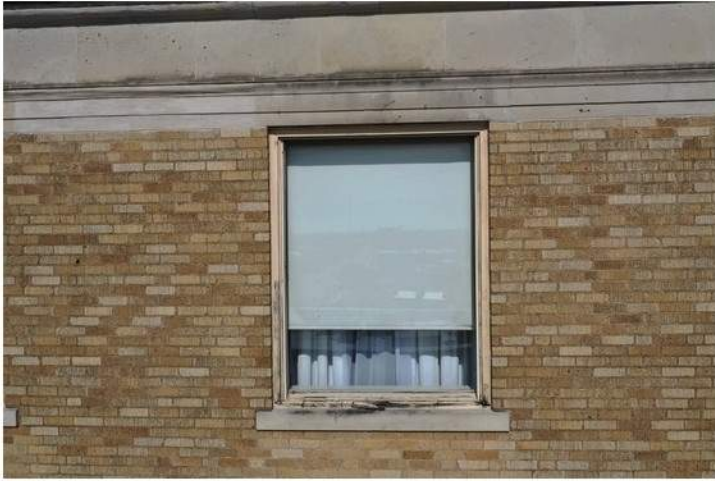
Notes: Wood rot, original window sash missing.

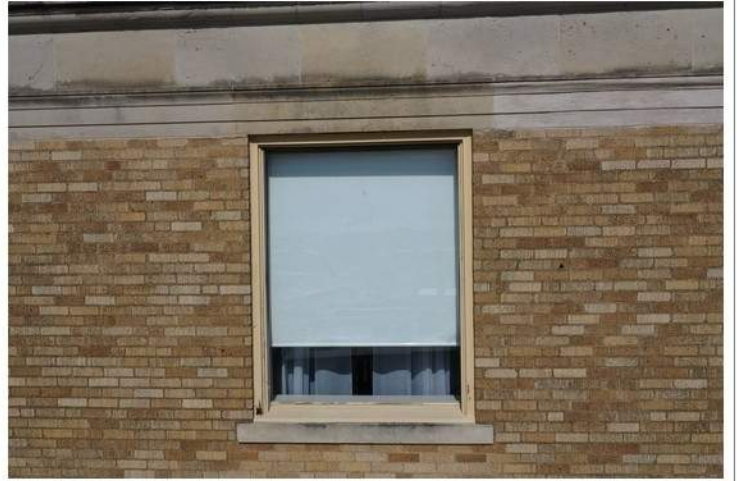
Notes: Wood rot, original window sash missing.

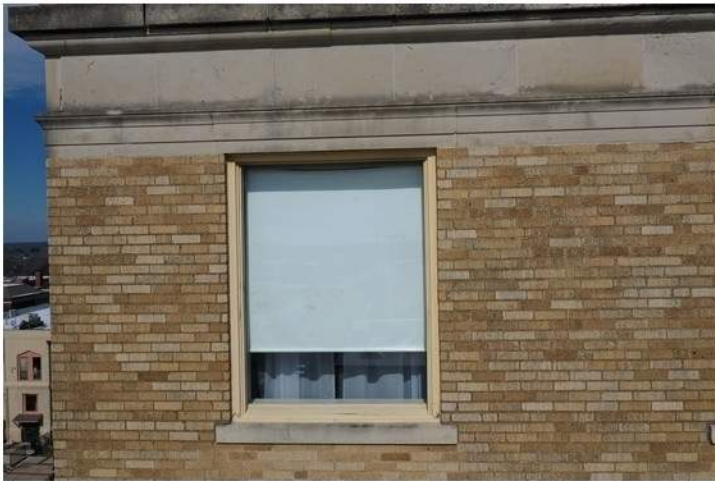
Notes: Wood rot, brick crack, original window sash missing.

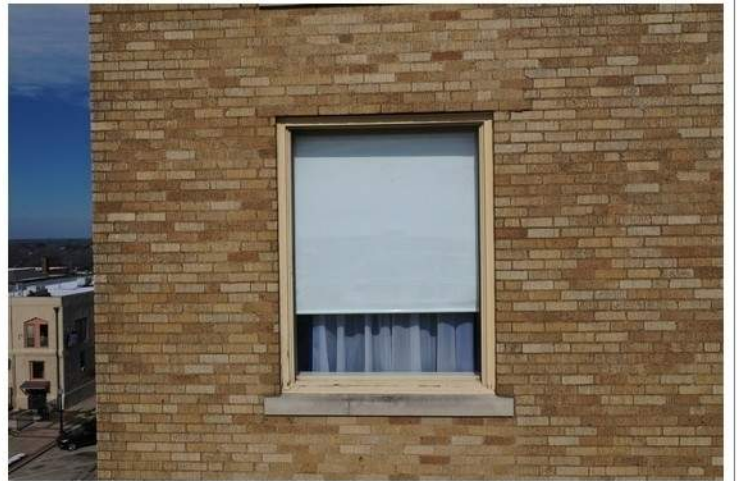
Notes: Wood rot, original window sash missing.

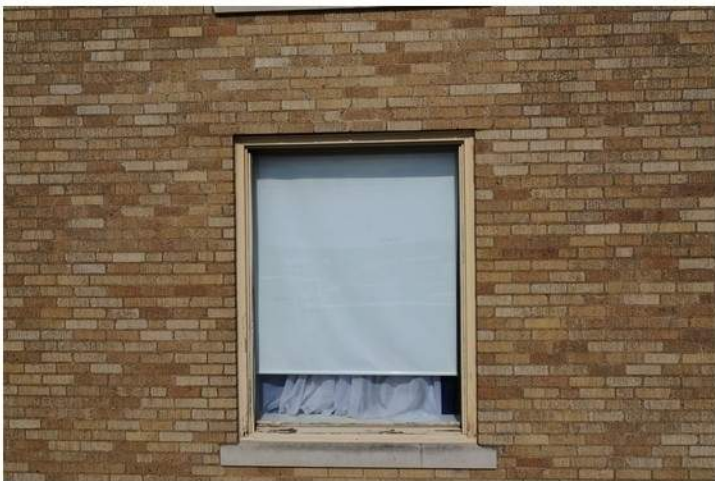
Notes: Wood rot, original window sash missing.

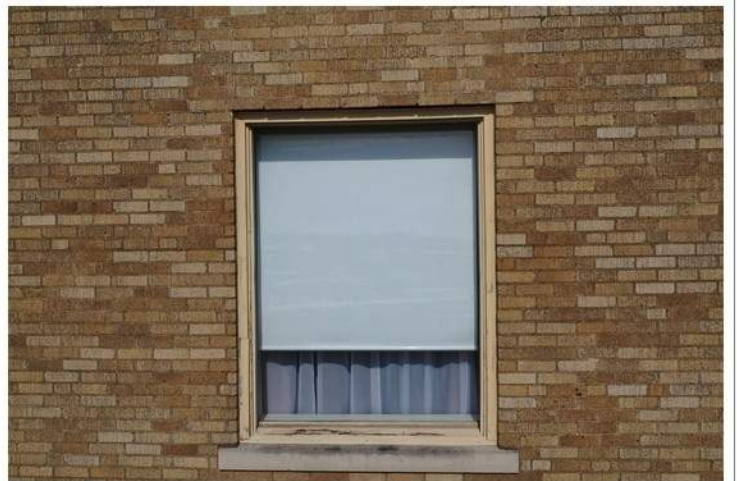
Notes: Wood rot, original window sash missing.

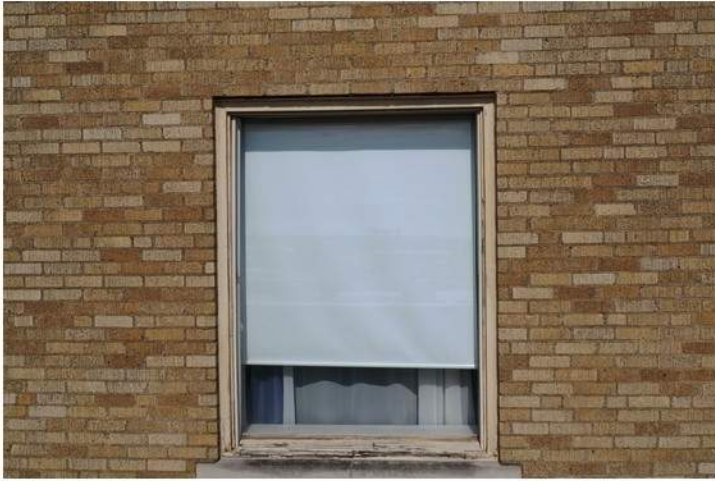
Notes: Wood rot, original window sash missing.

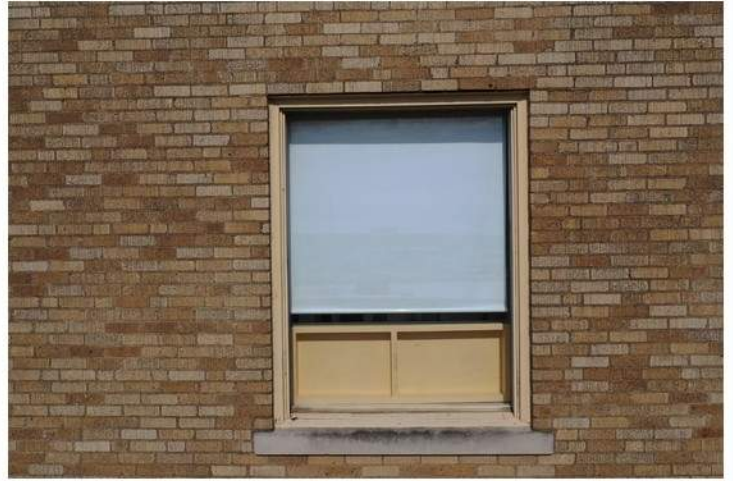
Notes: Wood rot, original window sash missing.

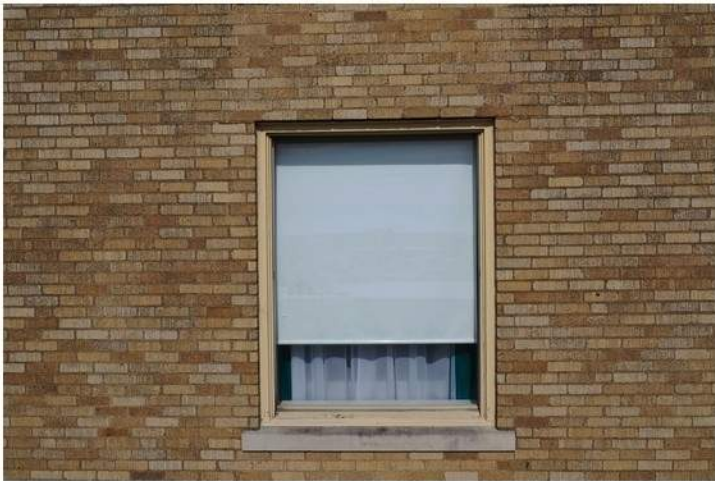
Notes: Wood rot, original window sash missing.

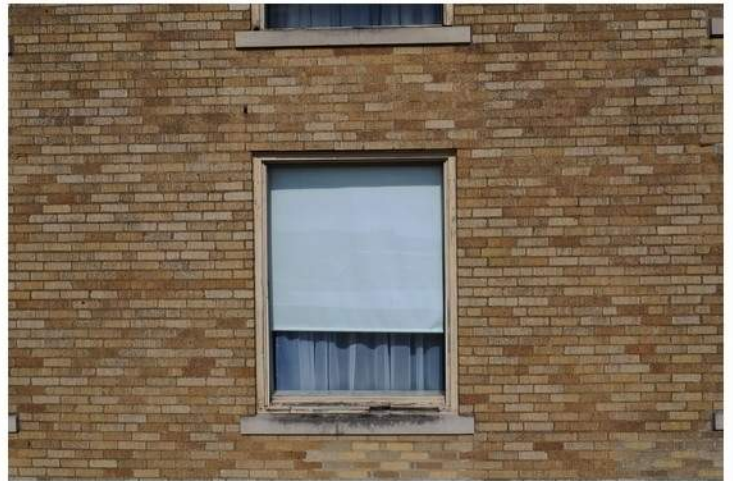
Notes: Wood rot, original window sash missing, excessive window vibrations.

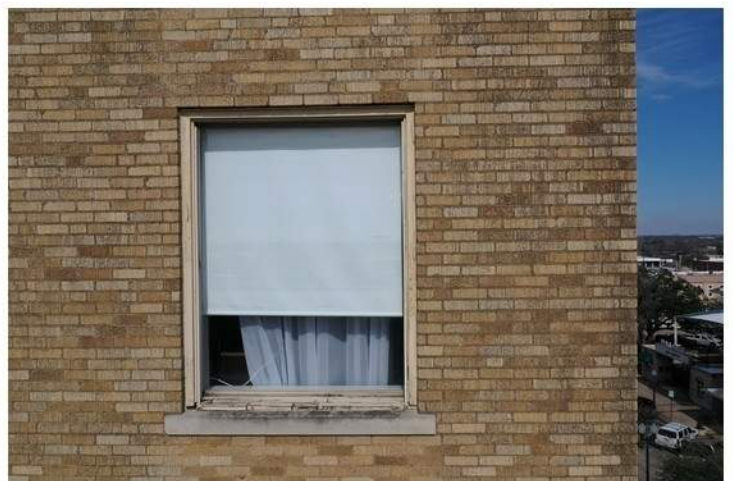
Notes: Wood rot, original window sash missing.

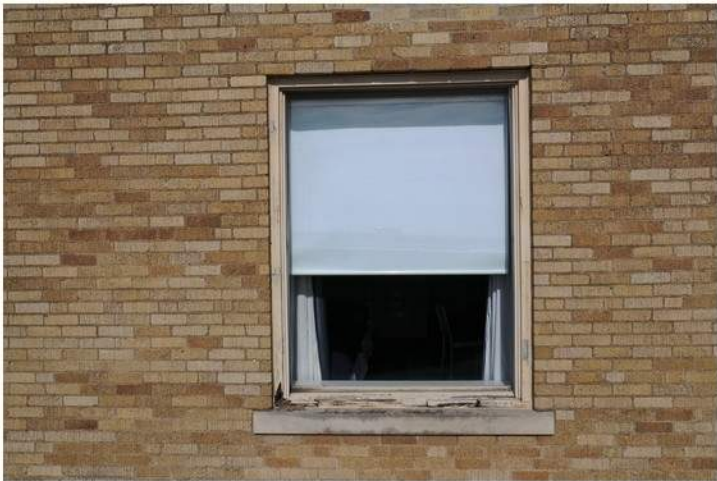
Notes: Wood rot, original window sash missing, poorly connected.

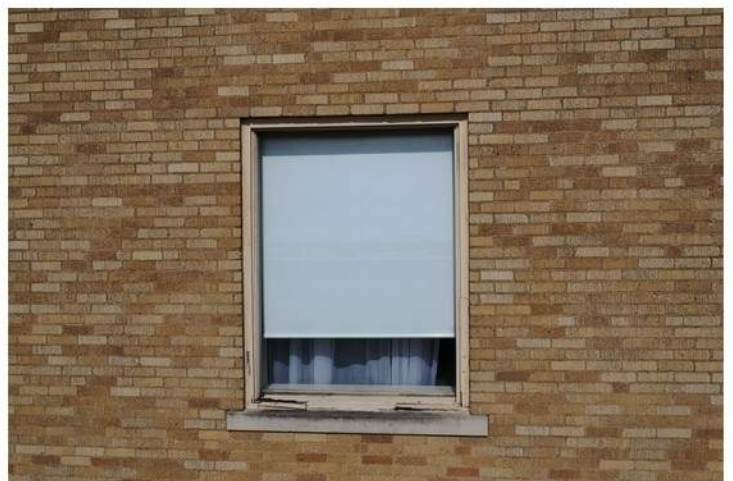
Notes: Wood rot, original window sash missing, poorly connected.

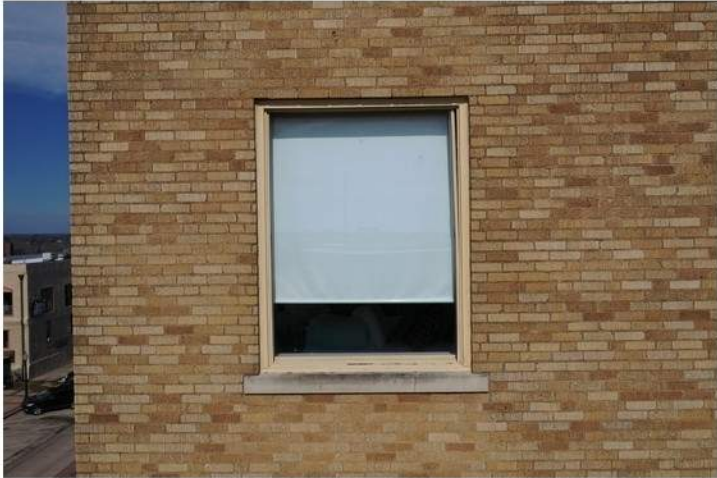
Notes: Wood rot, original window sash missing.

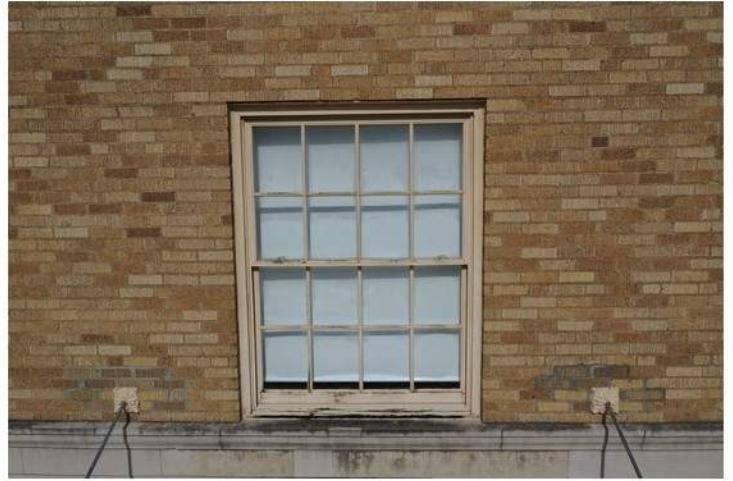
Notes: Wood rot, interior storm window missing.

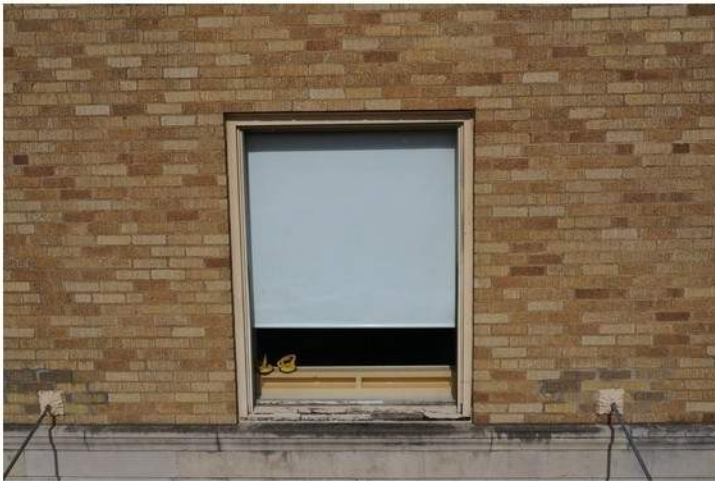
Notes: Wood rot, original window sash missing.

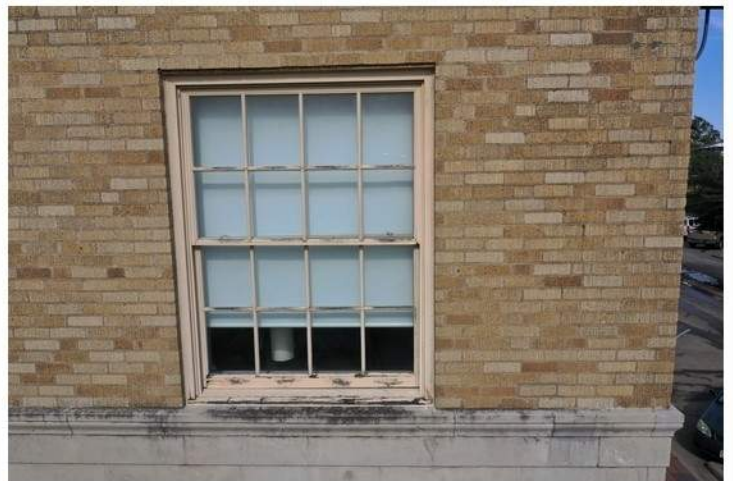
Notes: Wood rot, exterior window does not close completely.

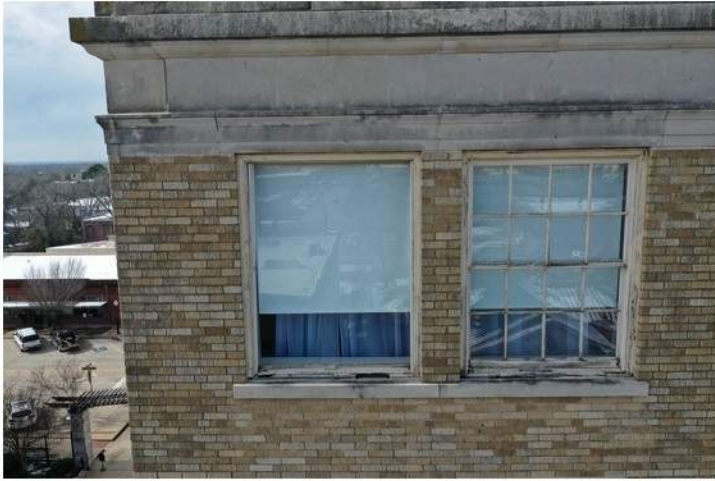
Notes: Wood rot, 7A missing original window sash.

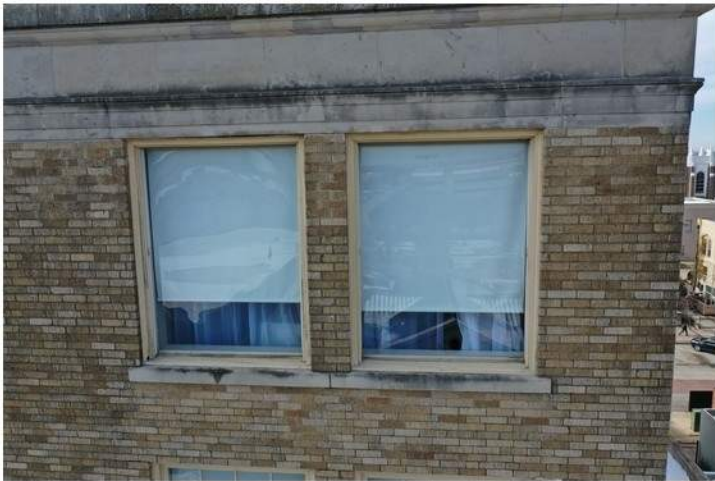
Notes: Wood rot, original window sashes missing.

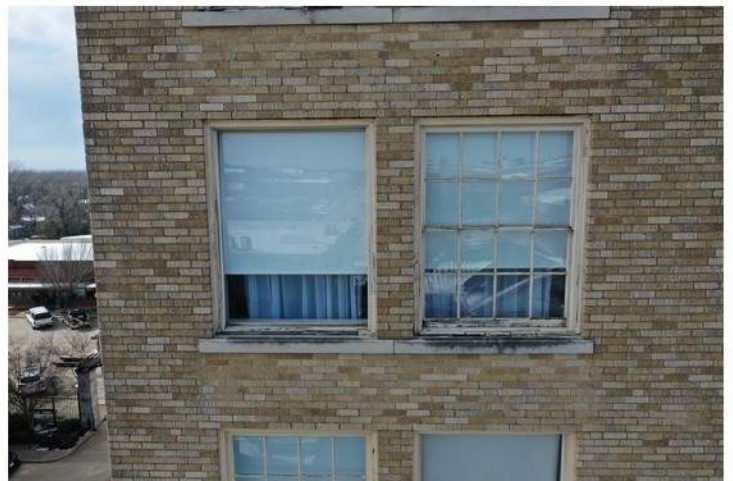
Notes: Wood rot, 6A missing original window sash.

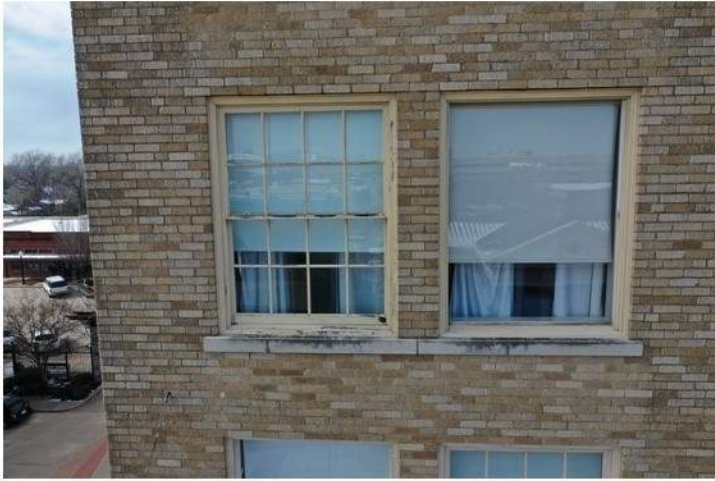
Notes: Wood rot, 5B missing original window sash.

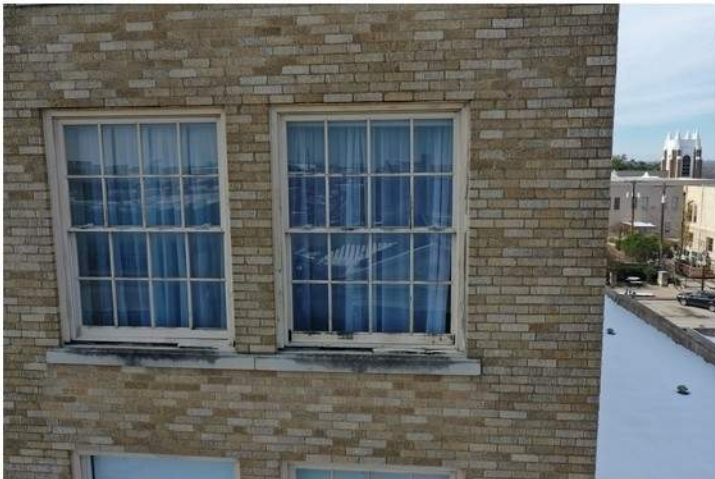
Notes: Wood rot, 5E interior storm window missing.

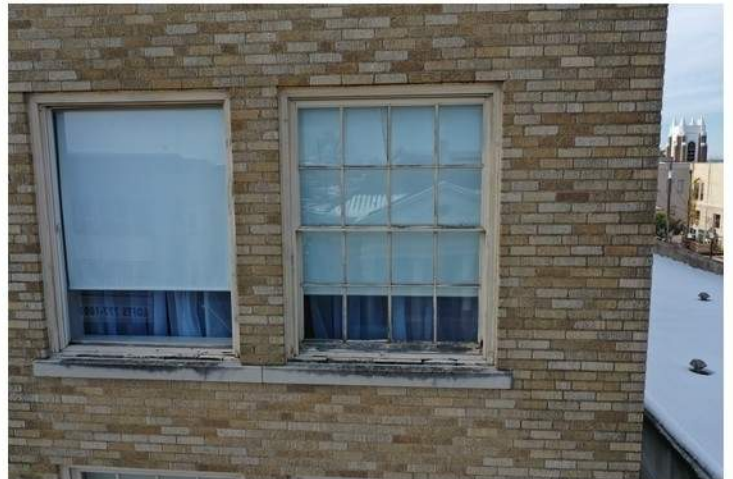
Notes: Wood rot, 4D missing original window sash.

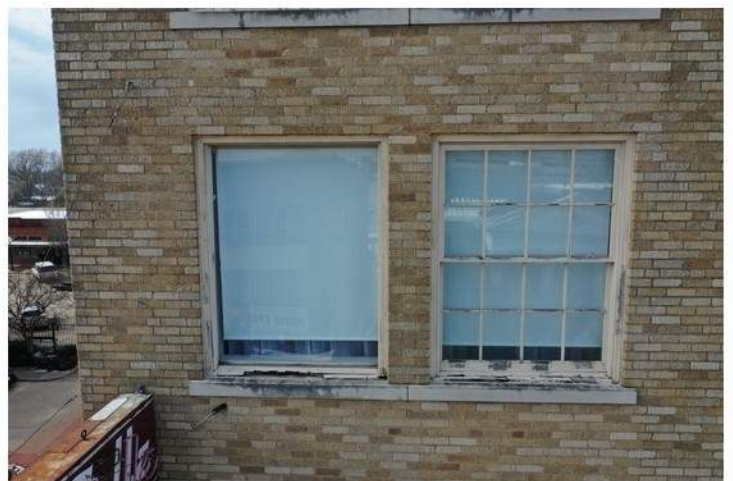
Notes: Wood rot, 4A missing original window sash.
