1 FLOOR
3/4" = 1'-0"

2 ELEVATION VIEW
3/4" = 1'-0"

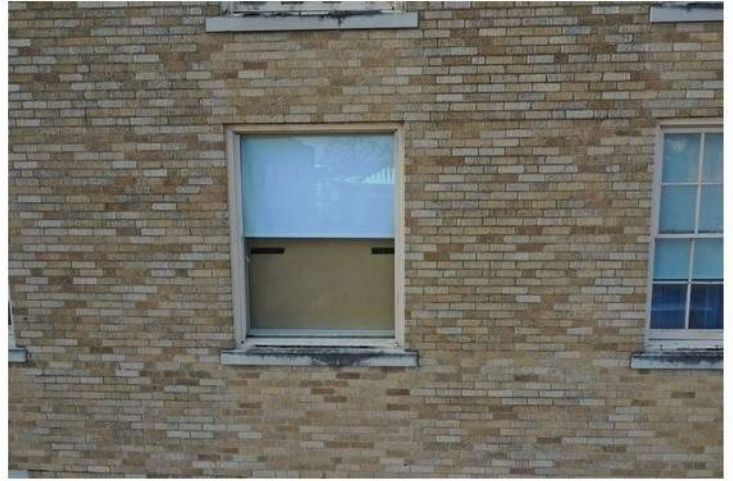
Notes: Wood rot, original window sash missing, poorly connected.

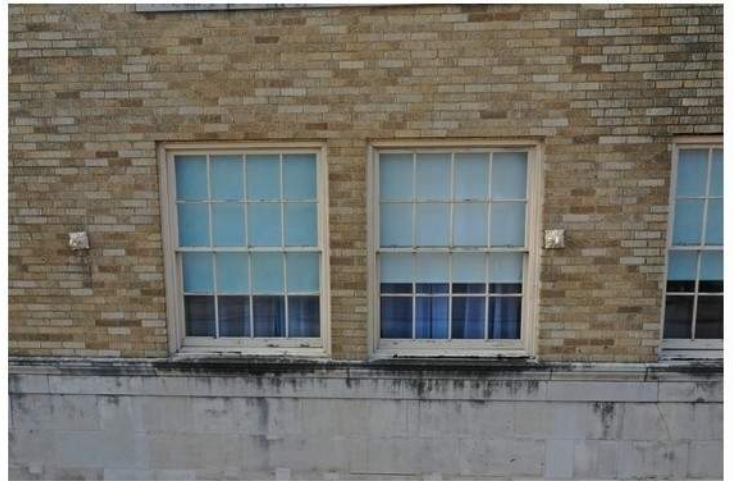
Notes: Wood rot, 2E has no interior storm window.

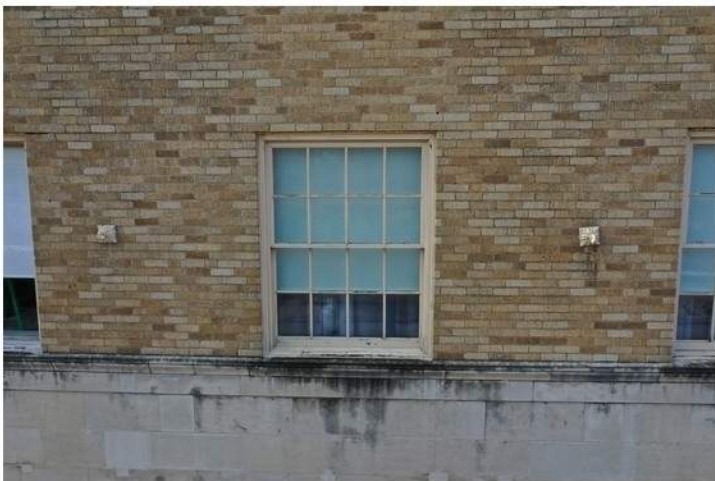
Notes: Wood rot, interior storm window loose.

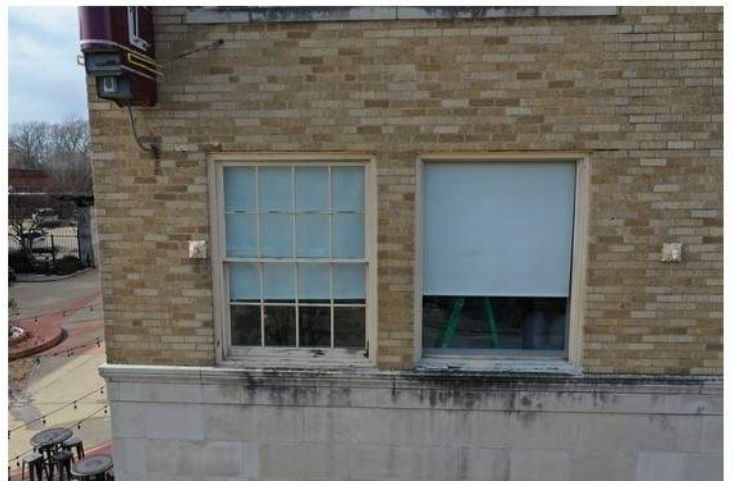
Notes: Wood rot, 2B missing original window sash, 2B poorly connected.

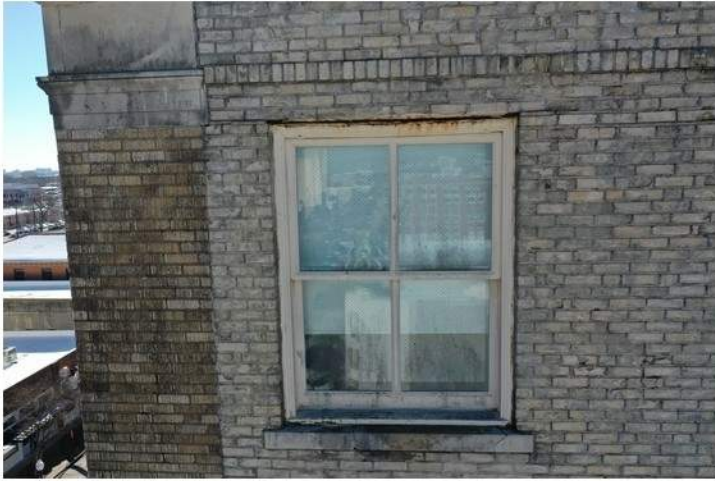
Notes: Rust, deterioration of window apron finish, brick cracking.

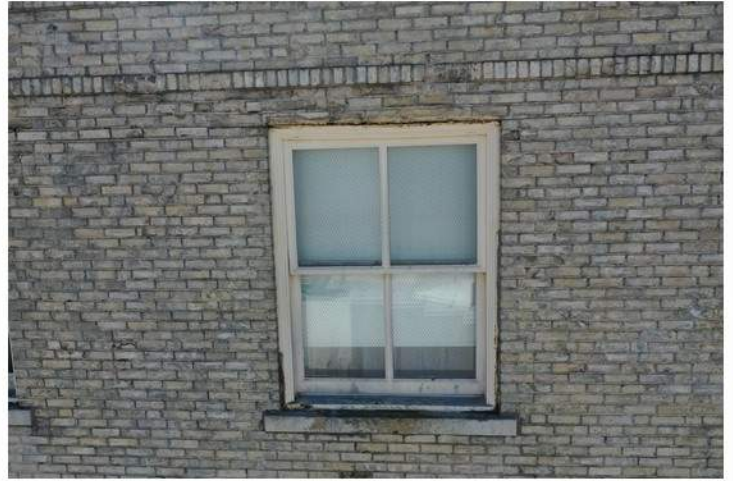
Notes: Rust, deterioration of window apron finish, brick cracking.

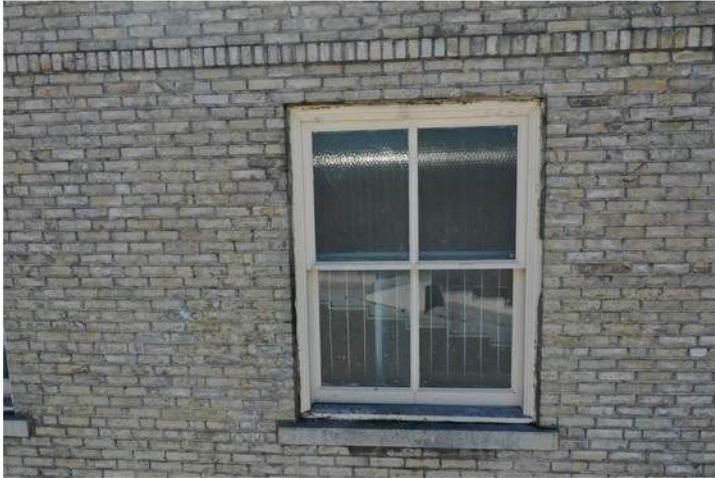
Notes: Rust, brick cracking.

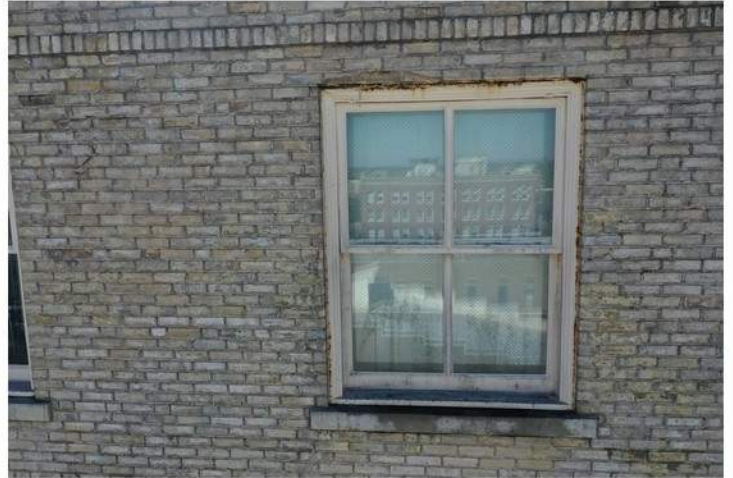
Notes: Rust, brick cracking.

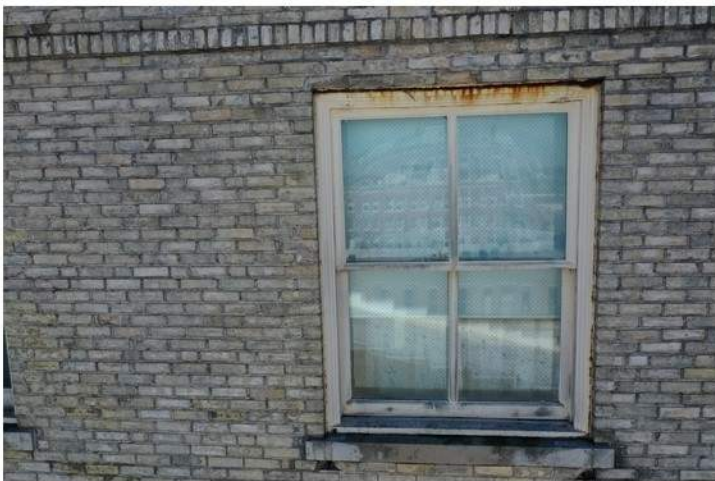
Notes: Rust, brick cracking, impact hole in glass.

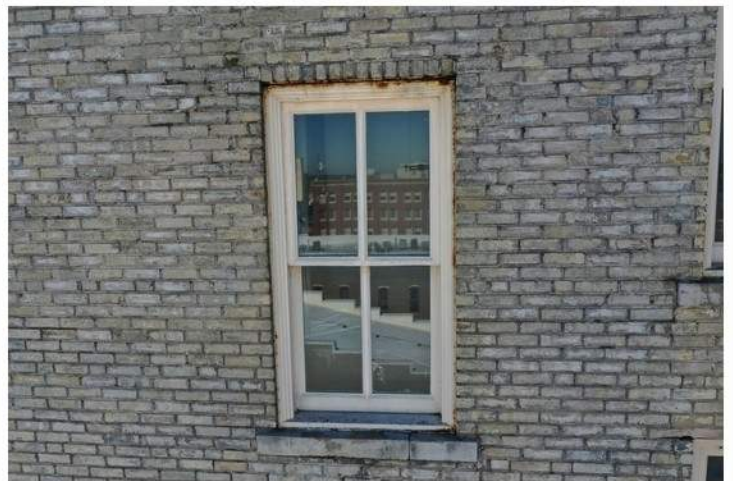
Notes: Rust, interior not observable (no access).

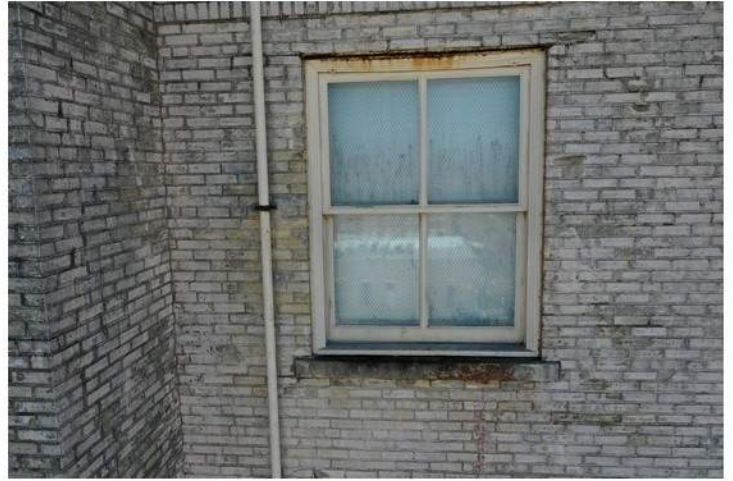
Notes: Rust, brick cracking.

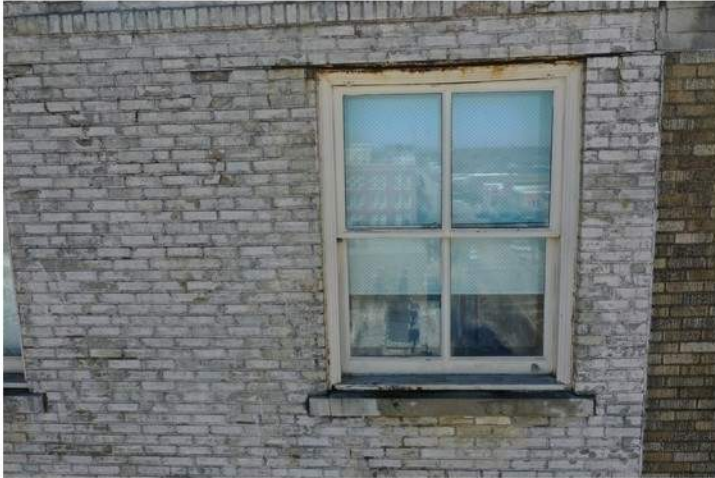
Notes: Rust, brick cracking.

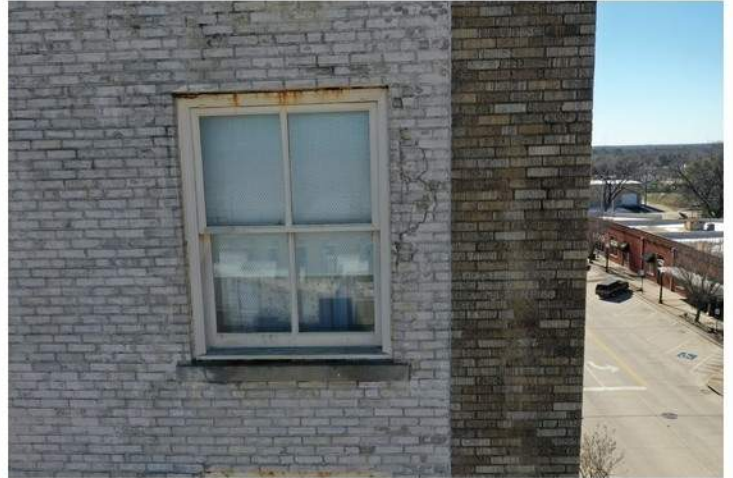
Notes: Rust, brick cracking.

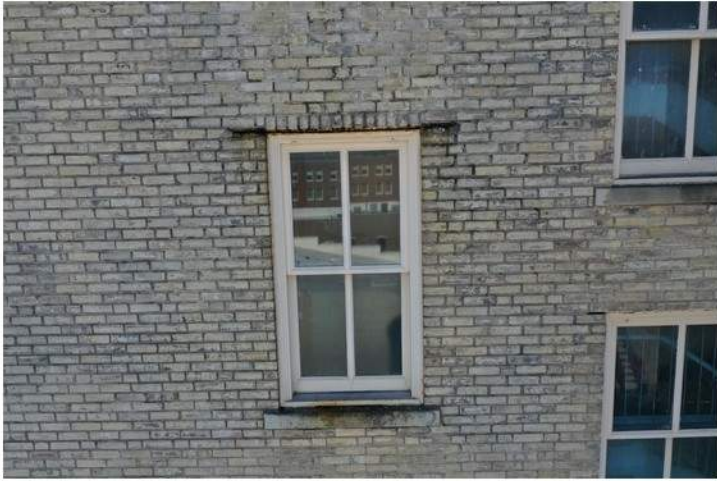
Notes: Rust, interior not observable (no access).

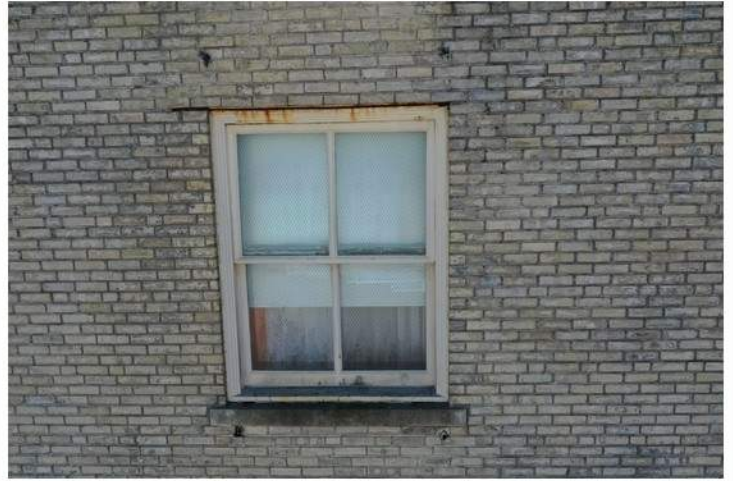
Notes: Rust, brick cracking.

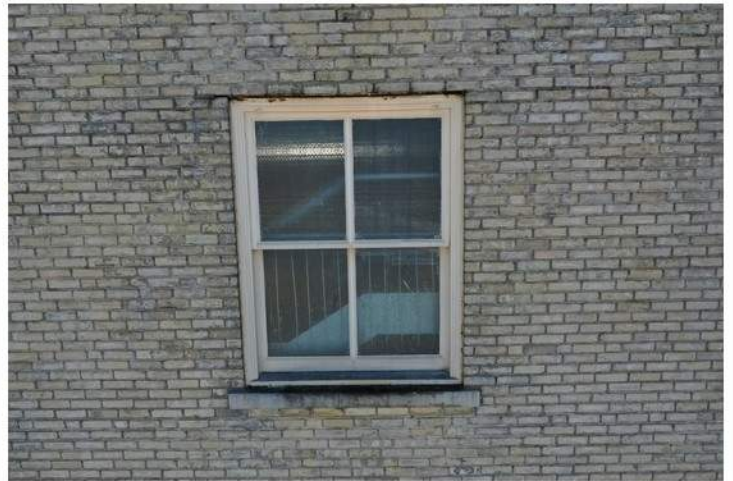
Notes: Rust, crack in window apron finish.

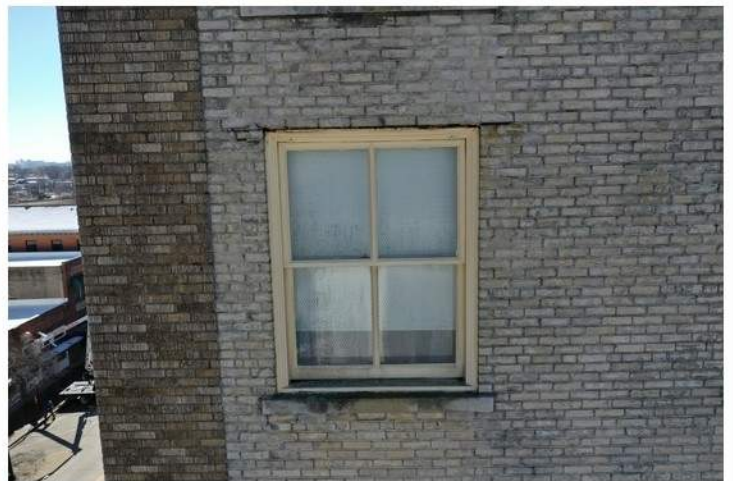
Notes: Rust, brick cracking.

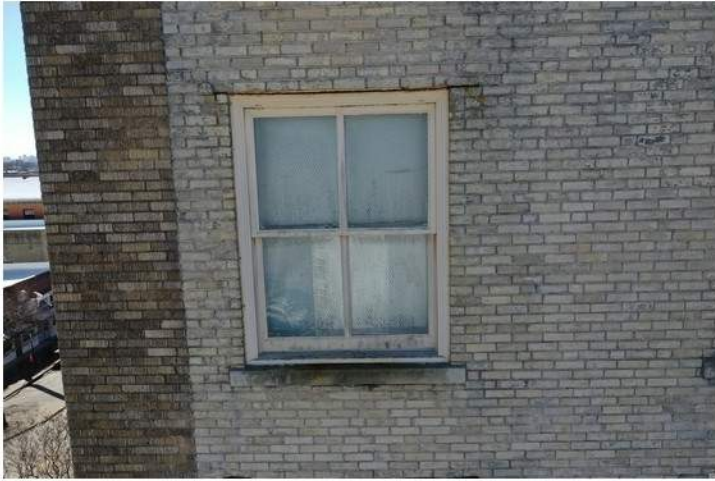
Notes: Rust, brick cracking.

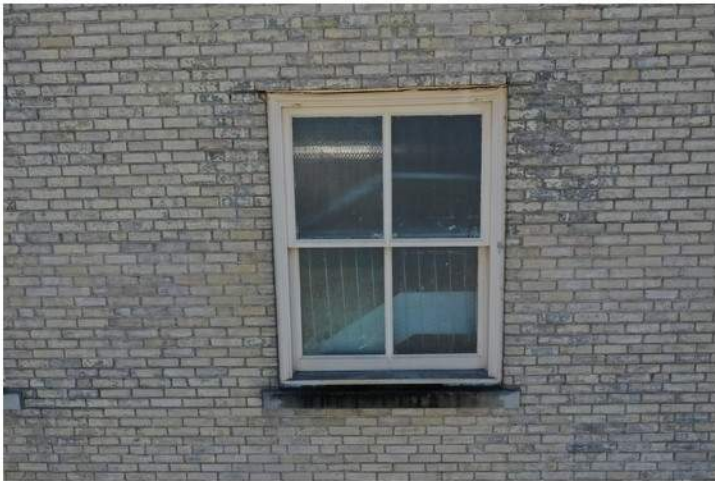
Notes: Rust, brick cracking.

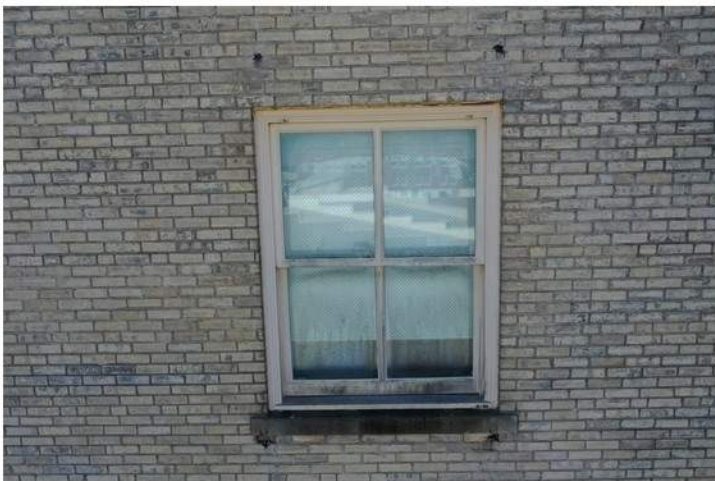
Notes: Rust, brick cracking.

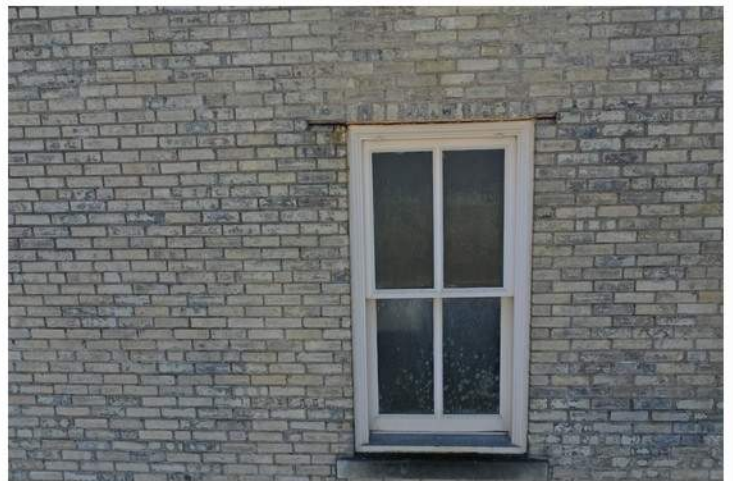
Notes: Rust, no access, interior not observable.

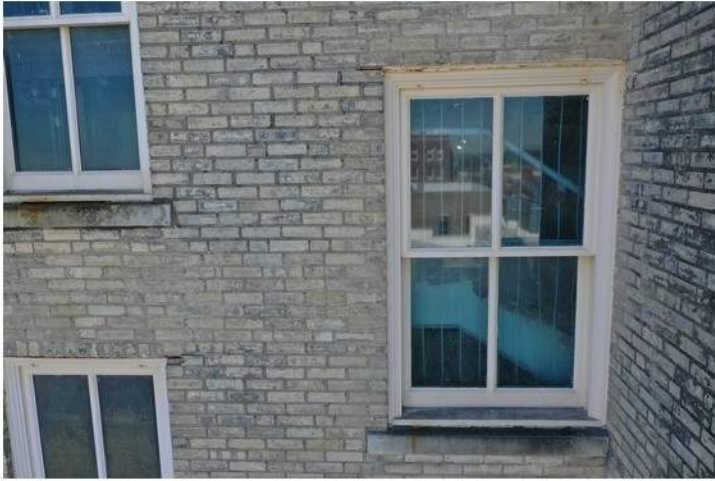
Notes: Rust, brick cracking.

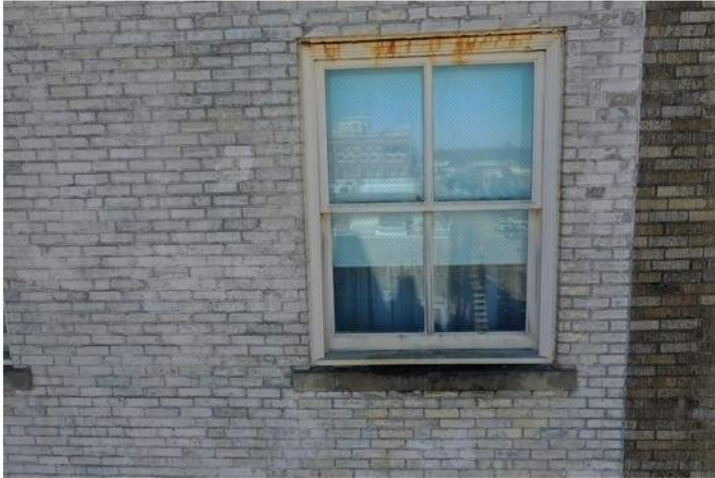
Notes: Rust, brick cracking.

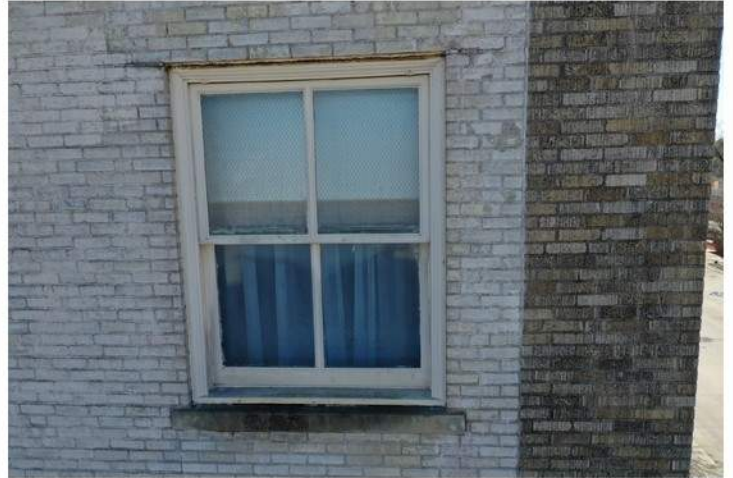
Notes: Rust, crack in window apron finish.

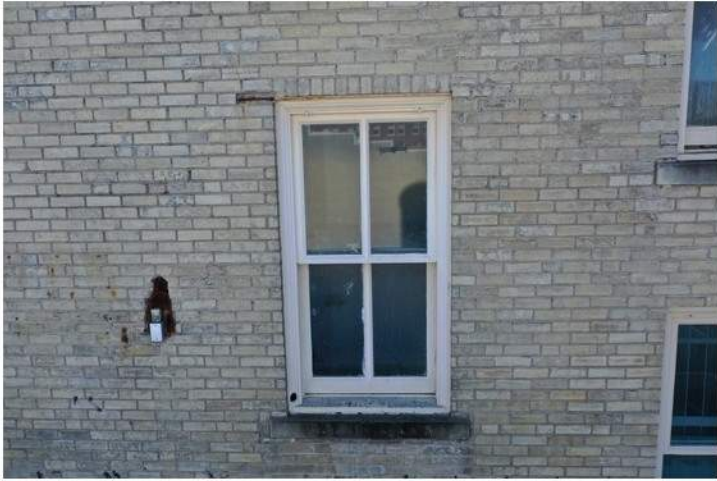
Notes: Rust, brick cracking, crack in glass, interior not observable (no access).

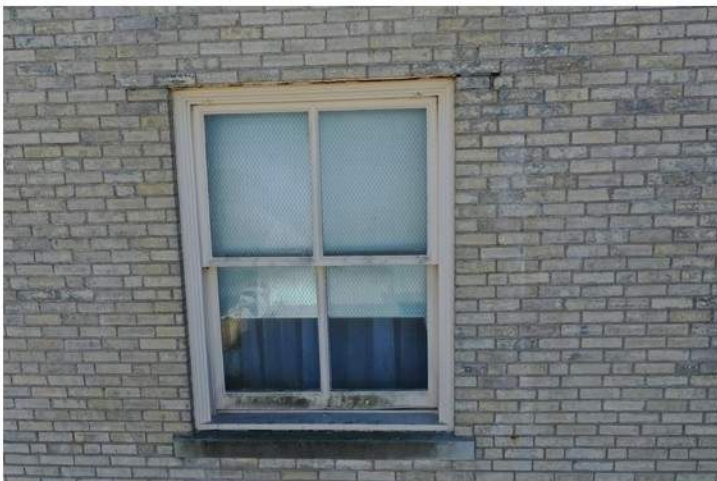
Notes: Rust, brick cracking.

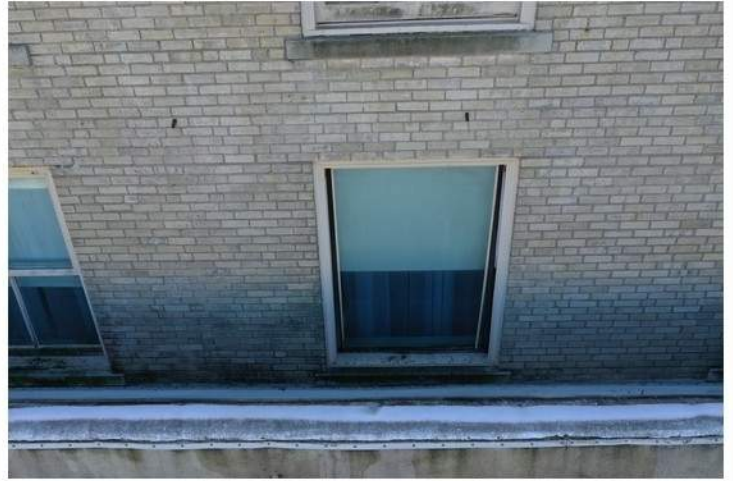
Notes: Rust, original window sash missing, non-operable.

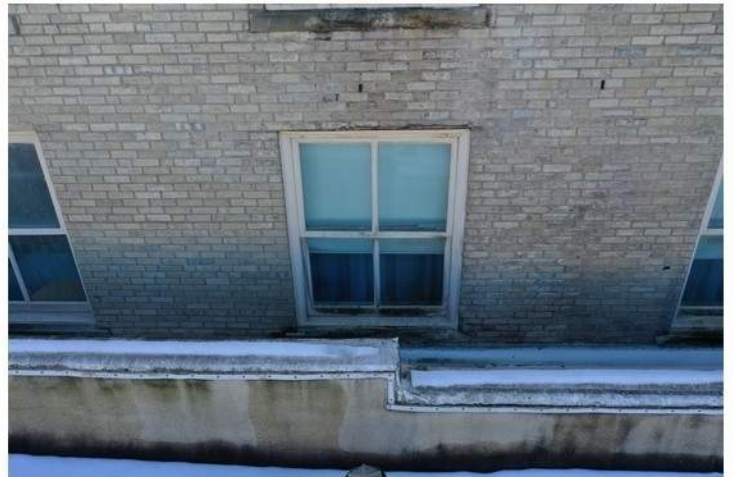
Notes: Rust, deterioration of window apron finish.

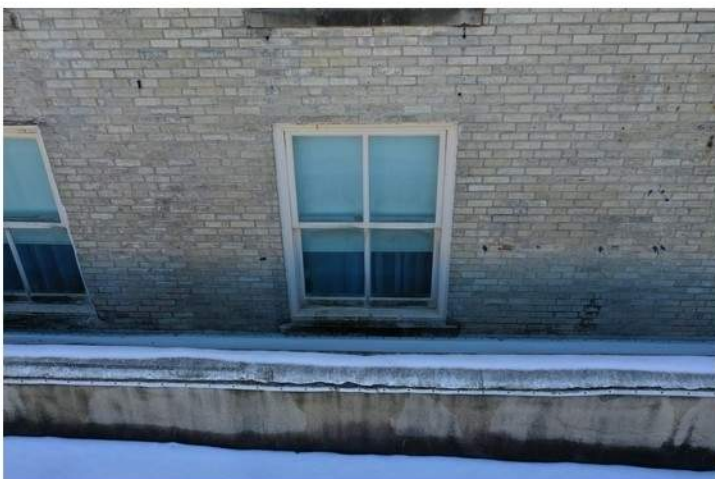
Notes: Rust, deterioration of window apron finish.

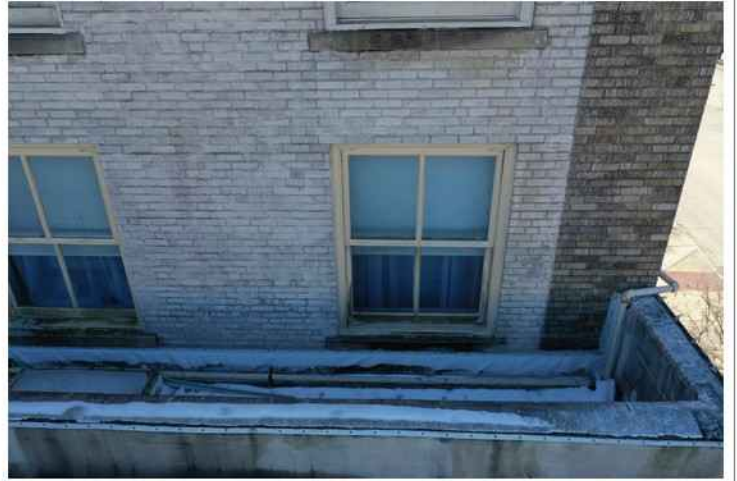
Notes: Storm window, crack in glass.

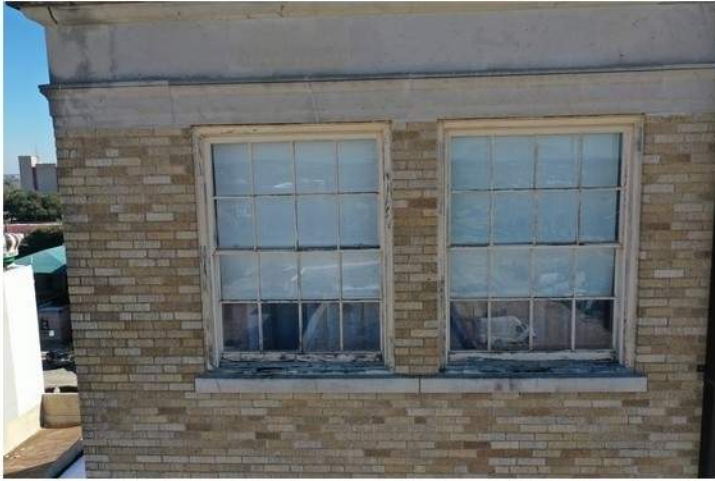
Notes: Wood rot, 7A missing interior storm window.

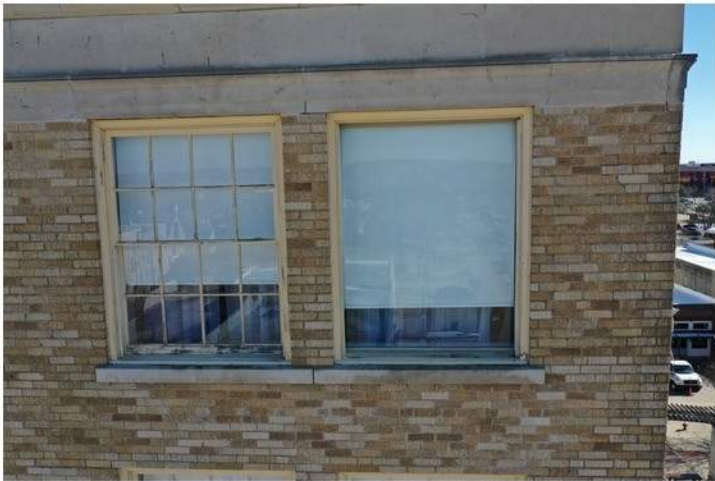
Notes: Wood rot, 7D missing interior storm window, 7E missing original window sash.

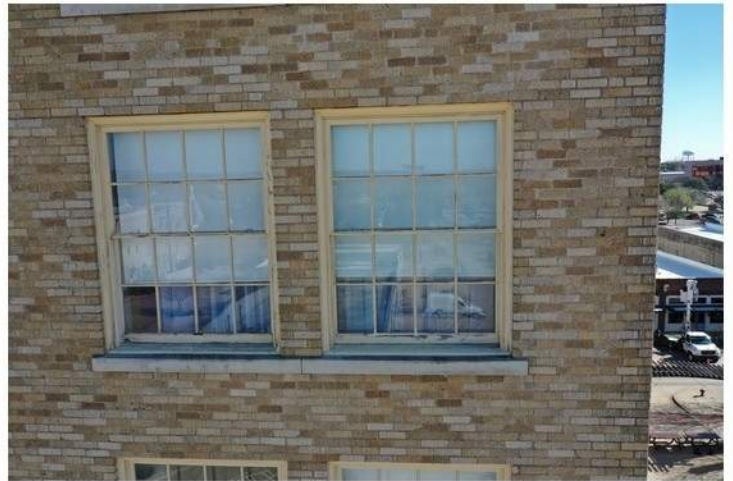
Notes: Wood rot, 6D missing interior storm window.

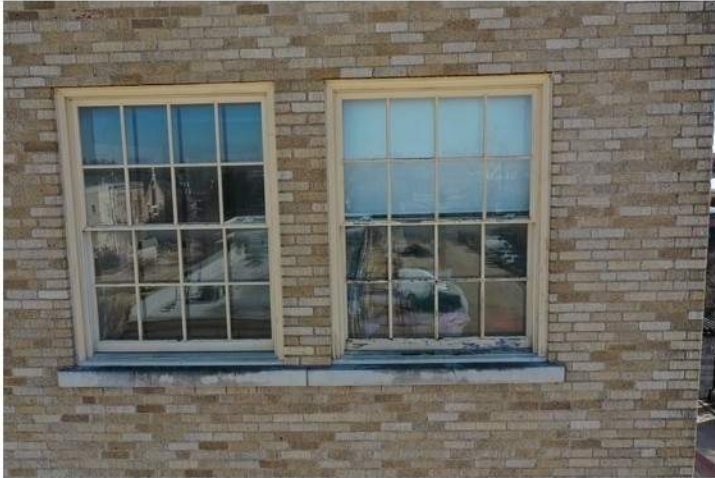
Notes: Wood rot, brick cracking.

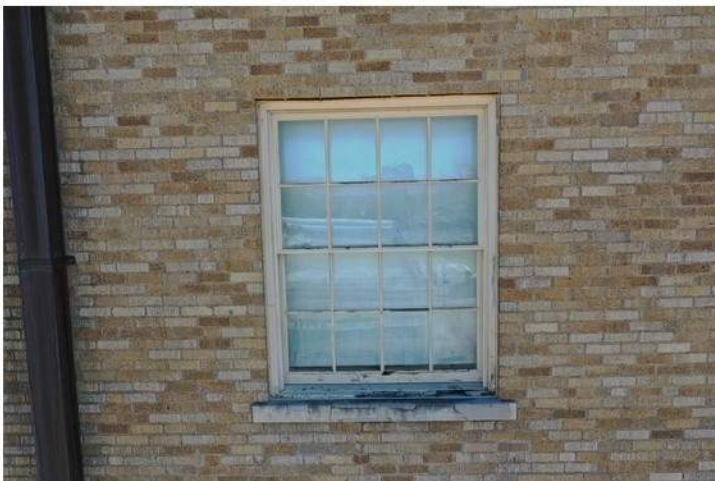
Notes: Wood rot, deterioration of window apron finish.
